**Draft Oldham Town Centre Conservation Area
Appraisal and Management Plan
Supplementary Planning Document**

January 2019

Donald Insall Associates
Chartered Architects and Historic Building Consultants

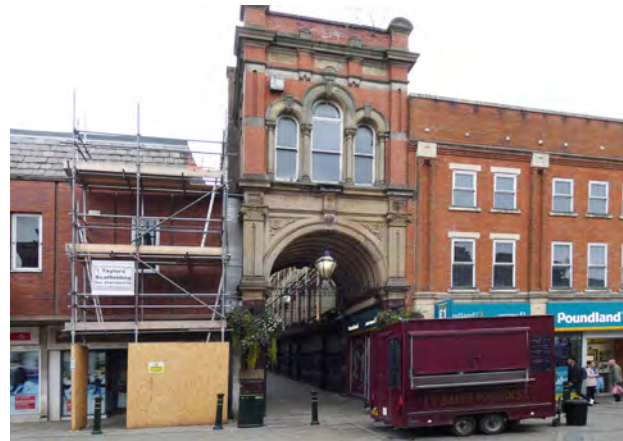
Plate 5.11 Hilton Arcade, recommended for inclusion on local list but marred by poor retail frontage and detracting building at nos.1-3 which cuts away corner

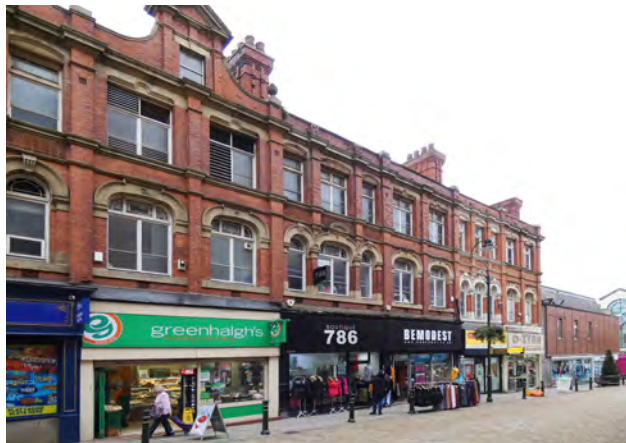
Plate 5.12 Poor retail frontage along Curzon Street at ground floor to Hilton Arcade group

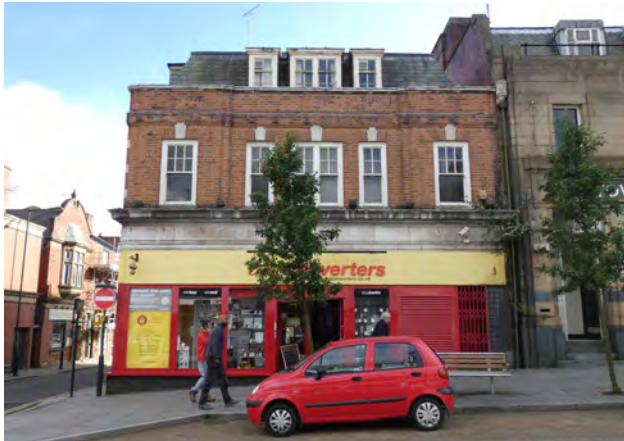
Plate 5.32 Impact of poor quality retail frontage, roller shutters and signage on quality of building above at 22-24 Yorkshire Street

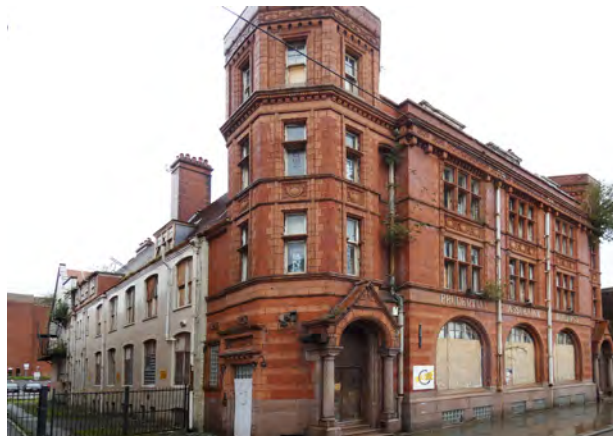
Plate 5.40 Prudential Assurance Building

The Prudential Building was constructed in 1889 to designs by Alfred Waterhouse. It is constructed in red brick with elaborate terracotta dressings set on a polished granite plinth with polygonal towers over the entrance to each side and rich ornamentation. The western return façade is clad in glazed brick. The building is vacant and in a very poor state of repair and is recommended for inclusion on a local heritage at risk register; it occupies a prominent location adjacent to Oldham Central tram stop and is in urgent need of reuse and restoration both for the conservation of the building itself and to improve the identity and wayfinding of the conservation area.

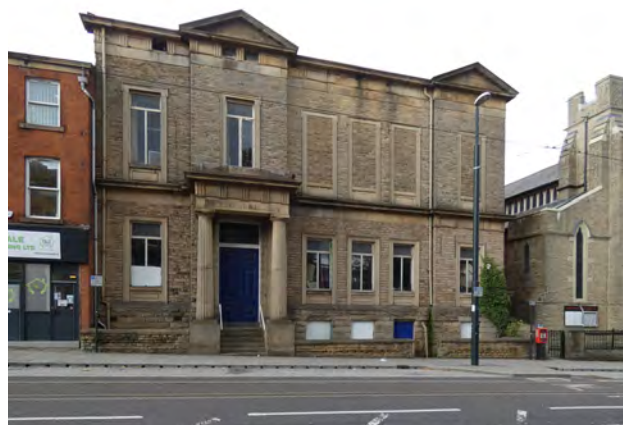
Plate 5.42 The Masonic Hall

The Masonic Hall was constructed in 1880 again in rusticated rubble in the Greek revival style including a portico with fluted Doric columns. A further red brick rear wing was added in 1924. It counterbalances the former post office and library on the facing side of the street and collectively they have a strong visual presence. The building is vacant and in a poor condition; it is in need of reuse, repair and refurbishment to secure its long-term conservation.

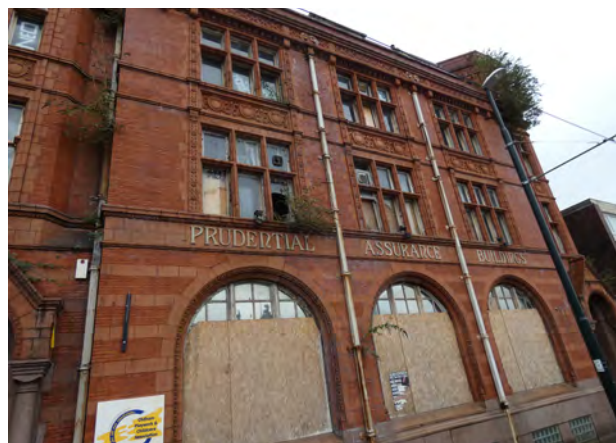
Plate 8.3 The Prudential Building, vacant and in a deteriorating condition

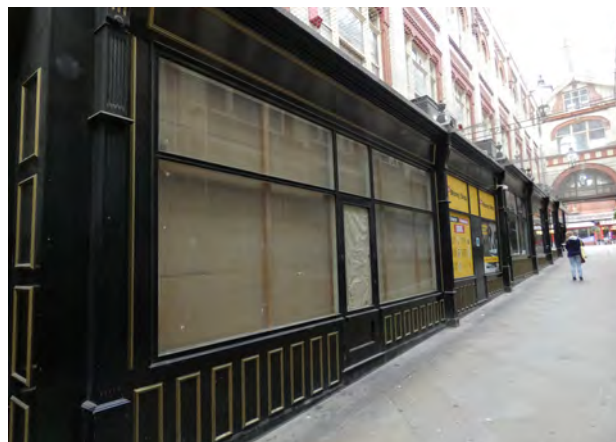
Plate 8.4 Blank shopfronts along the Hilton Arcade

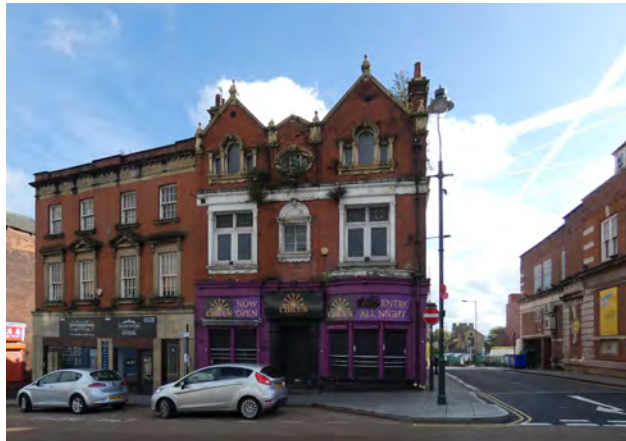
Plate 8.5 Poor condition typical of many buildings within the conservation area

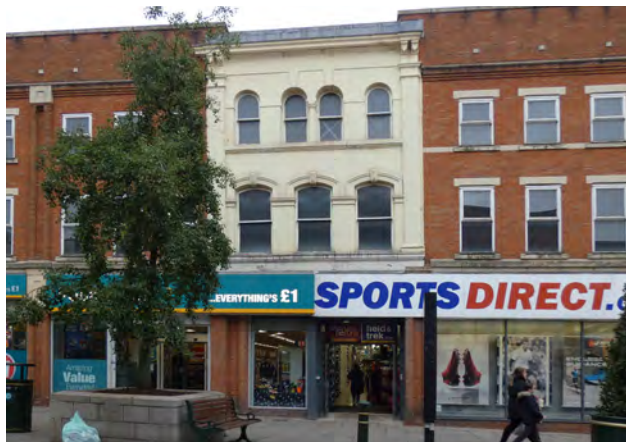
Plate 8.8 Poor shopfronts and signage across 15 -17 High Street which fails to relate to architecture of building above

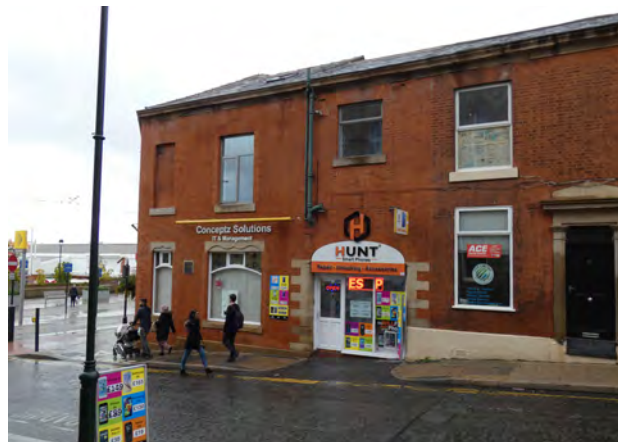
Plate 8.9 Poor shopfront infilling historic archway at southern end of Clegg Street

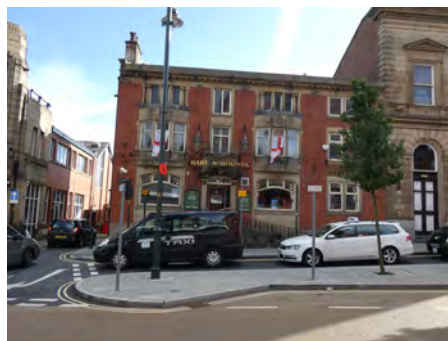
16 Yorkshire Street

Notes: Three storey public house in red brick; stone detailing provides attractive contrast but would benefit from cleaning. Conspicuous cabling and later windows at first and second floors detract; secondary glazing within visible from street level. East return elevation to Hunter's Lane built in three visible phases, stepping down to a single-storey elevation at rear. Conduit and condition of brickwork and windows detract.

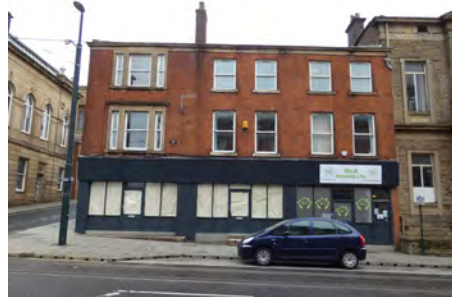
99-103 Union Street

Notes: Domestic scale and use of red brick and stone are positive elements found throughout the conservation area, windows are modern. Nos. 101-103 are of two bays at upper floors, whilst. No. 99 at the corner features tripartite arrangements with stone dressings. Present signage and heavy shopfront fascia detract.

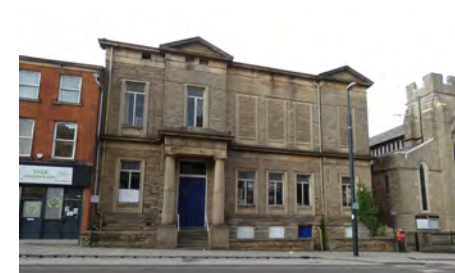
105 Union Street, Masonic Hall

Notes: Asymmetrical frontage in Greek revival style provides interest, but present condition detracts from the character of the conservation area, including laminating brickwork, poor repointing repairs, visible water ingress, broken pipes, etc. To the rear, a four-storey wing in red brick with stone detailing; blocked windows and a modern upper-storey extension are visible from Firth Street and detract. New use needed.

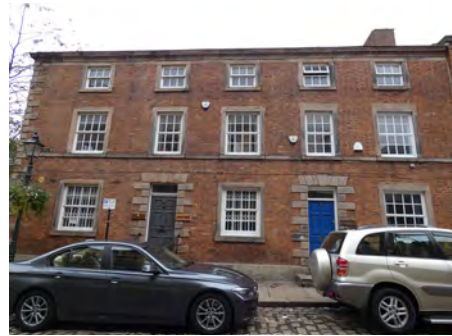
7-9 Church Lane

Notes: Pair of three-storey Victorian houses, in red brick with stone dressings and slate roofs. Rusticated stone entrance architraves, windows are later replacement. Detracting factors include visible alarm boxes and interior security grills to ground floor windows.

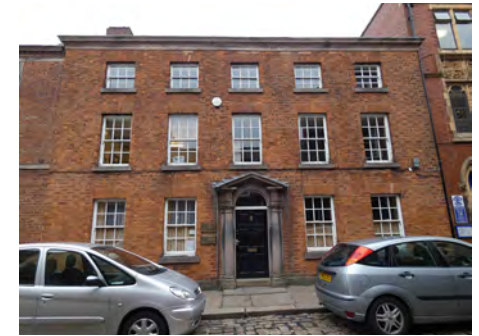
11 Church Lane

Notes: Three-storey Victorian house in red brick with stone dressings and slate roof. Symmetrical frontage of five bays. Detracting factors include horn detail to multiple replacement windows, visible cabling and alarm boxes.

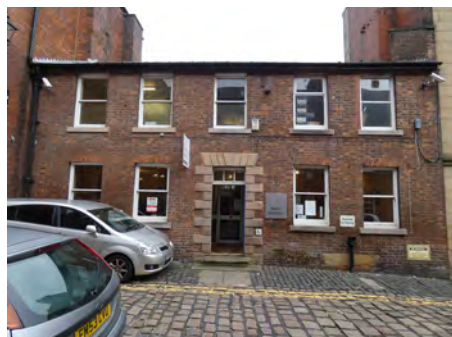
8 Church Lane

Notes: Two storey Victorian frontage in red brick with central principal entrance, domestic scale. Replacement windows in original openings. Extends into rear of bank building to west and south. Detracting elements include opaque window treatments, modern vents inserted in windows, CCTV cameras and inappropriate signage.

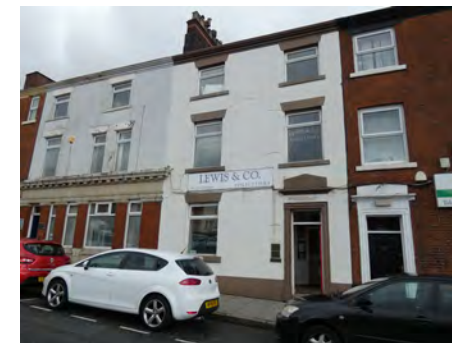
21 Queen Street

Notes: Fully rendered and modern windows throughout detract from the red brick of the wider range. Cracking to render visible in places.

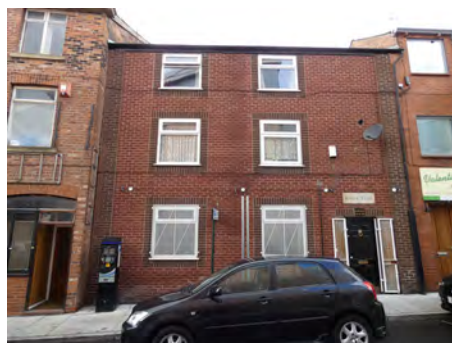
14-16 Retiro Street

Notes: Modern three-storey apartment building in red brick, with interesting brown-brick surrounds to the windows, which maintain Victorian proportion found elsewhere throughout the conservation area. Modern security grilles at the ground floor detract.

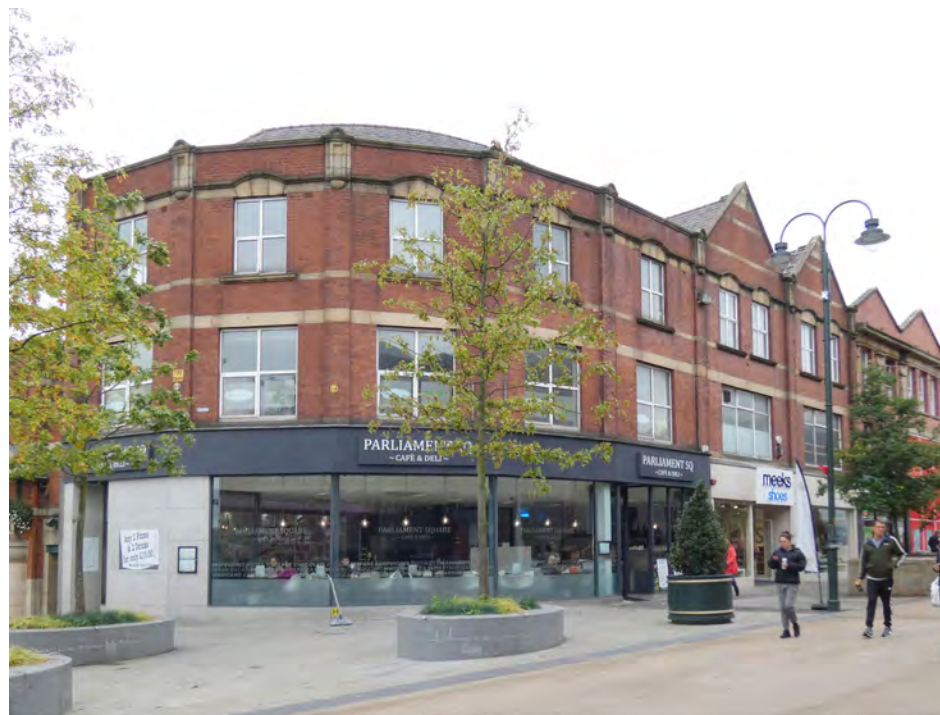
26-34 High Street

Notes: Three storey retail and office building in red brick with stone banding, wraps around to Parliament Square. Gables to High Street elevation. Windows are modern replacements in a style which detracts from the character of the building. Loss of original pilasters detracts from the frontage at the ground floor; shopfront are large and bulky for the most part. Signage to Parliament Square is fine, but background is poor. Poor signage to shoe shop.

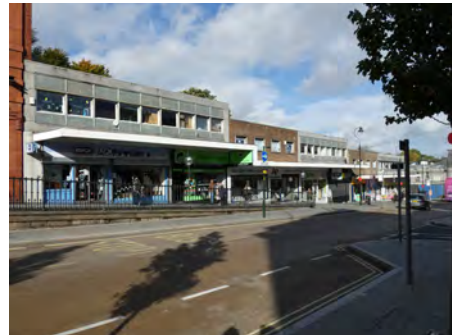
21-41 Yorkshire Street

Notes: While this frontage offers interest as a mid-century commercial block in tile which appropriately steps down from the top of Yorkshire Street, its projecting canopies, mixed signage and overall condition clutter and jar with the adjacent late-Victorian streetscape. East return elevation to St. Mary's Way is blind, in red brick, turning its back onto a vehicular route into the conservation area. Cluttered rear elevations, roller shutters and car parking facing historic route of Old Church Street also detract.
