Adopted Oldham Town Centre Conservation
Area Appraisal and Management Plan
Supplementary Planning Document

August 2019

Donald Insall Associates
Chartered Architects and Historic Building Consultants

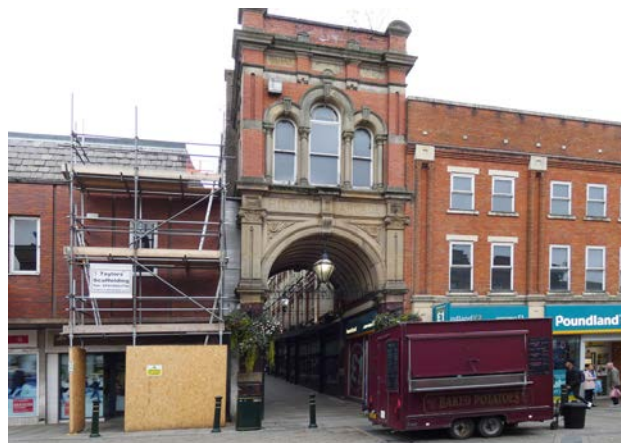
Plate 5.11 Hilton Arcade, recommended for inclusion on local list but marred by poor retail frontage and detracting building at nos.1-3 which cuts away corner

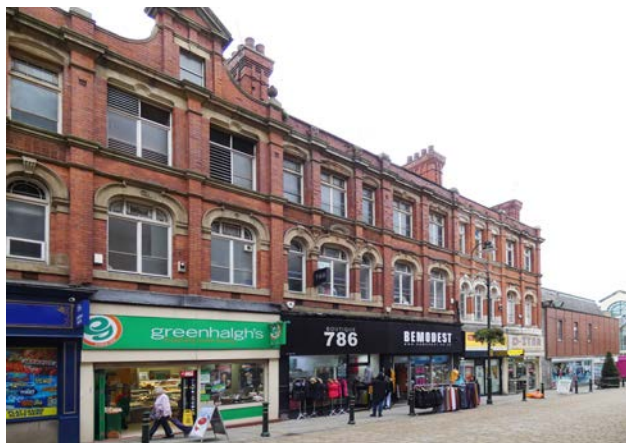
Plate 5.12 Poor retail frontage along Curzon Street at ground floor to Hilton Arcade group

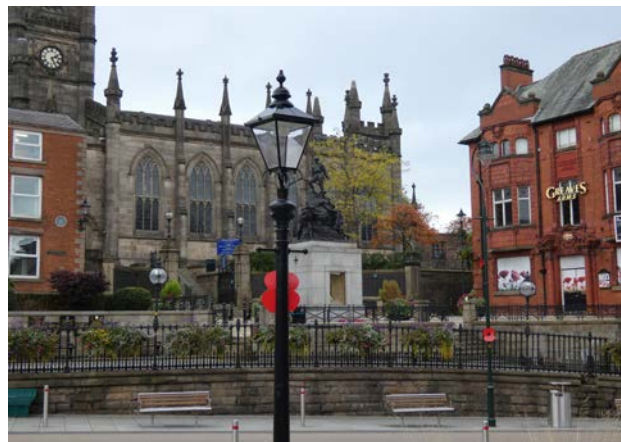
Plate 5.18 Listed war memorial set on terracing with Church of St Mary and St Peter behind and the Greaves Arm to its right

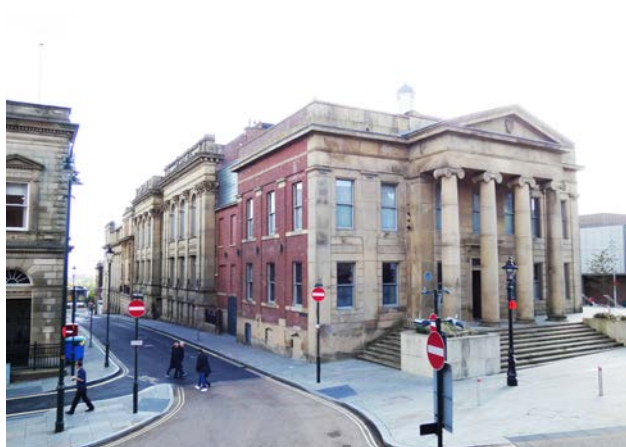
Plate 5.20 Eastern facade of former Town Hall extending southwards along Greaves Street

The Town Hall was constructed in 1841 and extended in 1879-80 by George Woodhouse of Bolton and Edward Potts of Oldham. The main block facing Yorkshire Street is in an austere Greek revival style, faced in ashlar, rusticated to ground floor and with an Ionic portico spanning the central three bays of seven. The long ranging extensions to Greaves Street and Firth Street also remain. The building was vacant and in a very poor condition from the 1980s until a major scheme to convert it into a leisure complex including a cinema and restaurants by BDP was completed in 2016. This scheme has brought about major change at the heart of the conservation area including a substantial extension to its west side and new surrounding public realm.

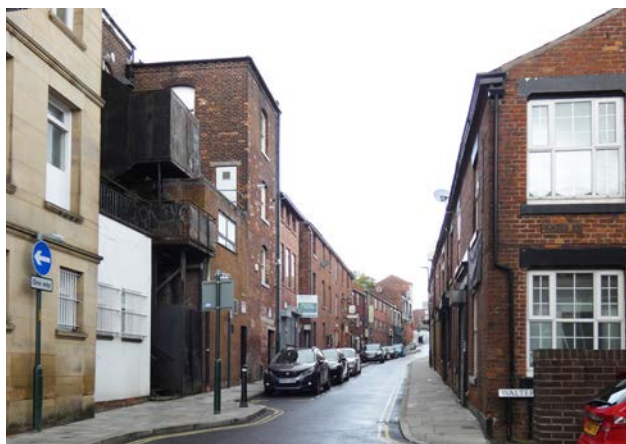
Plate 5.24 Looking north along Greaves Street and run of high quality buildings which mediate change in levels and form worthy neighbours to listed Town Hall

These streets follow the north-south axis running between Yorkshire Street and Union Street. Typically lined with domestic-scaled terraces of small-scale plot sizes and continuous rooflines which follow the slope of the hill. Whilst residential in character the buildings are typically in office/commercial use. A number of shared features are retained, including a continuous cornice to the eaves line, chimneys and window/door compositions; whilst numerous windows have been replaced these tend to be sash-style windows which do not shout out as modern features, however oversized casements and poor signage detract. The significant change in levels allows for larger-scale buildings to be accommodated; at their southern end they meet Union Street, providing bookends of more substantial buildings at both the northern and southern terminations **[Plates 5.24 and 5.25]**.

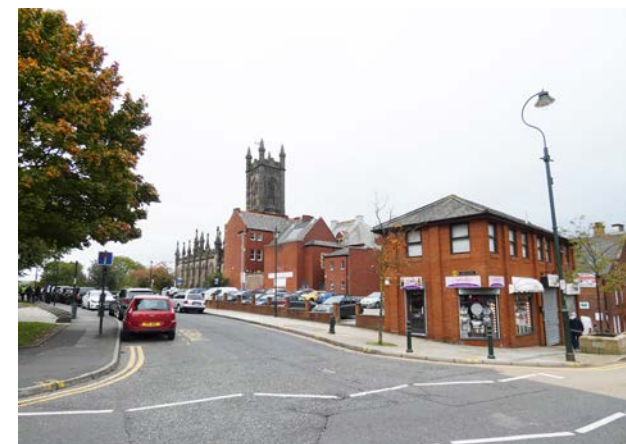
Plate 5.26 Church Lane with the Church of St Mary and St Peter terminating the view and the return elevation of Barclays Bank in the foreground

Church Lane has an intimate and domestic character which is unique to the remainder of the conservation area. It is the oldest intact street in the conservation area marred only by poorly-considered road markings, signs and poor infill to the cobbled streets. The narrow road width, the height of the flanking buildings and their architectural character gives a deeply historic atmosphere, as if one has stepped into another world from the town centre. Whilst the later (1827-30) Church of St. Mary and St. Peter now terminates the view, Church Lane forms part of a prehistoric route which passed through the town, running in front of the former parish church before the enlargement of the churchyard and lowering of the now-severed Church Street, in 1805. The buildings are almost entirely listed – including the cobbled road. The use of the street is predominately legal/office use following the opening of the County Court in 1894, which steps up in scale towards the church; however, this is now run by the Methodist Church as café and youth centre and the buildings which originally stood at the south-western end of the street have long since been demolished and replaced by the chambers of Barclays Bank and to facilitate road-widening schemes **[Plate 5.26]**.

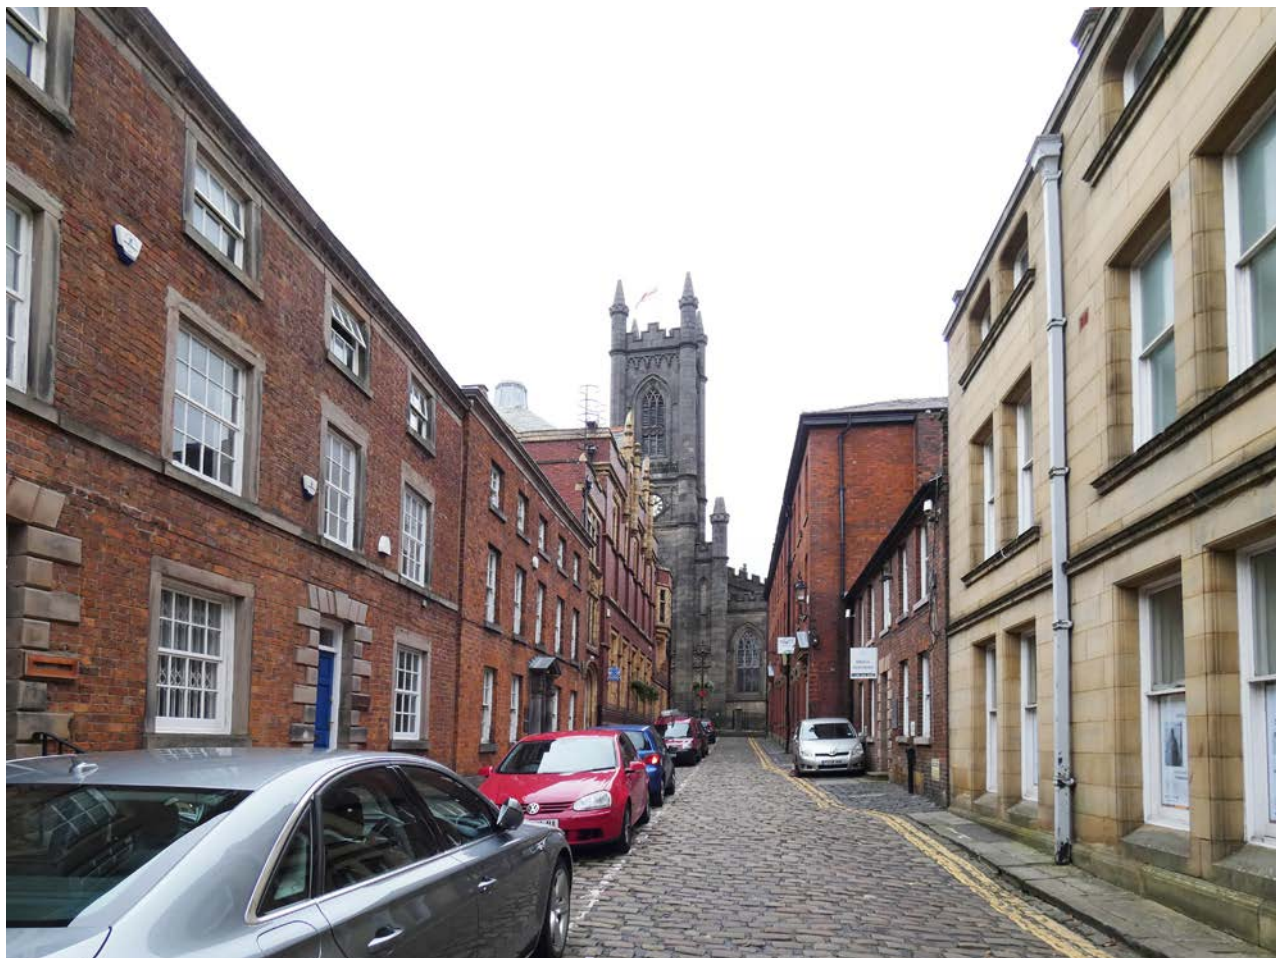
Plate 5.27 Church Passage connecting Church Terrace and Church Lane

Church Passage is a narrow passage which runs alongside the church grounds and connects Church Terrace, Church Lane and Rock Street **[Plate 5.27]**. A further alleyway runs up the side of the Prudential Building; this is a tight space which currently feels underused and not particularly inviting, not least because of the obviously vacant and deteriorating character of the Prudential Building itself **[Plate 5.28]**. The pedestrianised area which forms the southern boundary of the Cultural Quarter also has an intimate character, set within the heart of the key buildings which surround it, away from the principal thoroughfare of Union Street **[Plate 5.29]**.

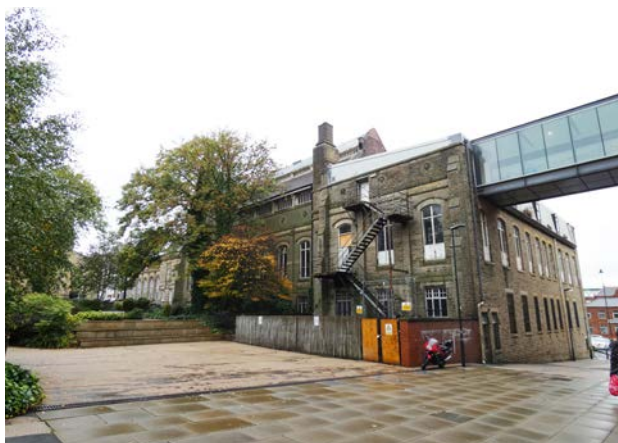
Plate 5.30 Typical 'back-of-house' appearance of buildings as seen from back streets behind

Set behind the secondary streets which run north-south there are a number of back streets which are typically lined by the rears of the buildings facing the secondary streets, often including car parking and exhibiting poor-quality extensions and alterations and plant equipment **[Plate 5.30]**. These necessary, 'back-of-house' streets are in places given undue prominence owing to the large surface level car parks which have formed chasms in the tight built form. These become even more intimate in places where buildings are tightly knitted together, such as between Church Terrace and Church Lane and along Plate Street **[Plate 5.31]**.

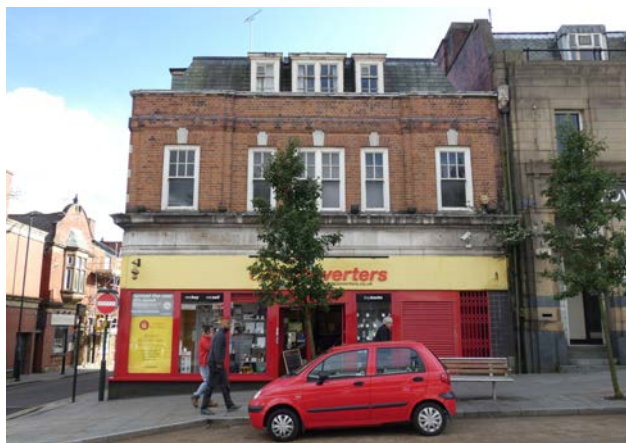
Plate 5.32 Impact of poor quality retail frontage, roller shutters and signage on quality of buiding above at 22-24 Yorkshire Street

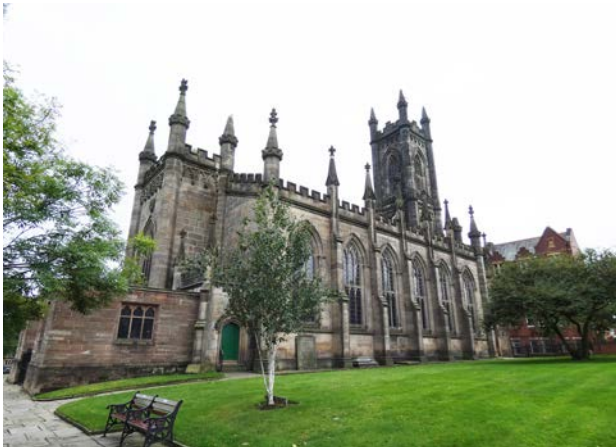
Plate 5.37 Church of St Mary and St Peter

The Church of St Mary and St Peter is Oldham's Parish Church, built in a simple gothic style in coursed and squared rubble to designs by Richard Lane between 1827-30. It comprises a west tower with clasping porches, nave and aisles accommodated under a single Welsh slate roof. The lining buttresses break the roofline with decorative pinnacles. A church has existed on this site since 1280, the current church being constructed to meet the growing population that the Industrial Revolution brought to the town.

The church is constructed in Kinder Scout Grit with the late-20th century vestries at the eastern end constructed in Liverpool Red sandstone taken from St. Peter's Church, demolished for the construction of the Spindles Shopping Centre [Plate 5.66]. Church Lane contains original local sandstone buildings refaced in brick, but with sections of sandstone exposed on Church Passage [Plate 5.52]. The church retaining wall which runs along Church Street comprises a mix of Oldham Edge stone at the bottom with local sandstones on top [Plate 5.19].

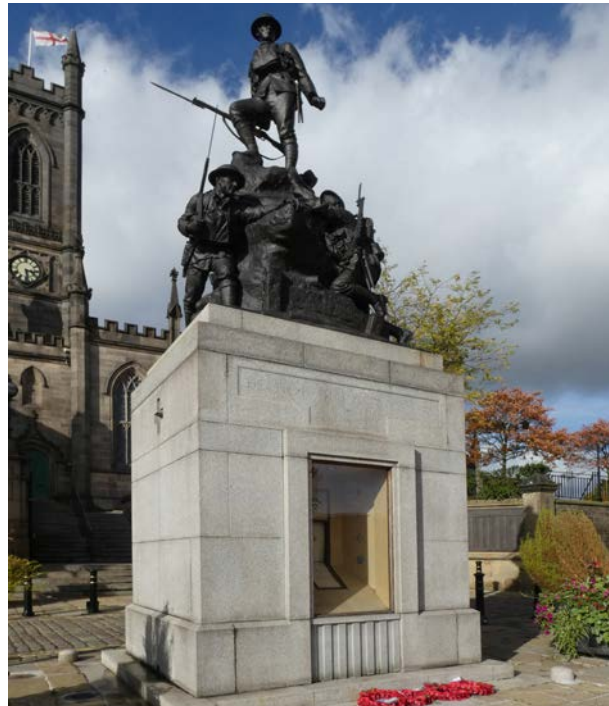
Plate 5.38 War Memorial

The listed status of the war memorial also includes the memorial wall, piers, gates and steps to St Mary's churchyard and forecourt walls, steps and balustrade (south side) and the railings to St Mary's Churchyard (west side). The list description notes that whilst the ensemble is listed as a group, it is only the war memorial components which warrant the II* status.

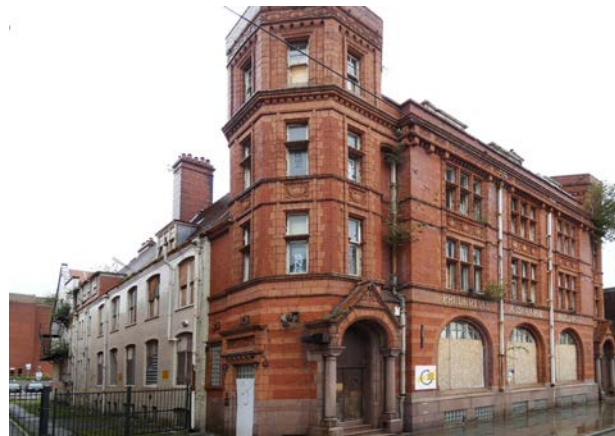
Plate 5.40 Prudential Assurance Building

The Prudential Building was constructed in 1889 to designs by Alfred Waterhouse. It is constructed in red brick with elaborate terracotta dressings set on a polished granite plinth with polygonal towers over the entrance to each side and rich ornamentation. The western return façade is clad in glazed brick. The building is vacant and in a very poor state of repair and is recommended for inclusion on a local heritage at risk register. It occupies a prominent location adjacent to Oldham Central tram stop and is in urgent need of reuse and restoration both for the conservation of the building itself and owing to the significant potential it presents for improving the identity of, and wayfinding into, the conservation area.

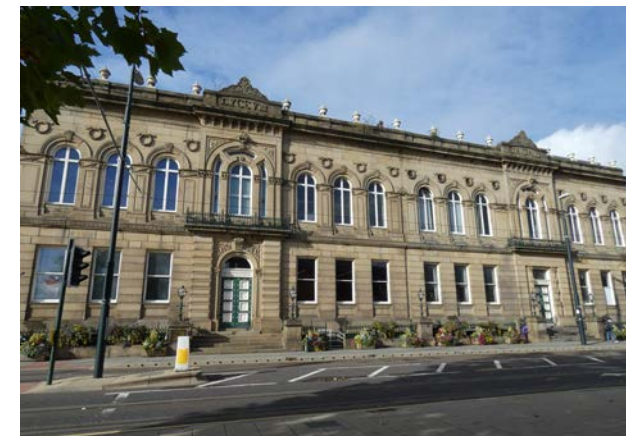
Plate 5.41 The Lyceum

The Lyceum and Art School were built in a single block and form one of Union Street's earliest buildings. The Lyceum was constructed in 1856 with the art school added in 1881 to designs by Pennington's of Manchester; it is of outstanding quality and is an important part of the Union Street townscape. The block exhibits an elegant neoclassical stone frontage with cast iron lanterns and robust railings, urns at the roofline and well-kept greenery all contribute positively to streetscape. Pediments to bays within each half of the building are inscribed with 'Lyceum' and 'Science and Art'. The Neoclassical design and fenestration pattern continues across the return elevations wrapping around to both Clegg Street and Greaves Street. Later white railings within the lightwells detract from the otherwise high quality decorative ironwork; the vacant half of the building is in a poor condition and a new use is required.

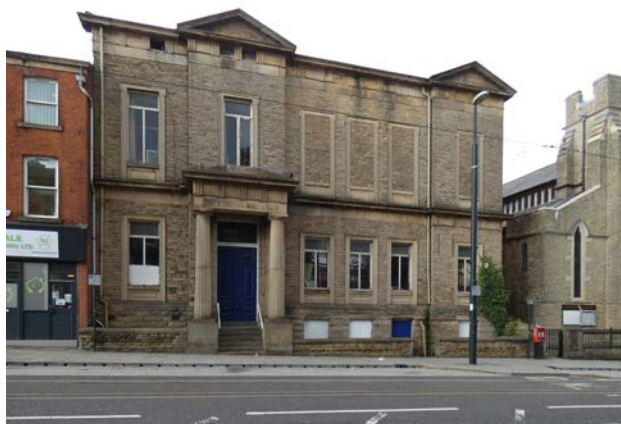
Plate 5.42 The Masonic Hall

The Masonic Hall was constructed in 1880 again in rusticated rubble in the Greek revival style including a portico with fluted Doric columns. A further red brick rear wing was added in 1924. It counterbalances the former post office and library on the facing side of the street and collectively they have a strong visual presence. The building is vacant and in a poor condition; it is in need of reuse, repair and refurbishment to secure its long-term conservation.

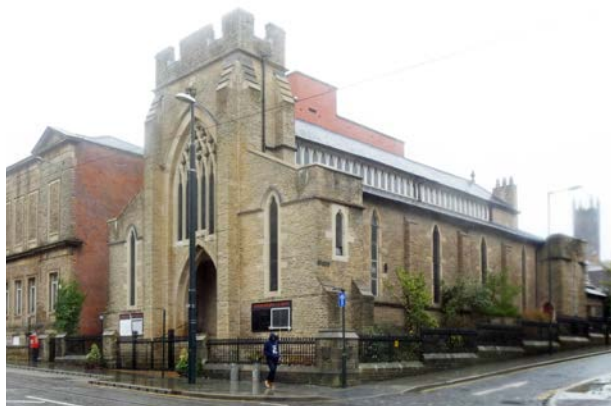
Plate 5.43 United Reform Church

The United Reformed Church was built in 1877 and was formerly a Congregational chapel. It follows the pattern for rusticated rubble with a squat central tower in the south wall with a six- light decorated window and wide plain stepped Early English arch to porch. The church sits next to the Masonic Hall and forms part of the grand architectural group with the former post office and library. The church is currently on Historic England's At Risk Register although it is noted that it has recently been the subject of a scheme of repair and refurbishment.

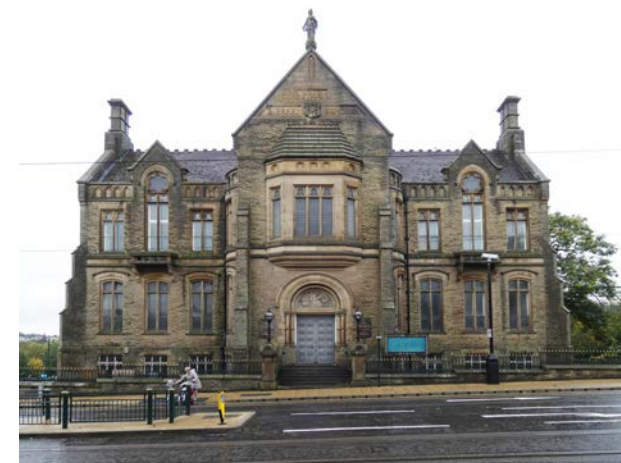
Plate 5.44 Former Central Library

The Library and Art Gallery were constructed in 1883 (with additions in 1894) in rusticated rubble, with a Romanesque style entrance and cresting to the pitched roof ridge. To the street frontage the cast-iron railings and terminating piers flanking the entrance steps with cast-iron globe lamps are good examples within the conservation area. Vacated by the new library and gallery constructed to the rear, the building is soon to be brought back into use as a Heritage Centre.

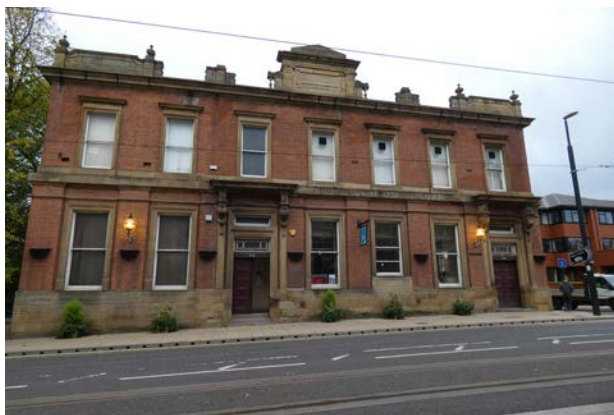
Plate 5.45 Former Post Office

The Post Office building was built in 1877; constructed in brick with stone dressings and a shallow pitched roof in the neoclassical style. In most recent times it has been in use as the Local Studies Archive which is now to be relocated into the former library building.

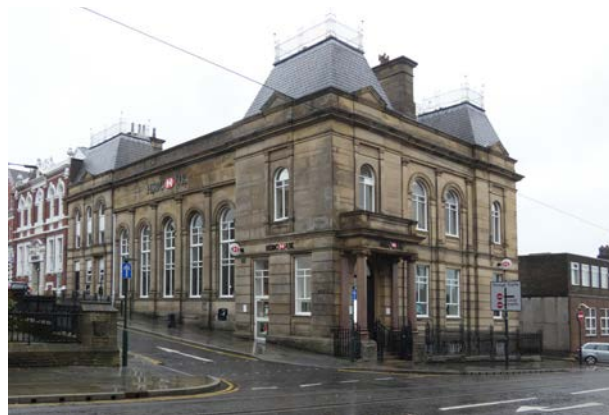
Plate 5.46 109 Union Street

The bank building dates from 1892; it exhibits a French Renaissance style; the steep hipped roofs of the outer pavilion towers are of particular interest crested with ironwork detailing.

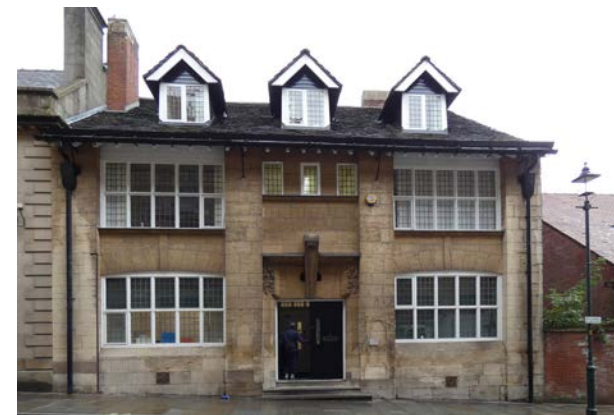
Plate 5.47 5 Greaves Street

The office building by Edgar Wood was built in 1901-02; it has a handsome ashlar frontage with full height pediments defining the three bays and Arts and Crafts detailing.

Whilst stone was the prevailing building material until the introduction of the railway, this is no longer a defining feature of the buildings in the conservation area (other than as decorative dressings [Plate 5.65], although it is possible stone remains but is now refaced in brick. The buildings within the conservation area can be generally divided into two construction materials: brick with stone dressings for the majority, with the higher status and/or civic buildings faced in sandstone. The latter is principally York stone, although there are interesting exceptions such as the Old Bill on Greaves Street [Plate 5.58] faced in local sandstone (from Oldham Edge, easily transported owing to its close proximity) and Edgar Wood's building at 5 Greaves Street [Plate 5.47], faced in Bath limestone.

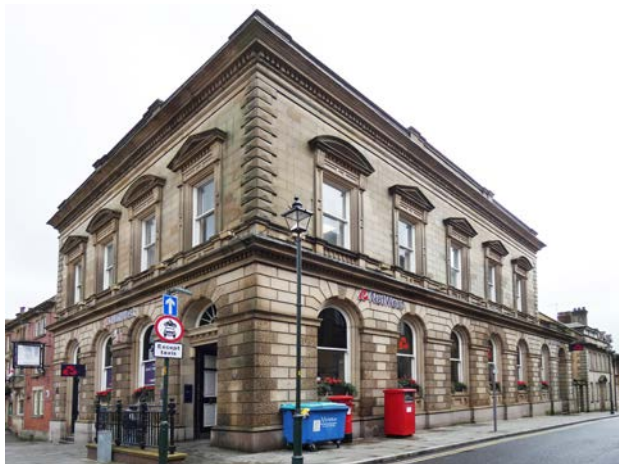
Plate 5.48 10 Yorkshire Street

Constructed as a bank in 1890 to a neoclassical design, the stone-faced facade forms an elegant pair with the former Town Hall.

The two banks at the heart of the town centre (Nat West and Barclays [Plates 5.48 and 5.51]) are both faced in stone; Darley Dale gritstone above on imported black gabbro; and coal measures sandstone above on Scottish Delbeattie Granite, respectively. The Former Town Hall is also constructed in coal measure sandstone; with Millstone Grit used for the plinth to the extension in Firth Street.

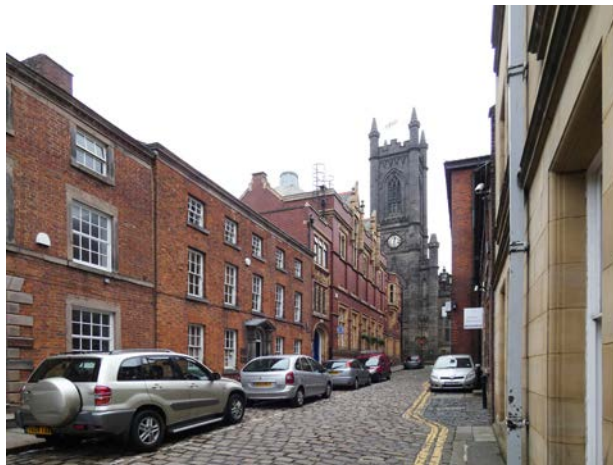
Plate 5.49 Listed buildings on north side of Church Lane

The listed buildings on Church Lane include the former Court House and Offices constructed in 1894 to designs by Henry Tanner in red brick with white terracotta dressings. The decorative and grand building at the north-west end of Church Lane is now in religious use as a café and community centre.

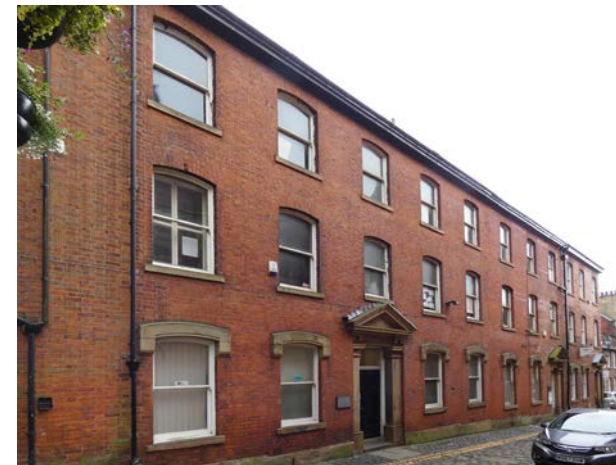
Plate 5.50 Listed buildings on south side of Church Lane

7, 9 and 11 Church Lane were originally constructed as houses c.1800 in brick with stone dressings; on the facing side of the road 8 and 10-14 Church Lane were also constructed c.1800 – 10-14 a grander group of three-storeys with stone dressings.

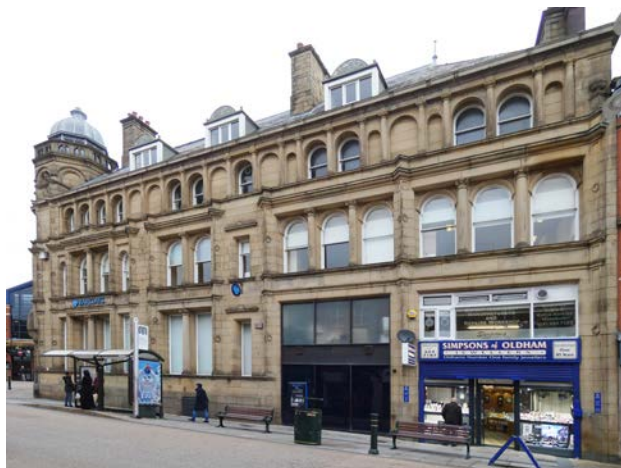
Plate 5.51 25 and 37 High Street

The Barclays Bank occupies a prominent location on the corner with Lord Street with four principal bays to High Street, a single return bay to Lord Street and a seven bay rear elevation fronting onto Church Lane; all ashlar faced. The main entrance is set in a canted angle with a tower and dome over.

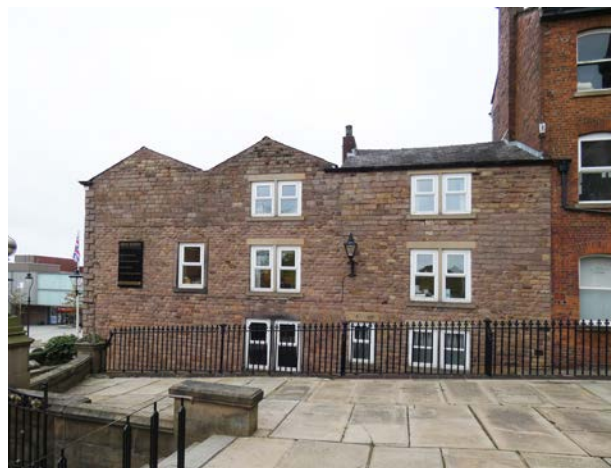
Plate 5.52 11 Church Terrace side return to Church Passage with sandstone finish

Originally constructed as a house in the early 19th century, although an earlier 18th century structure may also remain. The façade is constructed in brick on a stone plinth; the return elevation to Church Passage is stone – with poor quality uPVC windows.

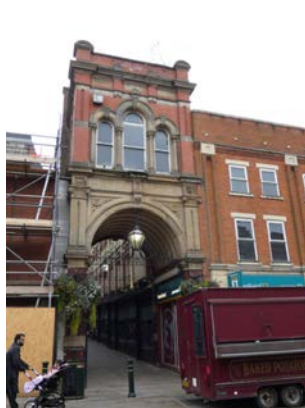
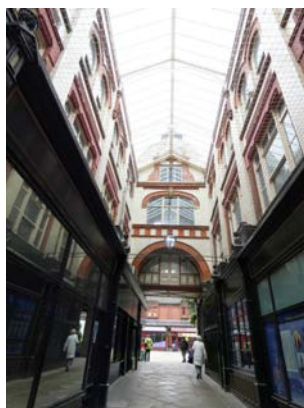
Plate 5.53 South face of Hilton Arcade

Plate 5.54 Interior of Hilton Arcade

Group Value: The Albion Street and Curzon Street facades are largely intact, forming a prominent feature in the conservation area with handsome stone detailing (although the modern shopfronts and signage and in places the condition detract). The corner building at 1-3 High Street is a modern building which bears no relationship to the arcade in terms of its scale, composition or design and as a consequence detracts to both its High Street and Curzon Street elevations. Nos. 15 and 17 High Street to its western side have been redeveloped and have a more comfortable relationship to the High Street elevation (and unapologetically contrasting to Albion Street replacing Market Avenue, the original arcade).

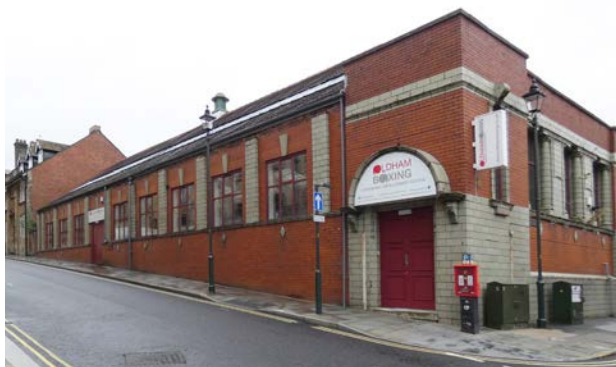
Plate 5.57 Victoria House, Greaves Street

Terracotta and faience-faced buildings are also found within the conservation area. The materials are used principally as decorative devices on buildings of architectural quality, such as Victoria House in Greaves Street which incorporates faience elevations to break down and model the massing of its large footprint [Plate 5.57]. Glazed bricks are also found within the conservation area, typically in more confined, intimate spaces to reflect light into tight-knit spaces.¹⁶

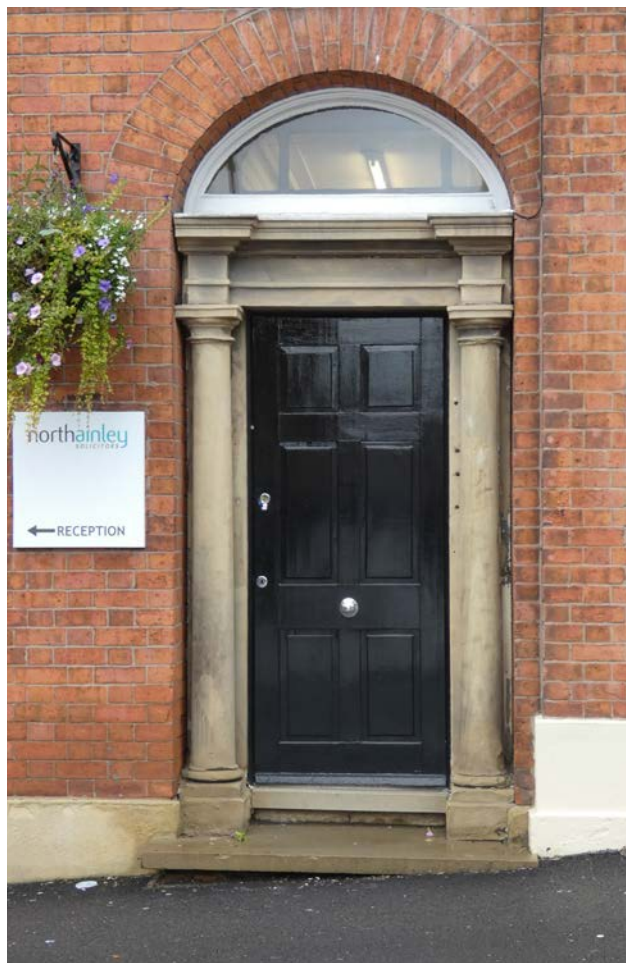
Plate 5.65 Stone doorcase to vernacular brick building on Clegg Street

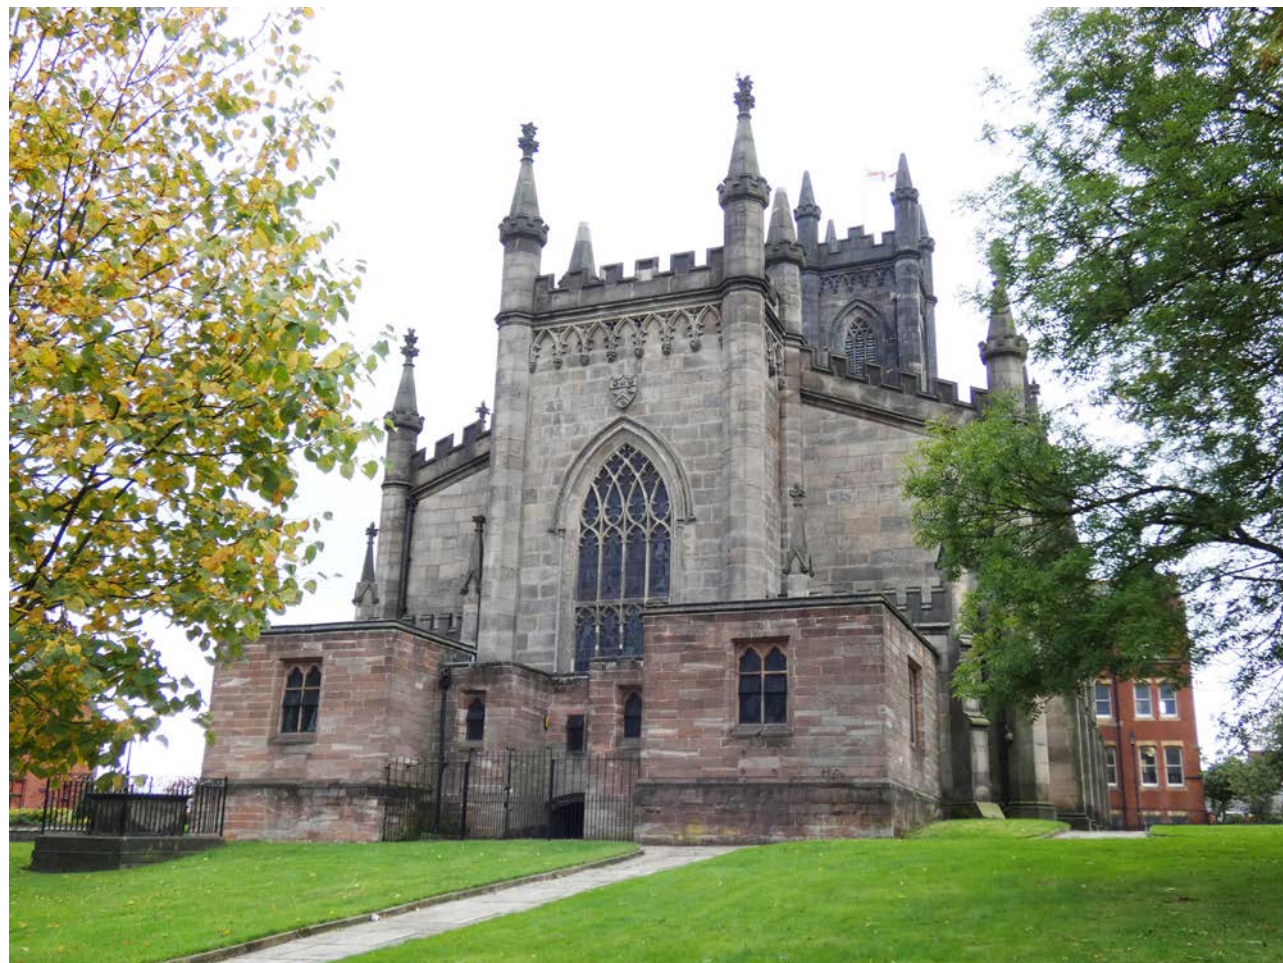
Plate 5.66 Liverpool Red sandstone to Church of St Mary and St Peter eastern vestries

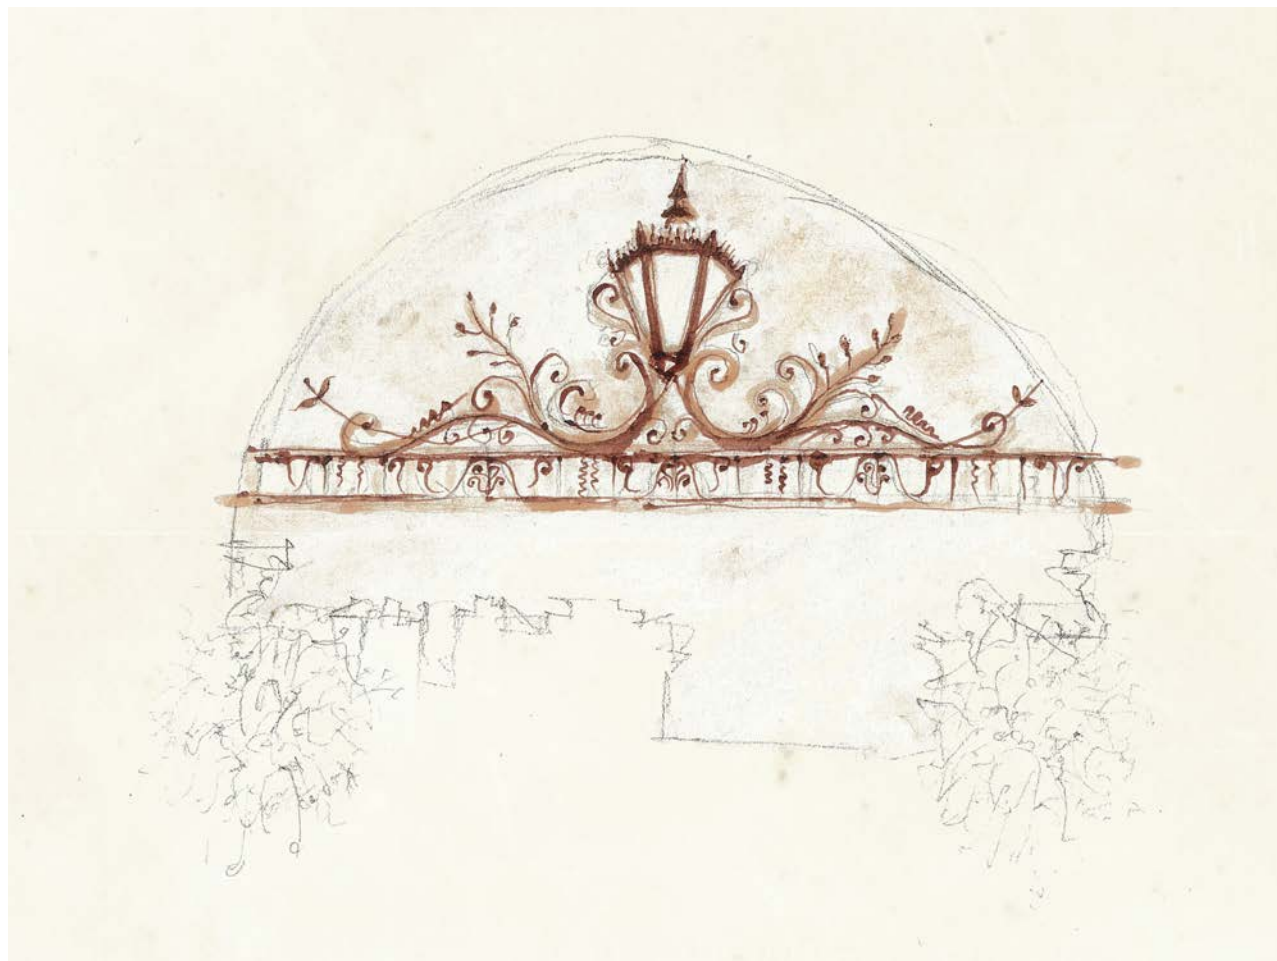
Plate 5.69 Decorative ironwork at entrance to Hilton Arcade

Ironwork is used as a decorative feature to the buildings of higher status in the area; the best example of this is to the Lyceum, where the high-quality detailed ironwork forms a key part of its overall aesthetic, although the utilitarian white handrails, etc. to the lower ground floor detract. Lanterns mounted on piers flanking the entrance stairs are also handsome features. Good examples also feature to the former library and within the Hilton Arcade; the decorative ironwork on its front façade is also a feature of interest [Plates 5.67 - 5.69]. The ironwork cresting to the steeply pitched roof of the

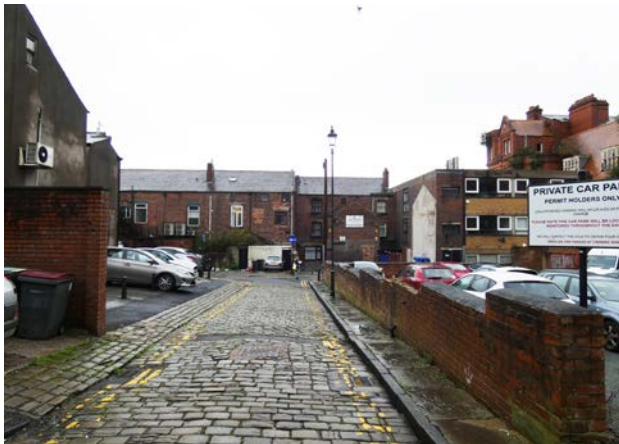
Plate 7.1 Cobbled roadway to Harrison Street

Outside of the largely pedestrianised/shared surface areas discussed below, the roads are typically tarmacked with large York stone flags for the pavements with kerb edges. To the southern end of Greaves Street a rare section of riven-finished York stone flags remains and Harrison Street on the western edge of the conservation area has a cobbled roadway **[Plate 7.1]**.

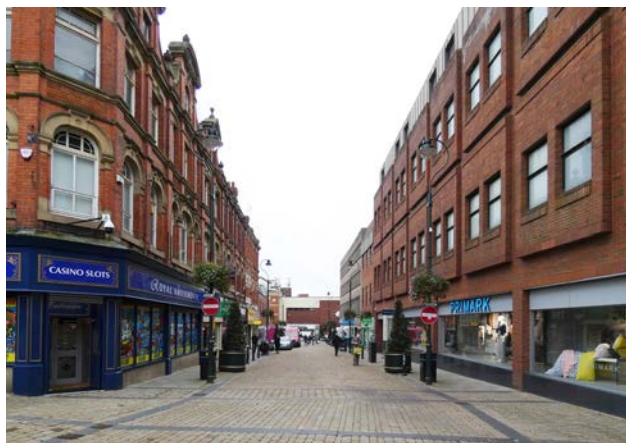
Plate 7.2 Level pedestrianised surface demarked by granite setts and bollards

The entire town centre retail area (both inside and outside of the current conservation area boundary) benefits from a uniform hard surface of large York stone flags to the footpaths and smaller setts within the roadway, which is both attractive and durable and very much adds to the character of the area. Larger granite setts define crossing points and add visual interest to larger open areas of paving such as to Albion Street. The town centre has a shared surface with no level change between the footway and roadway, instead defined again by the granite setts and bollards (discussed below). As High Street extends in front of the former Town Hall the roadway is tarmacked, but otherwise the finish remains the same **[Plates 7.2 and 7.3]**.

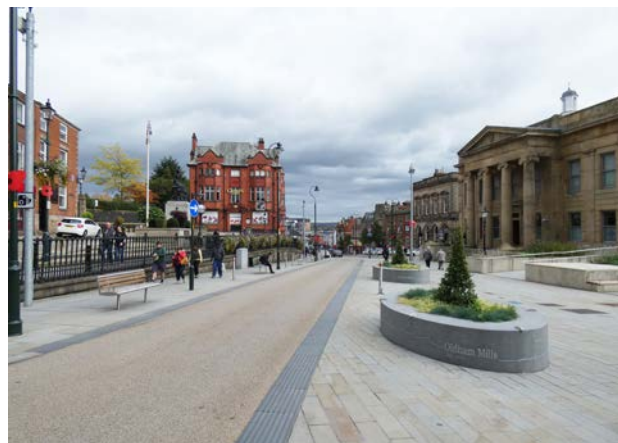
Plate 7.3 Shared surface running along northern edge of Parliament Square with tarmacked roadway

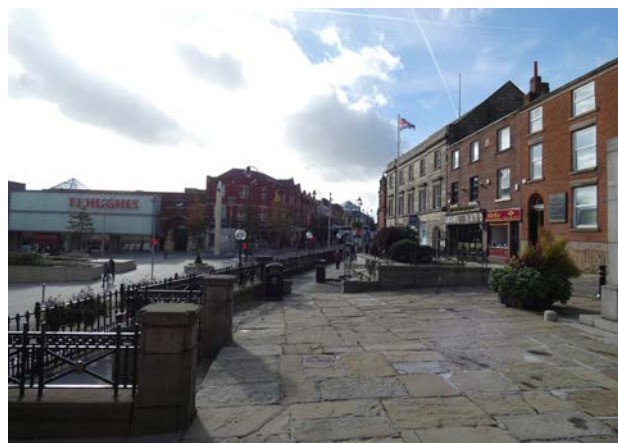
Plate 7.6 Terrace in front of war memorial

Church Lane, Terrace and Street retain large square setts; whilst asphalt infilling and recovering, road markings and parking detract they still make a significant contribution to the overall quality and historic character of these spaces. Church Passage, the steps and area in front of church and surrounding the war memorial are all laid with York stone flags **[Plate 7.6]**; to the churchyard these include memorial flags **[Plate 7.7]**.

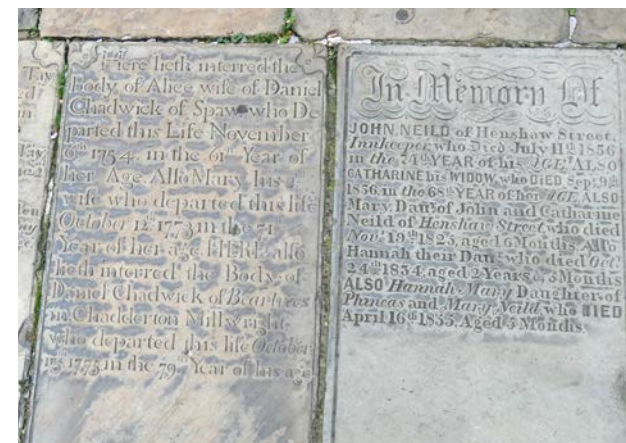
Plate 7.7 Memorial stones in church yard

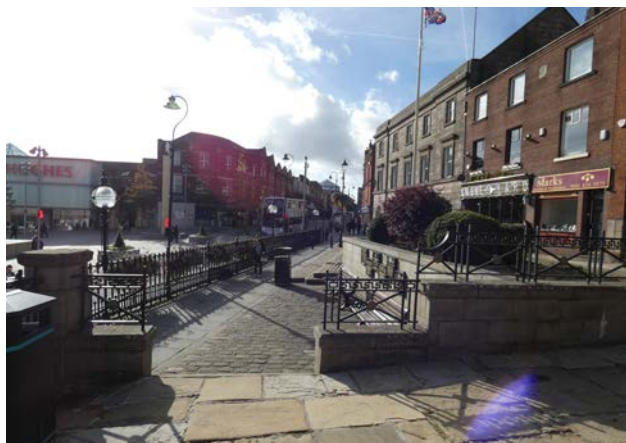
Plate 7.14 Railings and lamps integral to quality of terracing surrounding war memorial and leading up to church

Iron railings are a feature within the conservation area – particularly to the listed buildings along Union Street, as would be expected of their set-piece design and location on a boulevard of this nature. The Grade II-listed 19th century cast iron railings with integrated street lamps around the churchyard and war memorial are of the finest quality, reflective of the importance of this civic space at that time. They now occupy a prominent feature within the reworked public space alongside the steps, rising footpath and walls **[Plate 7.14]**.

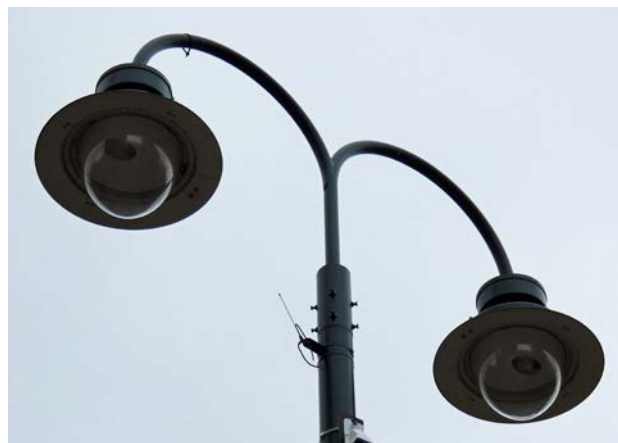
Plate 7.15 Modern decorative street lights

Street lamps are predominately modern but of a consistent decorative design throughout the High Street and down into Yorkshire Street up to St. Mary's Way; here the design changes but remains consistent **[Plate 7.15]**. Along Union Street, which includes the tramway are utilitarian highways lamps, as well as to some of the side streets. The area surrounding Parliament Square and the war memorial becomes confused where a number of different street lamp styles (linked to different public realm schemes) meet. Within the streets surrounding the former Town Hall this includes ornate lanterns which reflect the design of the remaining historic lamp standards on Rock Street, to Church Terrace and those which have been repositioned in front of the Former Town Hall **[Plate 7.16]**. Supplementary street cameras and lighting are utilitarian in character and of no merit but are a necessary evil.

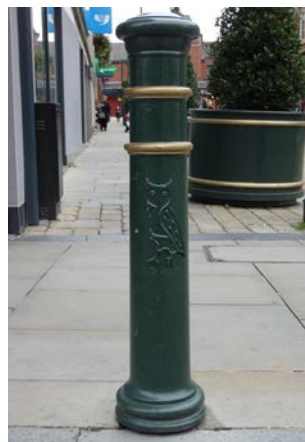
Plate 7.17 Street bollard with owl

Bollards feature heavily in Oldham, in part of owing to the shared surface through the town centre. They are typically finished green with gold bands and the remaining original ones are also embossed with the

Oldham owl (these have been reinstalled with no consistency to the direction the owl faces) **[Plate 7.17]**. Planters throughout the retail area are a mix of more substantial stone planters and round units in the same green finish with gold bands. There is a general build-up of street clutter, however this is largely all set on the same line and other than the proliferation of litter bins and unsightly telecommunications cabinets this is largely limited to the planters, bollards and benches – although food vans which park on High Street add further obstructions **[Plate 7.18]**. At the ends of the pedestrian areas are gates; these typically follow the style of the traditional green bollards **[Plate 7.19]**, although to the southern end of Parliament Square these are modern bollards which can be lowered into the ground. Discreet, modern wayfinding signs have been installed, although they struggle to compete with the busy retail environment along High Street, whereas near the tram stop on Union Street wayfinding is distinctly lacking **[Plate 7.20]**. The 'historic' street signs again in green with a gold trim are attractive and give a sense of the historic town centre; although these are perhaps too subtle as markers of the conservation area **[Plate 7.21]**.

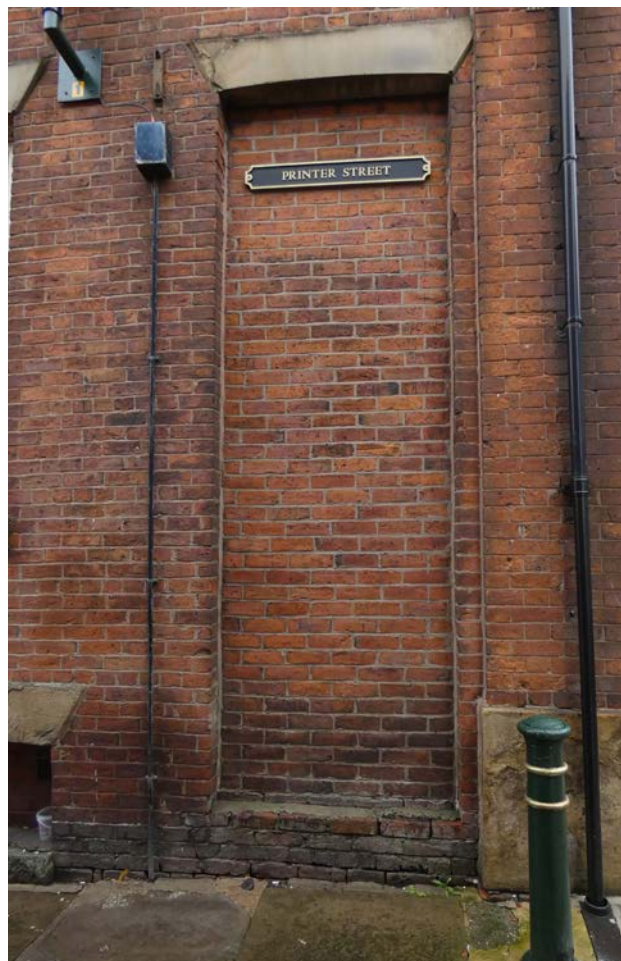
Plate 7.21 'Historic' street signs

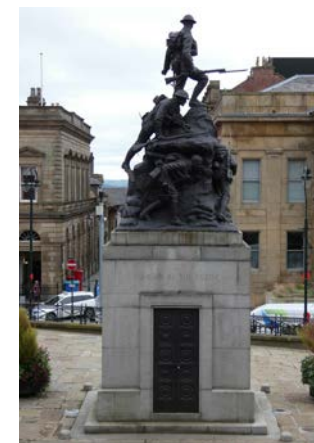
The predominate feature within the townscape, however, is the war memorial located on the raised area above Parliament Square outside the Greaves Arms, alongside the bronze plaques attached to the church wall immediately behind **[Plates 7.27 and 7.28]**. The memorial comprises a large granite pedestal resembling a mausoleum set on a shallow base with a large bronze sculpture place on top depicting five infantrymen going 'over the top' by Albert Toft. The memorial occupies a prominent elevated location above the town centre and aligns with the church steps and south porch behind.

Plate 7.27 War Memorial

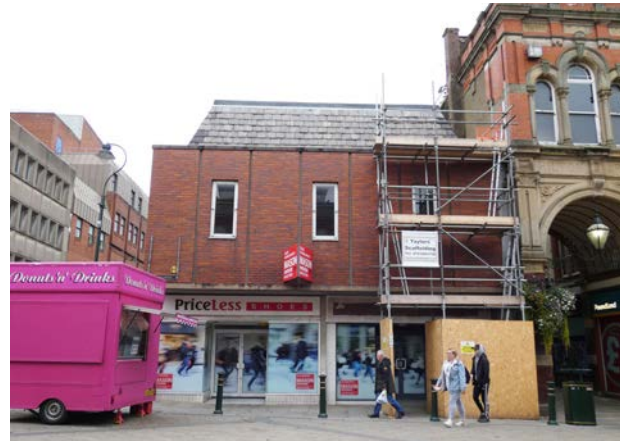
1 – 3 High Street is an unassuming building of the late 20th century; the red brickwork with inset channels and pitched, slate-clad roof behind have some aesthetic quality. However, its small scale is completely at odds with Hilton Arcade adjacent, and the block which extends north along Curzon Street. Occupying a prominent corner location (currently on the boundary of the conservation area) nos. 1 – 3 appear as if they have eaten away at the original handsome group, completely diminishing the strength of this townscape block. This is exacerbated further by the poor retail frontage and signage [Plate 8.1].

Plate 8.1 1-3 High Street detracting from the composition, scale and detailing of the Hilton Arcade block

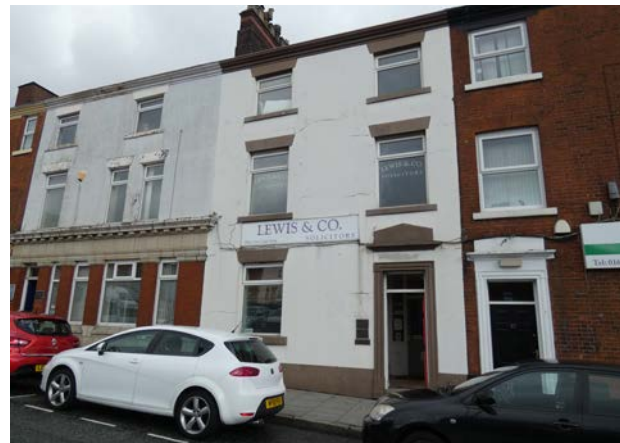
The pair form part of a continuous early-to-mid-19th century terrace group which is otherwise faced in brick. However, the rendered facades at 19 and 21 interrupt the uniformity of the terrace group and substantially detract from the overall appearance of the group, exacerbated further by the modern uPVC casement windows [Plate 8.2].

Plate 8.2 19-21 Queen Street

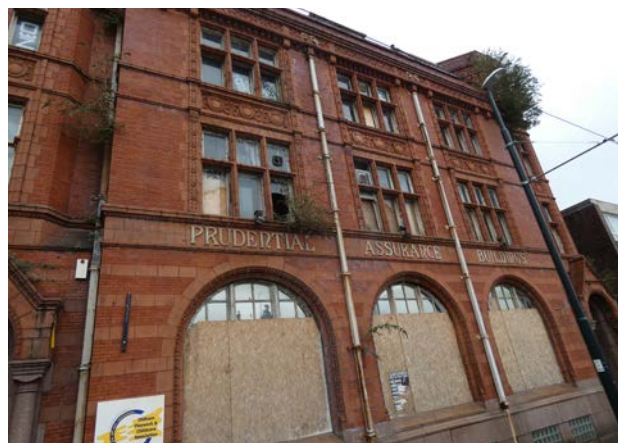
Plate 8.3 The Prudential Building, vacant and in a deteriorating condition

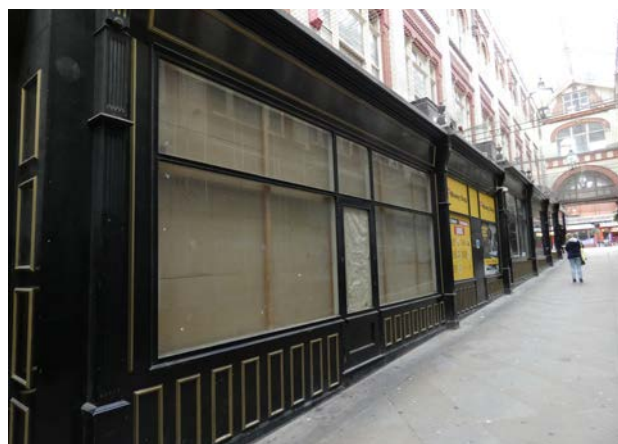
Plate 8.4 Blank shopfronts along the Hilton Arcade

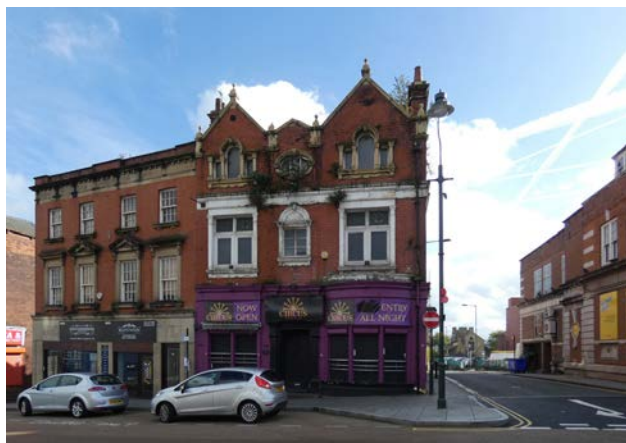
Plate 8.5 Poor condition typical of many buildings within the conservation area

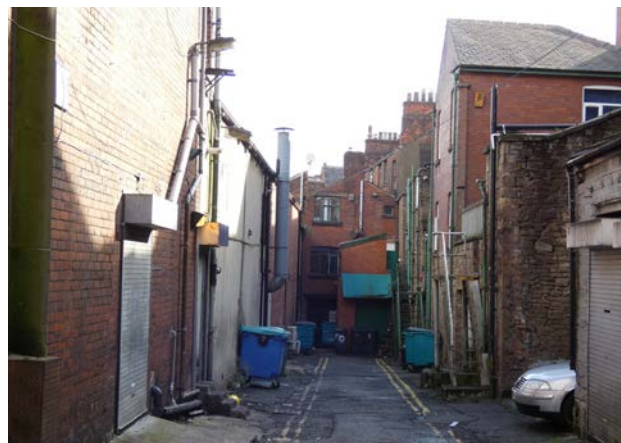
As well as the more critical condition issues associated with the vacancy of the key buildings listed above, there is a widespread issue with the general condition of buildings within the conservation area that is principally centred on general upkeep, repair and decoration – in the main part this is linked to economic factors and a poor understanding of the heritage value of building **[Plate 8.5]**. Typically this worsens in the back street areas with poor extensions, alterations and addition of plant, etc. **[Plate 8.6]**.

Plate 8.6 Plate Street typical of 'back-of-house' areas within the conservation area

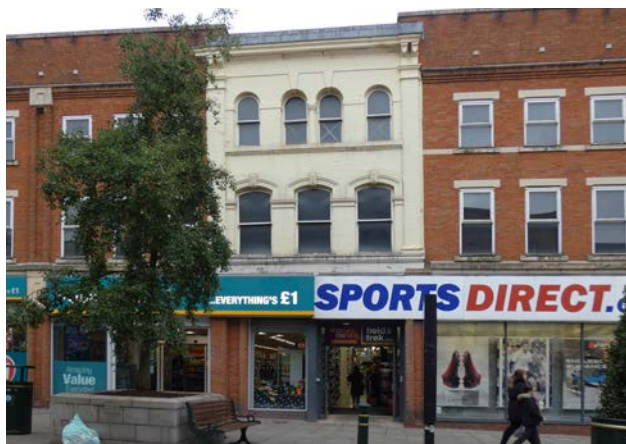
Plate 8.8 Poor shopfronts and signage across 15 -17 High Street which fails to relate to architecture of building above
