Adopted Oldham Town Centre Conservation
Area Appraisal and Management Plan
Supplementary Planning Document

August 2019

Donald Insall Associates
Chartered Architects and Historic Building Consultants

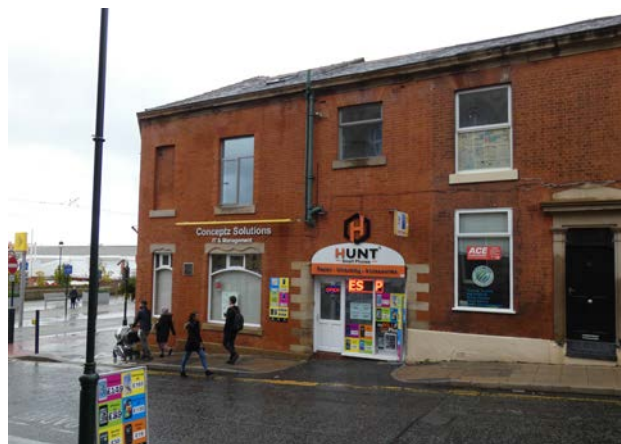
Plate 8.9 Poor shopfront infilling historic archway at southern end of Clegg Street

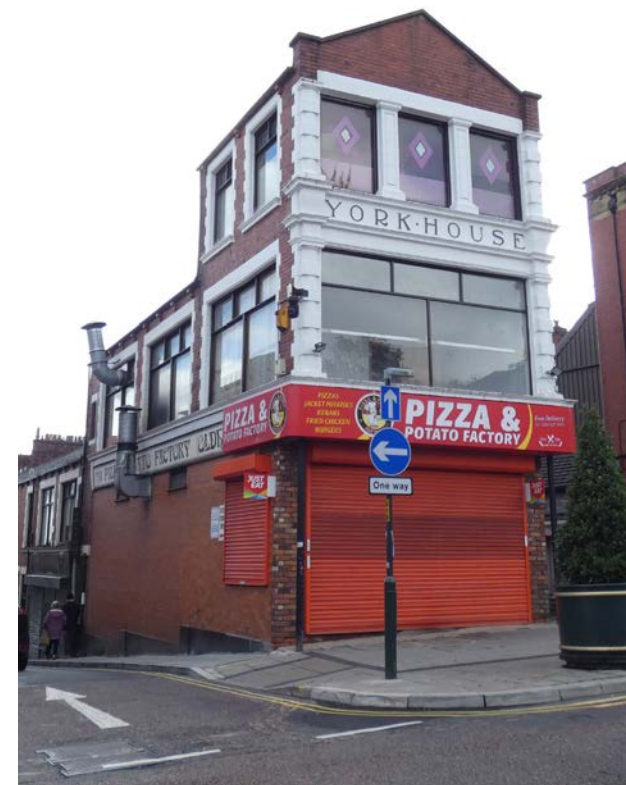
The most significant detracting feature within the conservation area is the retail frontage. Oldham Town Centre benefits from being largely pedestrianised, and as a consequence the human experience at ground level is dominated by a ground floor-level of buildings unhindered by traffic. Whilst the absence of traffic is a major benefit, the poor-quality contemporary shopfronts, often comprising large, single-glazed openings, projecting box signs and internally illuminated and often oversized fascias, dominate otherwise typically handsome buildings above and overly intrude into the streetscene. Roller shutters are also commonplace, creating a deadening frontage when closed and adding to the perception of crime and antisocial activity at night time **[Plates 8.7 – 8.9]**.

Plate 8.7 32 Yorkshire Street with poor shopfront and signage, roller shutters and unsightly flues

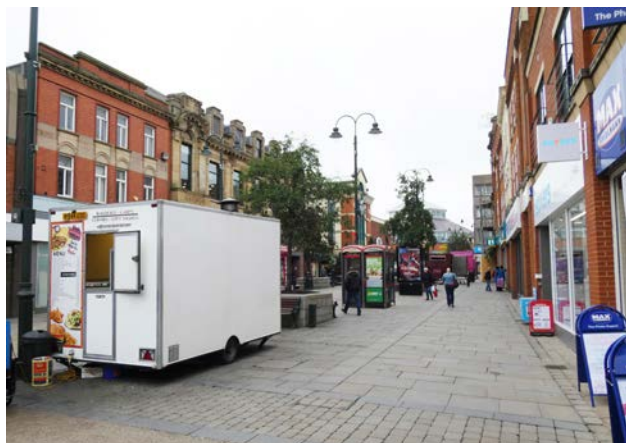
Street clutter is not a major issue across Oldham Town Centre. However, there are areas where the build-up becomes obstructive, particularly along High Street where the number of planters, bollards and benches are further cluttered by excessive bins, unsightly telecommunication cabinets and phone boxes principally serving commercial advertising. Temporary street food vans also create an additional obstruction [Plate 8.10]. Around the tram stop there is also a proliferation of signage, and the change in design of street furniture between areas – particularly around Parliament Square, can become unsightly.

Plate 8.10 Street clutter including advertising on telephone boxes, advertising boards, food vans, bins, planters and benches

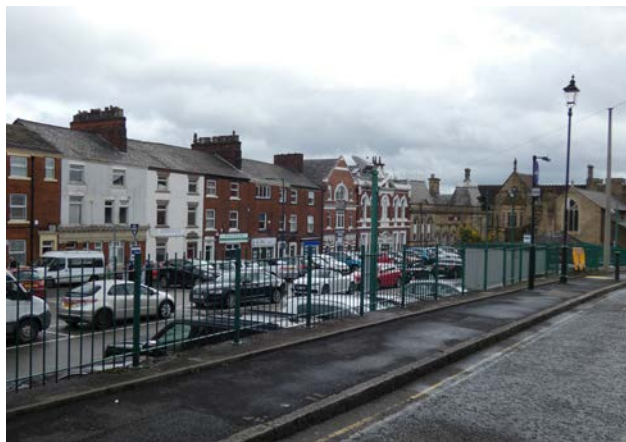
There are a number of cleared vacant sites within the conservation area and along its boundary (or within the proposed extensions) now used for parking. The most substantial are the cleared sites between Back Greaves Street and Queen Street which form a chasm in the conservation area and would benefit from appropriate redevelopment [Plate 8.12]. The small empty site to the west of the Prudential Building on the fringe of the conservation area is overgrown and is a detracting feature which does not draw people northwards or give any sense of the town centre which lies beyond (see Plate 8.3).

Plate 8.12 Large vacant site between Back Greaves Street and Queen Street

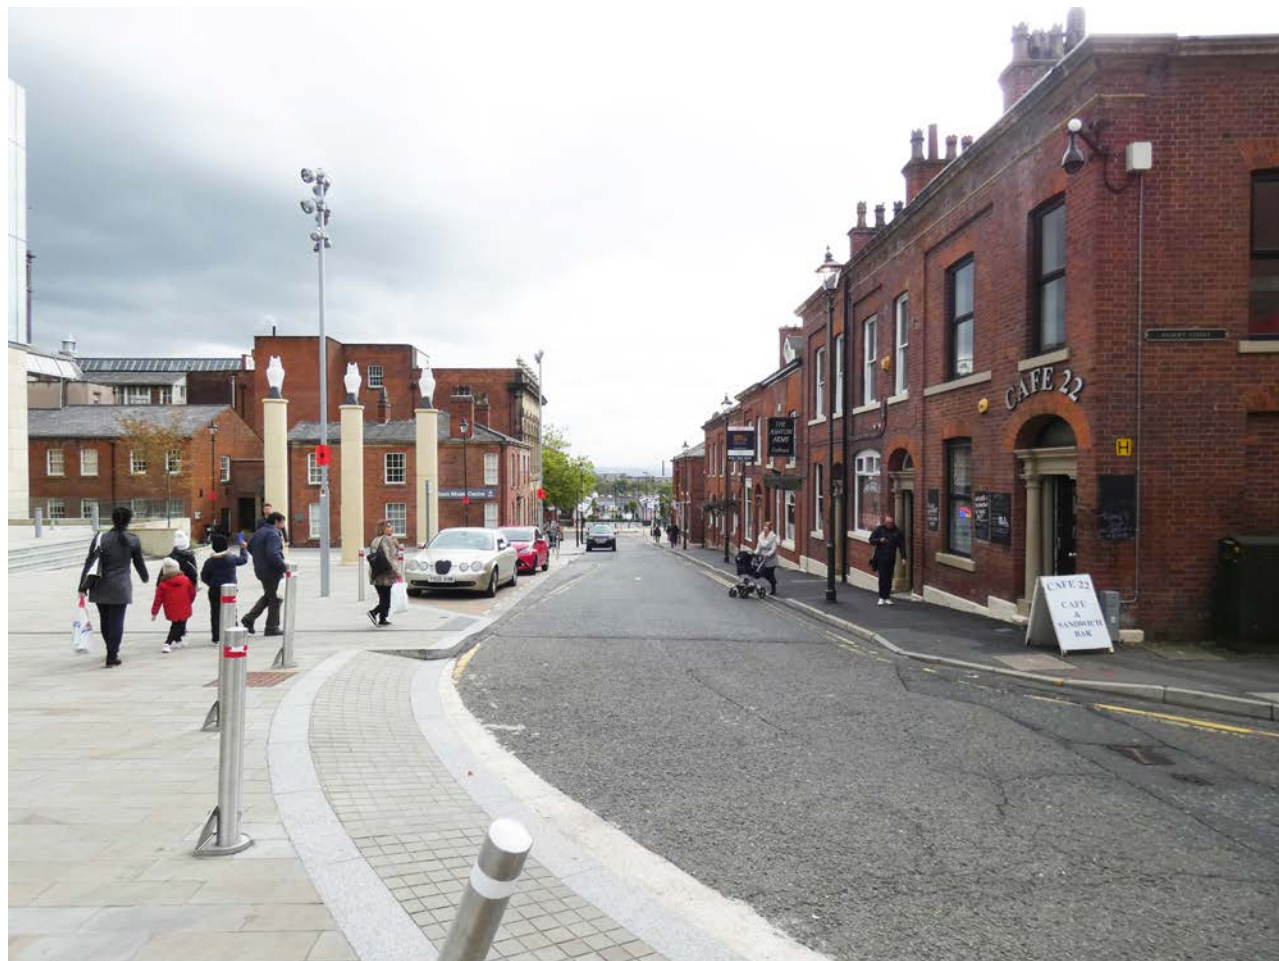
In terms of wayfinding, the elevated position of the town centre does it no favours, hindered further by the substantial intervention that the construction of the Spindles Shopping Centre created. In essence the town is closed off to the western side; this and the lower level of the tram stops prevent a natural route into the town centre. In addition, Parliament Square does not align with the new tram stop, so the natural processional boulevard which Parliament Square could offer, drawing people up into the heart of the town centre and capped by the church behind, appears incidental [Plate 8.11].

Plate 8.11 The southern end of Parliament Square peters off into Clegg Street and does not align with tram stop or provide natural wayfinding into the town centre

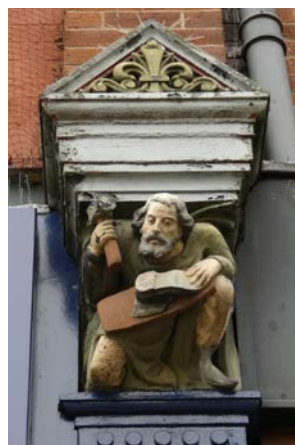
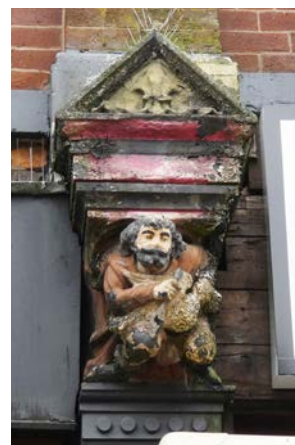
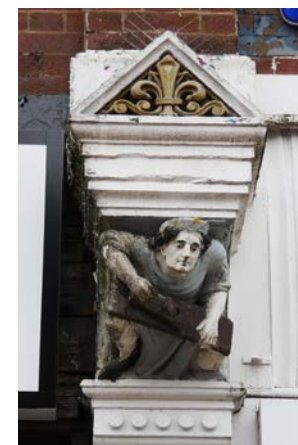
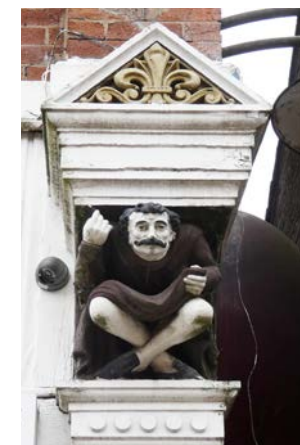
Plate 9.10 Carved capital and corbel brackets to 19th century retail frontage on Henshaw Street

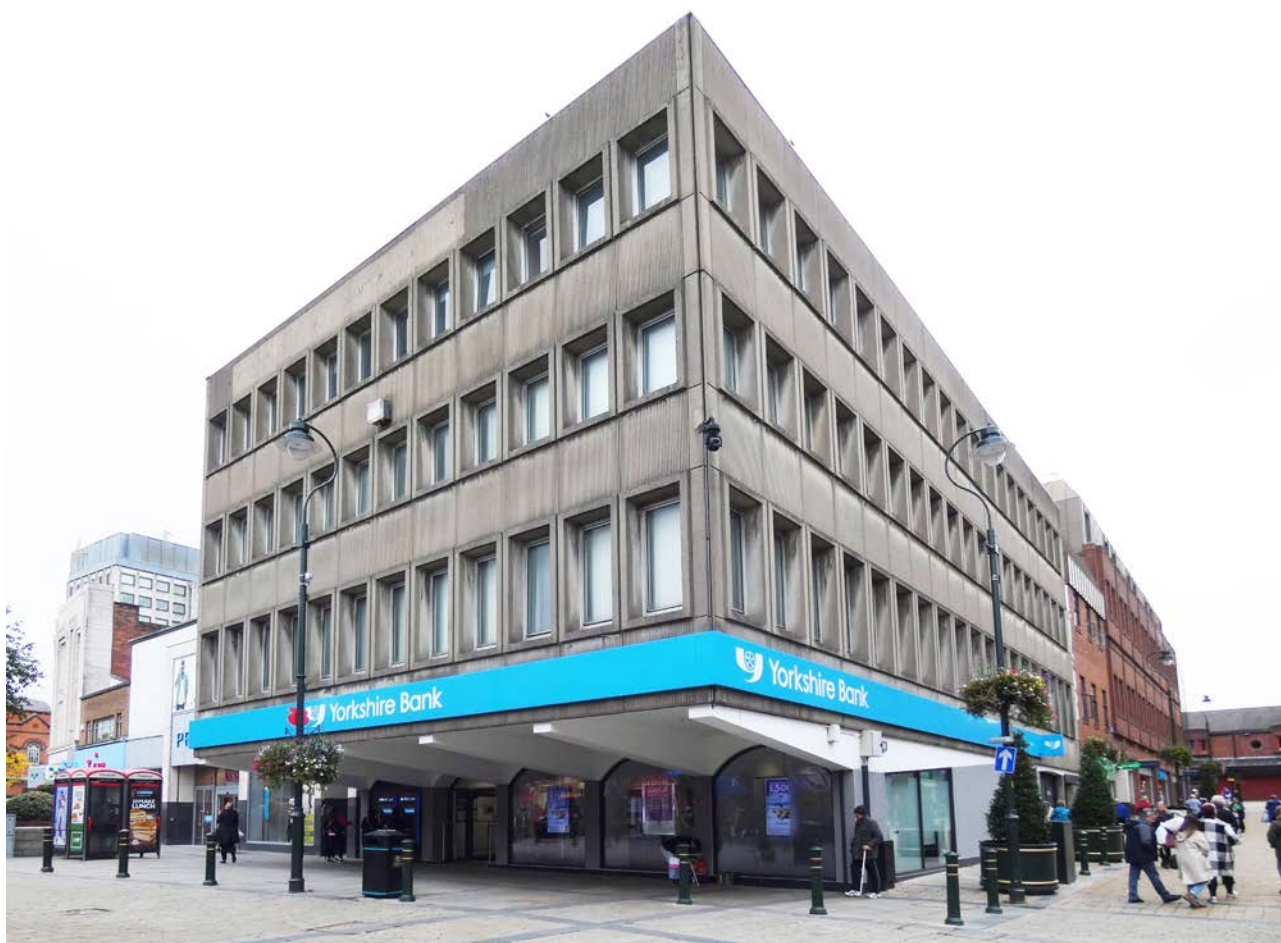
Plate 9.14 Interesting cantilevered design but detracts from overall character of conservation area

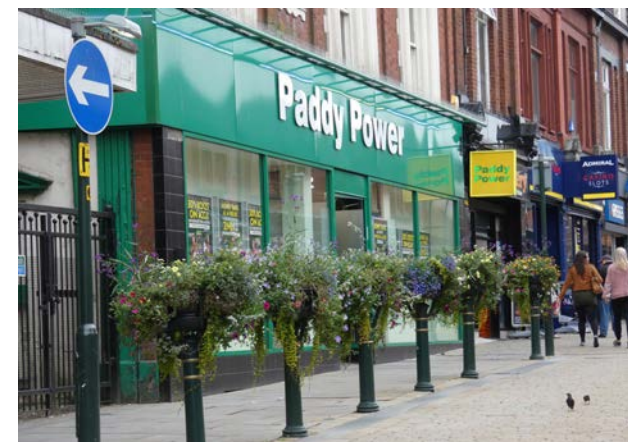
The extension includes many buildings which make a positive contribution to the conservation area; of particular merit is the curved group of buildings turning the corner from Market Place into Henshaw Street with a distinct form and Art Deco design **[Plates 9.7 and 9.8]**, and the carved-and-painted sandstone capitals and corbel brackets depicting different trades to the fine row of 19th century shops on Henshaw Street **[Plates 9.9 – 9.13]**. At the heart of the proposed extension, a group of modern buildings at 35-47 Market Place, which in part extend the full depth to Albion Street, detract from the established character of the area, although in instances such as the Yorkshire Bank with its substantial cantilevered overhang, buildings comprise architectural interest in their own right **[Plate 9.14]**. This area suffers from the same issues with detracting shopfronts and signage as found elsewhere within the conservation area **[Plates 9.15 and 9.16]**.

Plate 9.15 Poor signage and shopfronts within proposed extension

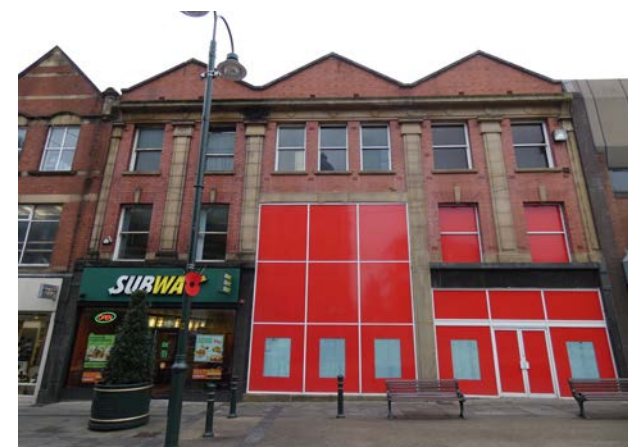
Plate 9.16 Poor signage and shopfronts within proposed extension causing harm to overall appearance of building which makes a positive contribution to the conservation area

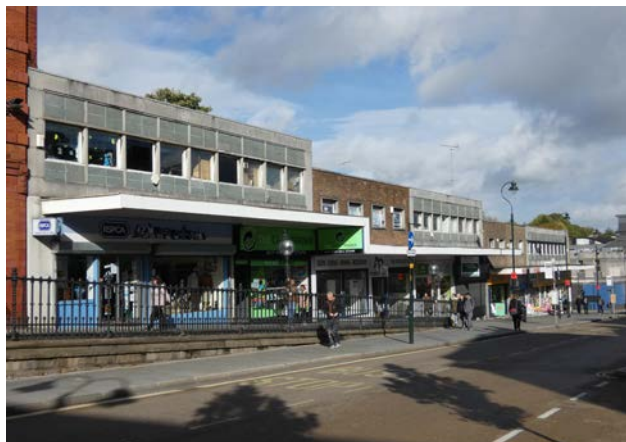
The modern block between Church Street and Yorkshire Street at 21 – 41 Yorkshire Street is a detracting feature at odds with the prevailing character of the conservation area, and has diminished the historic character of Church Street. However, it occupies a key location mediating between the differing levels of the two streets which bound it. It is of particular importance to the setting of historic Church Street, and its suggested inclusion within the conservation area recognises both this and the opportunity for future enhancement. This follows for the detracting block which stands on the corner with St. Mary’s Way **[Plates 9.20 – 9.22]**.

Plate 9.20 21 - 41 Yorkshire Street, a modern block at odds with the prevailing character of the conservation area

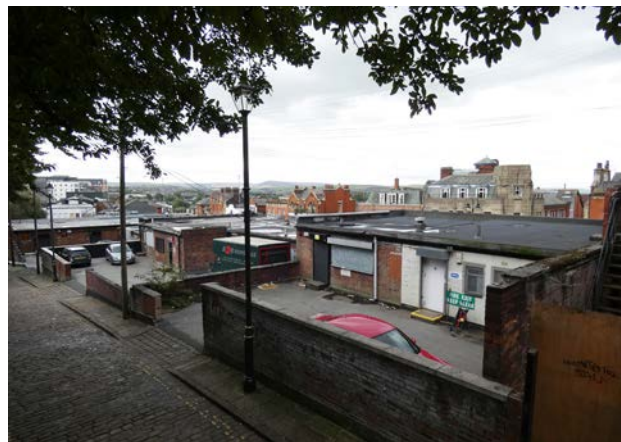
Plate 9.21 Rear side of 21 - 41 Yorkshire Street block providing poor backdrop to the historic character of Church Street

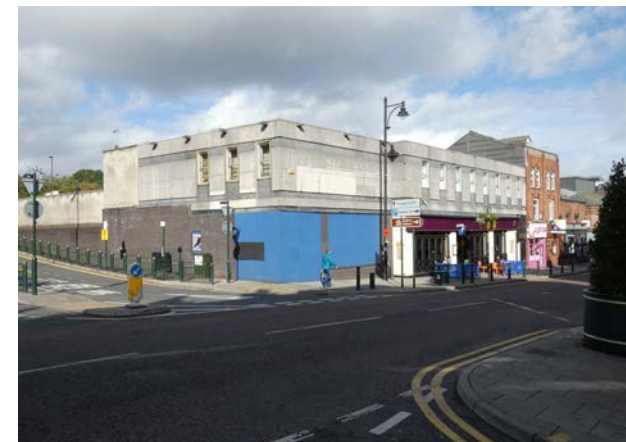
Plate 9.22 Modern block on corner of St Mary's Way and Yorkshire which does not follow the established character of the conservation area

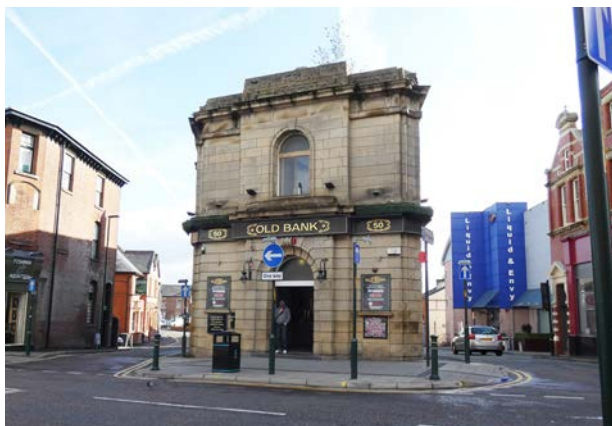
Plate 9.23 Old Bank Pub stood on narrow site between Bow Street and Waterloo Street

Aesthetic Interest: It is a neo-classical design in channelled ashlar to Yorkshire Street with a central projecting entrance bay with return elevation in red brick with stone dressings to Waterloo Street and Bow Street. The stone string courses extend along the return elevations with handsome window surrounds and keystone detailing. Vegetation growing out of the roof and the state of some windows suggests it may be in a poor condition.

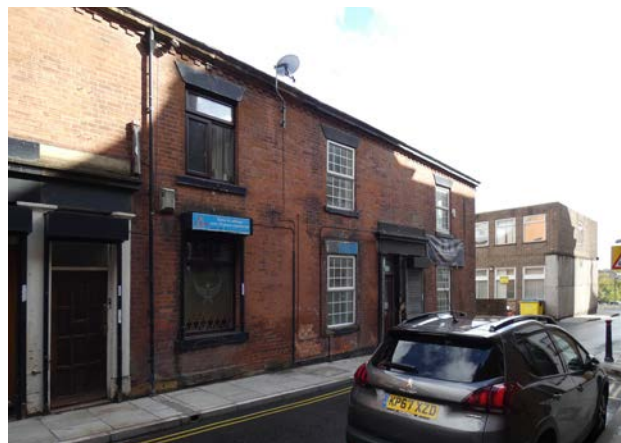
Plate 9.25 Poor quality alterations including modern windows, roller shutters and signage to southern end of terrace group

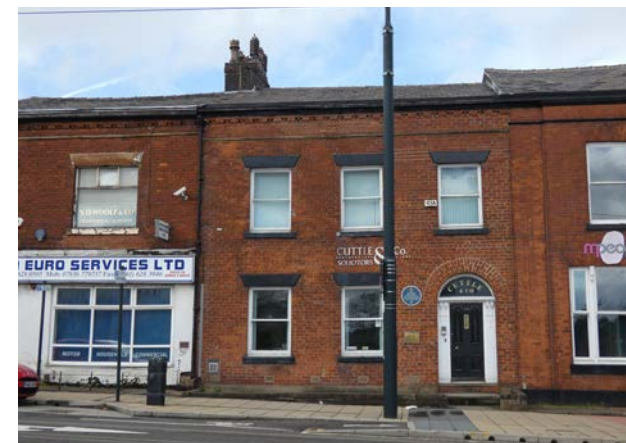
Plate 9.26 Examples of poor ground floor frontage and more sensitive solution within proposed extension on Union Street

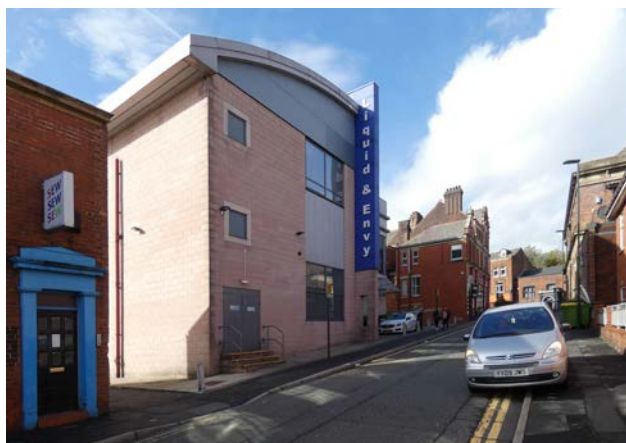
The last area of the proposed extension covers the remaining linking streets between Union Street and Yorkshire Street; whilst subject to alteration and exhibiting detracting features, they share the same character as the west side of Retiro Street at least in part (already within the conservation area), featuring continuous terrace groups of domestically-scaled buildings with continuous sloping eaves, slanted to follow the gradient of the street and unbroken by party walls, and elements of early shopfronts on Waterloo Street which make a positive contribution to the conservation area **[Plates 9.24 to 9.26]**. The nightclub which spans between Retiro Street and Waterloo Street is a major intervention which detracts from the established character of the area, and the Limo Lounge garage-style infill to the terrace group on Waterloo Street breaks its historic building line, which is further marred by alterations to the remaining facades **[Plates 9.27 and 9.28]**.

Plate 9.27 Modern nightclub which spans between Retiro Street and Waterloo Street

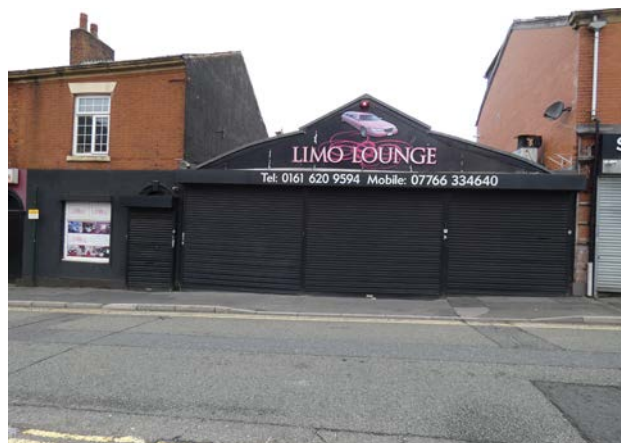
Plate 9.28 Unsightly infill within terrace group on Waterloo Street

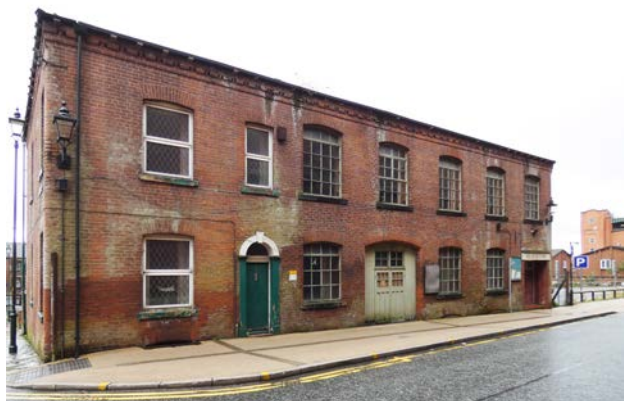
Plate 9.32 1 - 3 Ascroft Street, front elevation

Aesthetic Interest: The buildings exhibit charming industrial character although they are in poor condition and in need of refurbishment and in the case of No.3 reuse. No.3 retains numerous original features; replacement modern windows at No.1 detract.

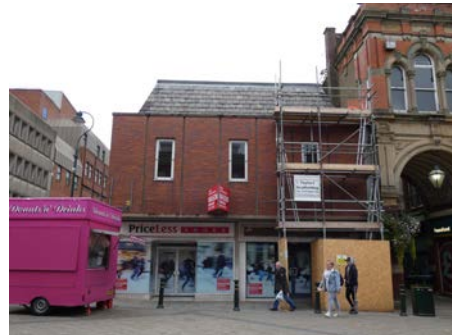
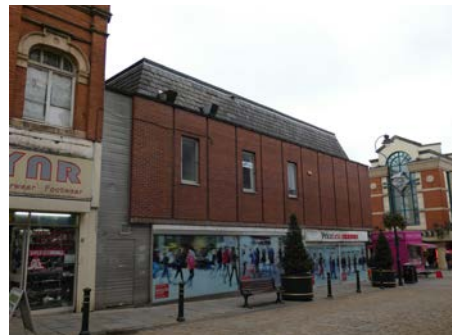
Notes: Late-20th century office building in red brick with recessed tiled shopfront, west return elevation onto Curzon Street. Visible slate mansard and vertical brick detailing provide some character; projecting upper storeys give a Tudor-esque effect. Poor metal link to Hilton Arcade to east. Shopfront signage also detracts.

1-3 High Street, west elevation to Curzon Street

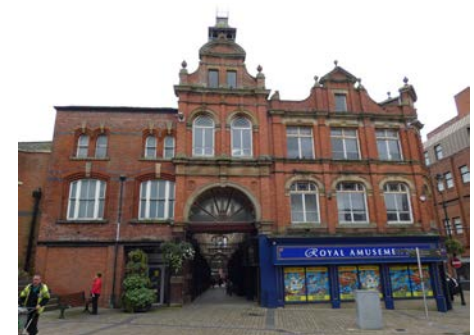
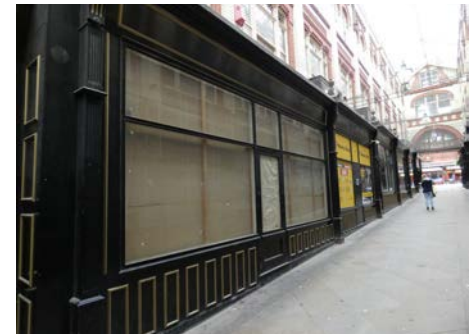
Notes: Particularly handsome late-Victorian arcade, though has fallen on hard times due to vacancy. Ornate, carved stone archways to High Street and Albion Street; in red brick at upper storeys with elaborate stone dressings, including tripartite window arrangement at second floor. Original domed roof has been lost. Much of the interior has been retained, including glazed brick and iron work, but the dead frontages significantly detract from the character of the building and streetscape. Active use is gravely needed. Internally, one of three bays on the east side appear to have been historically infilled. No. 12 Curzon Street provides a good example of a retained arcade frontage (though plant detracts). Opaque pigeon netting has collected dust and detracts, but could be improved. Externally, visible vegetation growth at both ends detracts, as do modern floodlights. Deteriorating condition facing Albion Street and projecting services are also a concern.

Hilton Arcade, north elevation to Albion Street

Hilton Arcade, disused shopfront

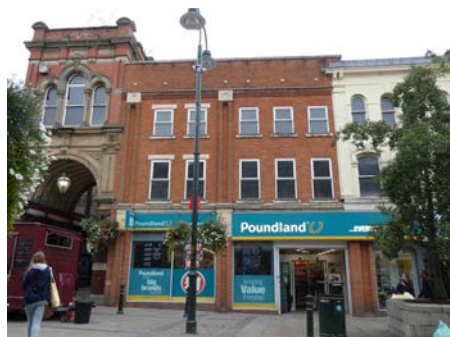
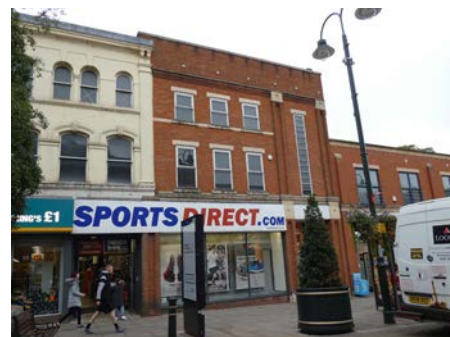
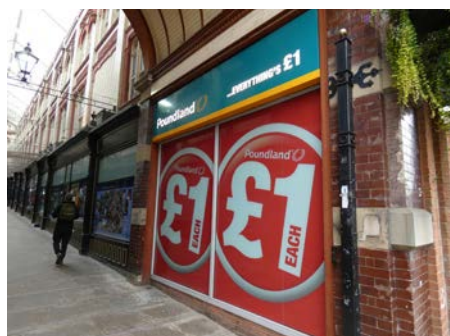
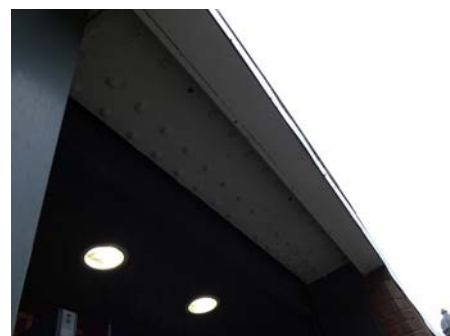
Notes: Forms three-four storey brick range. Surviving historic frontage has been painted white. Group has been awkwardly split into two to form nos. 15-17. Enlarged rebuilt shopfronts and box facias detract, the latter overlapping over pilaster, shop windows facing into Hilton Arcade also detract. Modern sash windows at upper floors are acceptable

15-17 High Street, west side of frontage

15-17 High Street, east side of frontage

15 High Street, detracting shopfront to Hilton Arcade

15-17 High Street, box signage detail

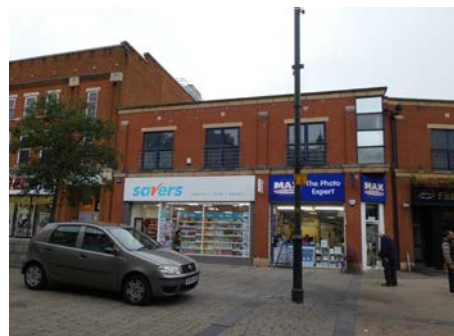
19-21 High Street

Notes: Forms part of group with no. 23. Late-20th century retail unit has been sensitively designed to not detract from streetscape. Red brick with stone bandking and lintels. Corner glazing lined with film, enlarged signage and Juliet balconies at first floor detract.

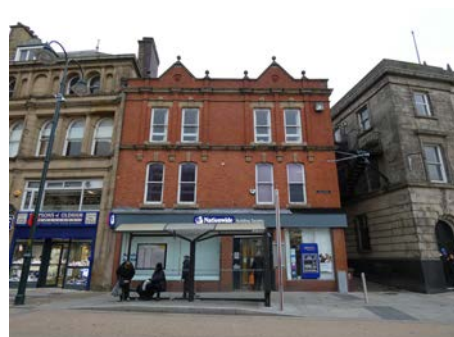
39-41 High Street

Notes: Attractive Victorian office frontage in red brick with subtle stone details. Two small gables at roof line feature spherical spheres. Modern shopfront detracts but fascia is of appropriate proportion; this wraps to side elevation to the south. Ground floor brickwork appears rebuilt. Security camera projects egregiously from southeast corner of the building on unattractive metal arm.

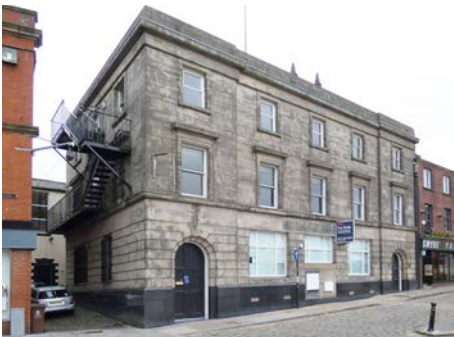
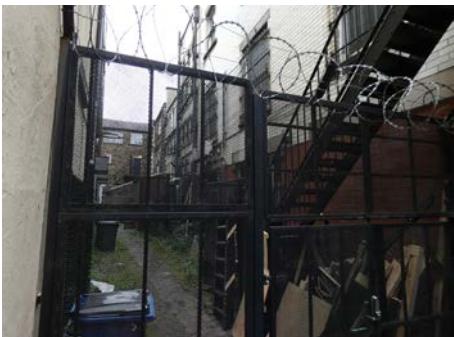
Notes: Three-storey Neoclassical frontage in ashlar, channelled with a course of granite at the ground floor; flanking bays project slightly. Prominent corner location opposite Parliament Square, from which slate roof is visible. Noticeable vacancy and alterations to ground floor windows and insertion of ATM detract. Stone continues to return west elevation which faces a cobbled alley; exterior security bars and large fire escape stair affixed to this side is visible from High Street and detract. Rear elevation in white glazed brick, red brick at ground floor. Security bars also present here; elevation obscured by modern metal security gate and barbed wire.

1-5 Church Terrace

1-5 Church Terrace, rear elevation

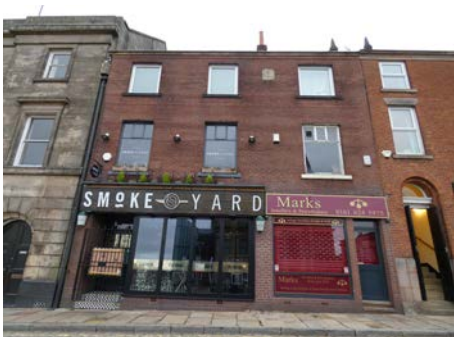
7-9 Church Terrace

Notes: Plain three-storey elevation in red brick, modern shopfronts, though shopfront to no. 7 is of good quality. Modern windows – those at second floor are single pane and of the wrong style. Rear elevation partially visible from rear alleyway.

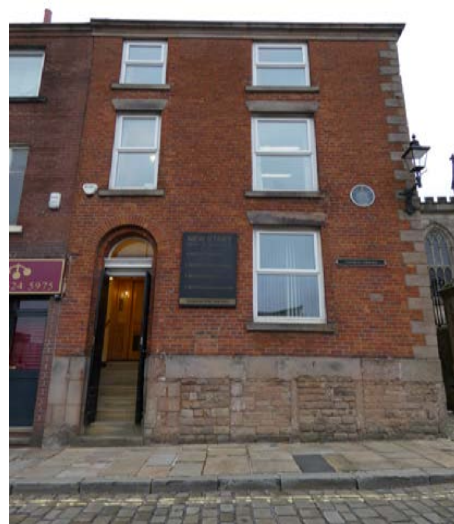
11 Church Terrace

Notes: Simple three storey façade in red brick with stone plinth, handsome east return in coursed rubble with two gables faces narrow pedestrian passage to Church Lane and churchyard. Prominent, elevated position within conservation area facing Parliament Square. Stone quoin detailing where it turns the corner, pronounced stone window lintels and cills. Recessed entryway. Modern windows are suitable enough. Local blue plaque from 2003 commemorates Oldham citizens who awarded the Victoria Cross, linking the building with the adjacent war memorials.

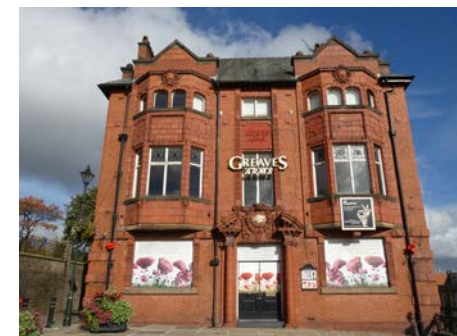
Greaves Arms

Notes: Prominent position at summit of Yorkshire Street, features heavily in views down High Street. Interwar red-brick hotel/public house building with lively frontage facing war memorial. Rear and north return elevations detract with infilled windows and doors, fire escape, extract vents and plant. Ground floor windows and door to principal elevation also blocked. New use strongly needed, particularly given its important relationship with the public realm. South return elevation to Yorkshire Street includes a detracting betting shop shopfront and poor signage.

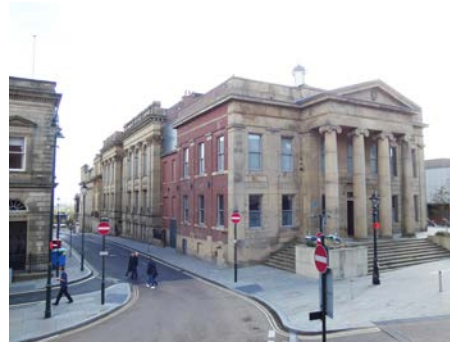
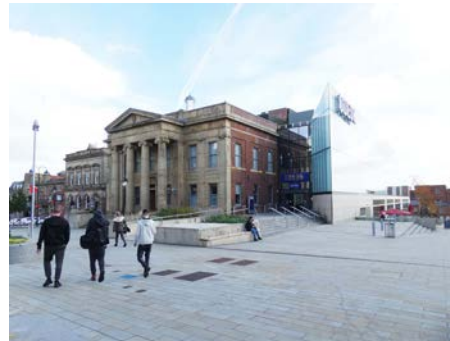
Notes: Former town hall building by George Woodhouse and Edward Potts in robust Greek revival style. Dominant Ionic portico projects into square, mirrored in pilasters to either side. Channelled ashlar finish to Yorkshire Street, east return to Greaves Street starts in red brick with stone dressings before continuing again in stone as part of the late-19th century extension, where Classical elements dramatically repeat. West return to Parliament Square also begins in red brick; late-19th century elevation is now enclosed by a bold, 2016 glazed two-storey extension, though the historic façade can still be articulated through the glass. A number of modern windows, but of sensitive design.

Town Hall and east return to Greaves Street

Town Hall and west return to Parliament Square

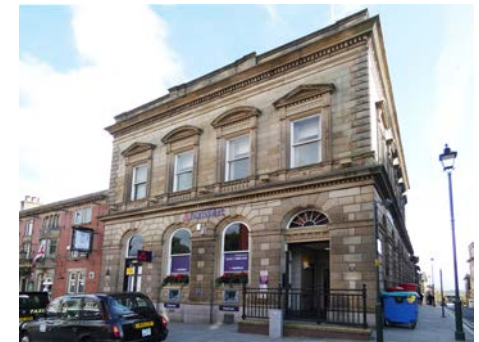
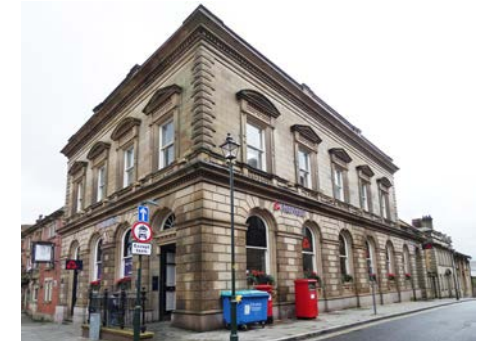
Notes: Strong classical frontages to Yorkshire Street and Greaves Street in ashlar, pairs elegantly with adjacent Town Hall. Architectural details include dentilled cornices, first floor window pediments and corner quoins. Ground floor windows to Yorkshire Street have been infilled with cashpoint machines and detracting signage. Rear elevation in red and yellow brick is visible from Greaves Street.

10 Yorkshire Street

10 Yorkshire Street, west return elevation

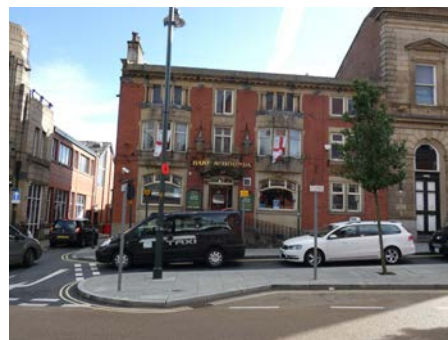
16 Yorkshire Street

Notes: Three storey public house in red brick; stone detailing provides attractive contrast but would benefit from cleaning. Conspicuous cabling and later windows at first and second floors detract; secondary glazing within visible from street level. East return elevation to Hunter's Lane built in three visible phases, stepping down to a single-storey elevation at rear. Conduit and condition of brickwork and windows detract.

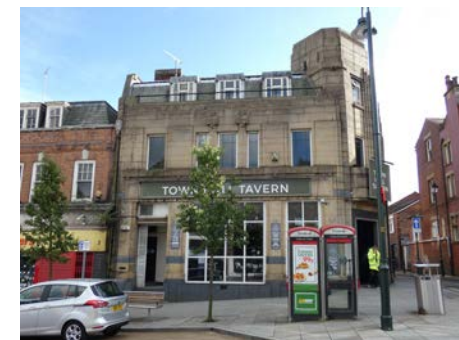
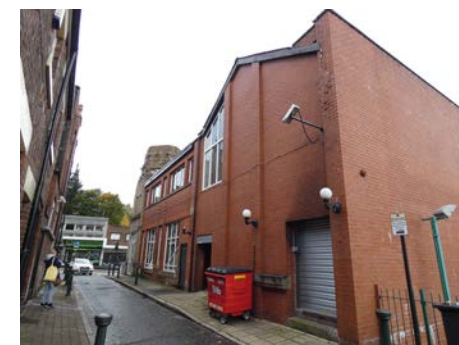
Notes: Robust Art Deco-style frontage in ashlar; canted corner entrance and second storey gable to the corner of Yorkshire Street and Hunter's Lane. Granite banding and door surround, carved figures accentuate a first floor tripartite window facing Yorkshire Street. Roofline comprises mansard extension with three conspicuous dormers to Yorkshire Street, creating imbalance in southeast views. Long west return elevation to Hunter's Lane in red brick; use of ground floor roller shutters detracts. Rear elevation is blind, three storeys in red brick face a car park. Modern windows throughout detract from streetscape, including large public house/shopfront windows to ground floor and first floor windows (without glazing bars) and inappropriate casement at the second floor of the canted corner. Oversized signage to canted corner.

18-20 Yorkshire Street

18-20 Yorkshire Street, west return elevation

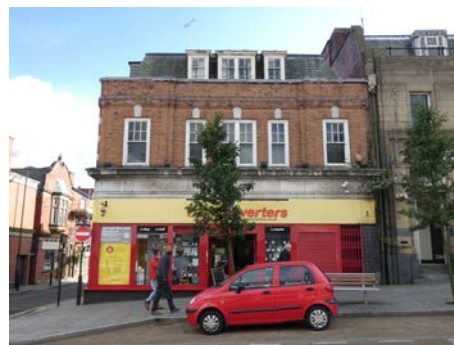
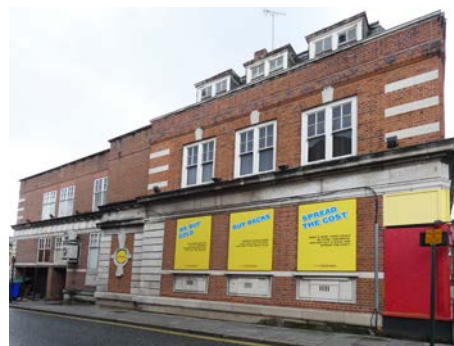
Notes: Charming two-storey early-20th century office building with attic mansard, in stone at ground floor and red brick above. Large and robust shopfront at the ground floor obscures ground floor detailing almost completely and substantially detracts from the character of the building. Signage continues to obscure ground floor windows along east return elevation to Queen Street, where plant fixed to the façade and a poor service door arrangement also detract. Windows to rear elevation have been infilled.

22-24 Yorkshire Street

22-24 Yorkshire Street, east return elevation

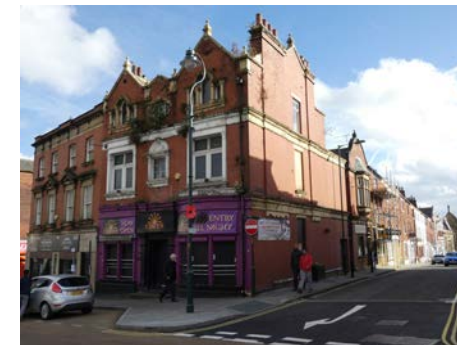
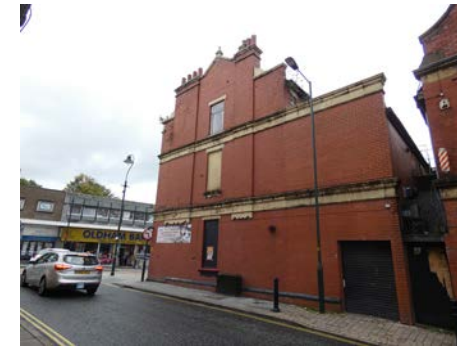
Notes: Three storey office building in Queen Anne revival style. Red brick with elaborate stone detailing to the principal façade; stone has been painted at the first floor, which detracts from the appearance of the building. Twin gables, stone finials and column detail to second floor tripartite windows enrich the elevation to Yorkshire Street. Red brick and stone string courses continue along the west return to Queen Street; ground and first floor windows here have been blocked. Plant and modern infill along the rear of the building visible from Queen Street. Modern windows and signage, paint and roller shutters to the ground floor shopfront detract from character. Substantial vegetation growth at first floor, second floor and roofline.

26 Yorkshire Street

26 Yorkshire Street, west return elevation

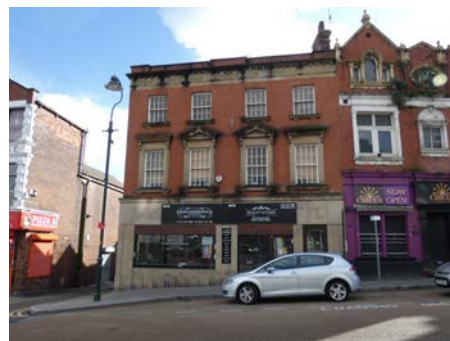
28-30 Yorkshire Street

Notes: Neoclassical frontage in red brick with stone detailing, including modillion cornice and pedimented windows at the first floor. Ground floor shopfront in ashlar. Stonework in need of cleaning; state of stone, poor shopfront signage and modern alterations to shopfront windows detract from the streetscape. Narrow east return elevation to Plate Street, where red brick and stone work wrap around.

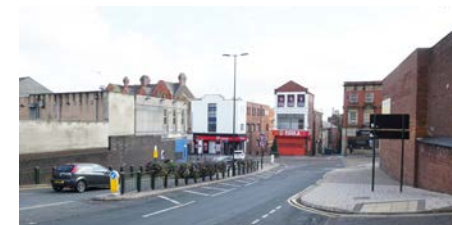
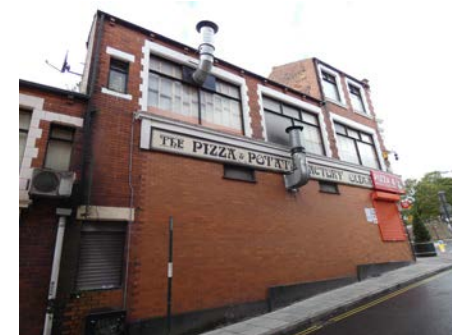
Notes: Striking solitary façade to Yorkshire Street, flanked by Plate Street and Retiro Street; forms terminus to south-facing views into conservation area from St. Mary's Way. Poor ground floor shopfront, signage and roller shutter detract. In red brick with gable at roofline; stone detailing at first and second floors has been painted white, with elegantly carved 'York House' lettering to fascia between floors. Return elevations highly visible, blind to Plate Street with modern ventilation pipes, roller shutter and vegetation growth near roof. First floor windows span elevation to Retiro Street, back of modern interior stud wall obscures windows and is visible from the street. Projecting extract servicing projects from brickwork and through windows, also detracting.

32 Yorkshire Street, view from St. Mary's Lane

32 Yorkshire Street, east return elevation to Retiro Street

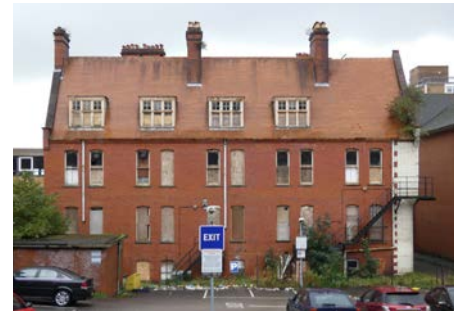
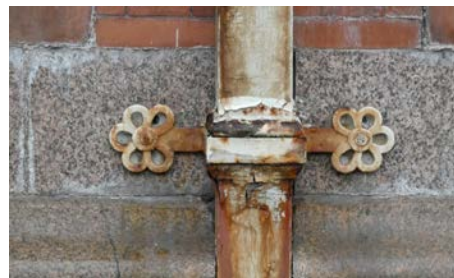
Notes: Office building of high architectural quality by Alfred Waterhouse, flanked by towers (which have lost their roofs) with elaborate terracotta and polished granite dressings. Rich ornamentation and powerful form provide a dramatic anchor for the wider conservation area, broad rear elevation is highly visible in views from Ascroft Street. The building is in need of reuse (which the LPA is pursuing); its current dilapidated condition presently detracts from the character of the conservation area. Pedestrian walkway to the east of building provides close appreciation of architectural detail. Placement on a local heritage at risk register is recommended.

79 Union Street, rear elevation

79 Union Street, detail

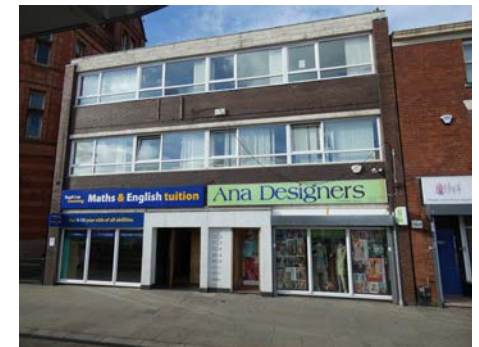
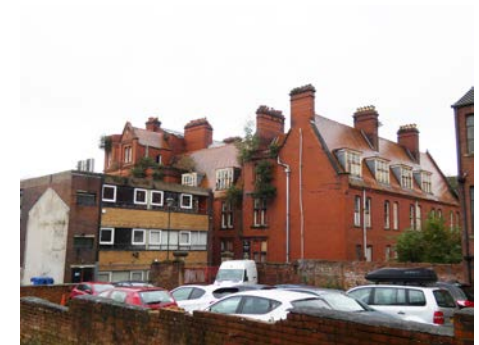
Notes: Typical mid-century commercial frontage, large shopfront windows in-keeping with architectural character of building; signage, conduit and roller shutter detract. The massing, mixed materials and detailing of the rear of the building facing Printer Street detract from the character of the area, however, and hinder views of the Prudential Assurance Building.

81 Union Street

81 Union Street rear elevation, Prudential Assurance Building to west

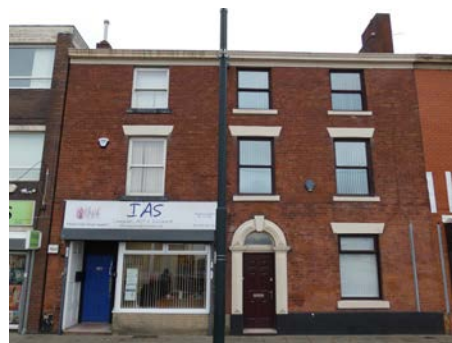
83-85 Union Street

Notes: Retained Victorian domestic scale and use of red brick and stone are positive elements, windows are modern. Present shopfront and signage detract.

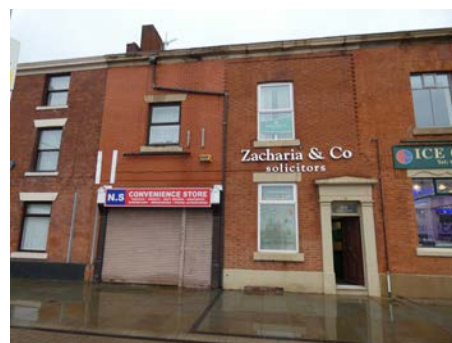
87-89 Union Street

Notes: Retained Victorian domestic scale and use of red brick and stone detailing are positive elements, canted SE corner (a 20th century alteration) provides a gateway effect into Clegg Street. Windows are modern. Alterations, signage and roller shutter at no. 87 detract.

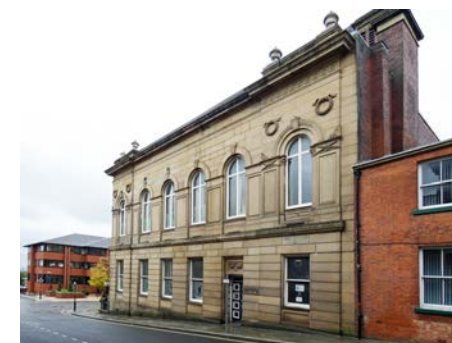
95 Union Street, east elevation to Greaves Street

Notes: Elegant Neoclassical stone frontage is one of Union Street's earliest buildings; cast iron lanterns and robust railings, urns at the roofline and well-kept greenery all contribute positively to streetscape. Condition of vacant section of the building detracts; use needed throughout. Railings painted white at lower ground floor also detract. Neoclassical return elevations and fenestration pattern wrap around to both Clegg Street and Greaves Street.

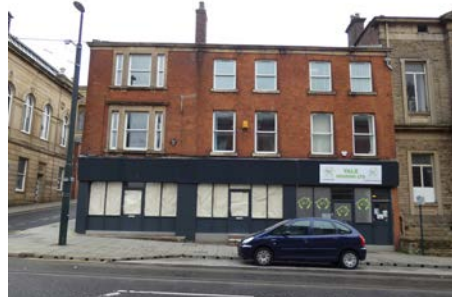
99-103 Union Street

Notes: Domestic scale and use of red brick and stone are positive elements found throughout the conservation area, windows are modern. Nos. 101-103 are of two bays at upper floors, whilst. No. 99 at the corner features tripartite arrangements with stone dressings. Present signage and heavy shopfront fascia detract.

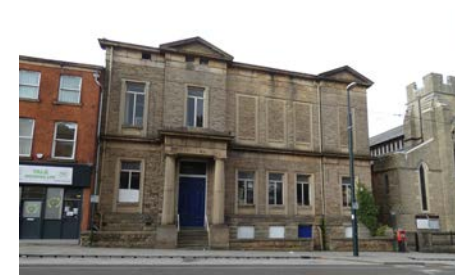
105 Union Street, Masonic Hall

Notes: Asymmetrical frontage in Greek revival style provides interest, but present condition detracts from the character of the conservation area, including laminating brickwork, poor repointing repairs, visible water ingress, broken pipes, etc. To the rear, a four-storey wing in red brick with stone detailing; blocked windows and a modern upper-storey extension are visible from Firth Street and detract. New use needed.

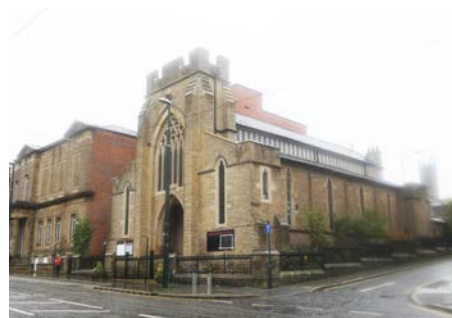
107 Union Street, United Reformed Church

Notes: Improved condition following a recently-awarded HLF repairs grant, but remains on the Buildings at Risk Register. One of few remaining churches by Moffat Smith; Gothic, non-conformist style in sandstone. Distinctive spire lost in 1930s. Rear is in good condition.

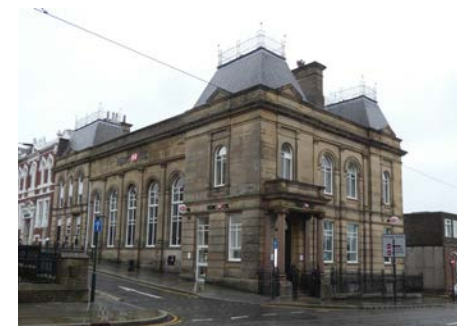
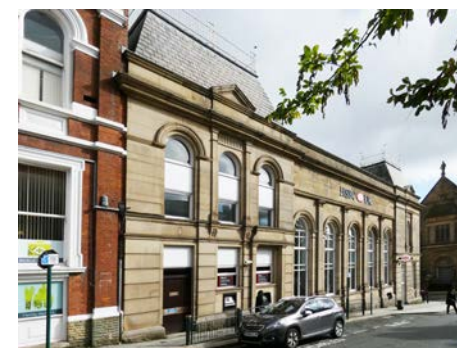
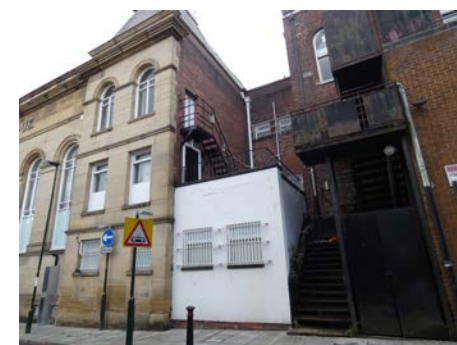
Notes: Ashlar-faced in French Renaissance style by Thomas Taylor. Highly positive contributor to character of conservation area with decorative frontages to Union Street, Queen Street and Retiro Street, including dominant portico with granite columns and cast iron railings. Rear elevation in red brick. Appropriate signage. Detracting elements include an ATM which cuts into stonework, modern doors and infill panels to some windows. A single-storey rear extension facing Retiro Street also detracts, painted white.

109 Union Street

109 Union Street, west elevation to Queen Street

109 Union Street, east elevation to Retiro Street

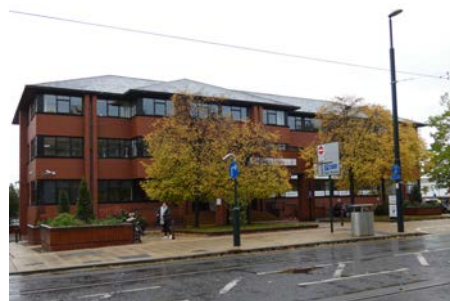
80 Union Street

Notes: Typical late-20th century office building in red brick. While the building line detracts, it allows for greenery and public realm space; this could be enhanced or better-utilised, particularly given its location at the base of the conservation area.

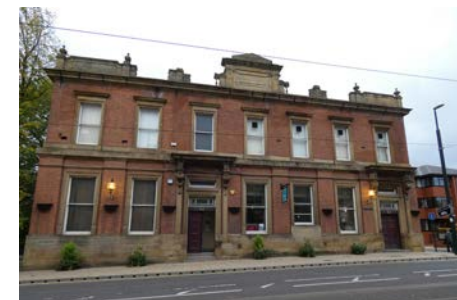
84 Union Street, former Post & Telegraph Office

Notes: Neoclassical façades in red brick with stone dressings in a corner location make a highly positive impact on the character of the conservation area; modern vents inserted in several windows detract. Engraved 'post & telegraph office' lettering indicates its original use. East side of building faces the greenery and tranquil public realm of Oldham Park.

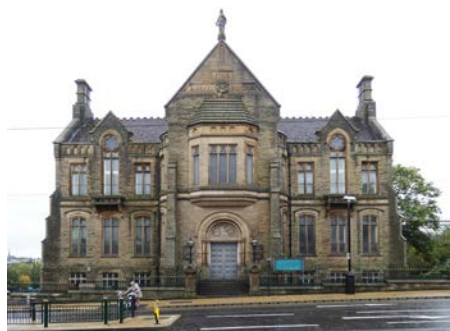
88 Union Street, Oldham Library

Notes: Imposing, Gothic elevations to the north and east; gables enliven the roofline. Rusticated rubble façade with stone dressings and cast iron railing and lanterns are positive contributors to the conservation area, though the eastern side elevation facing a car park is somewhat drab; the setting here could be enhanced. The modern wall, plant area and fence to the rear of the building, as well as some blocked windows and doors, are visible from the new library and its public realm space; these detract from the area.

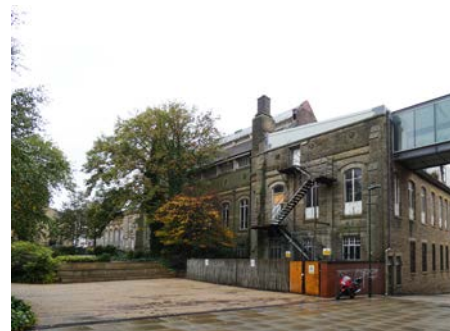
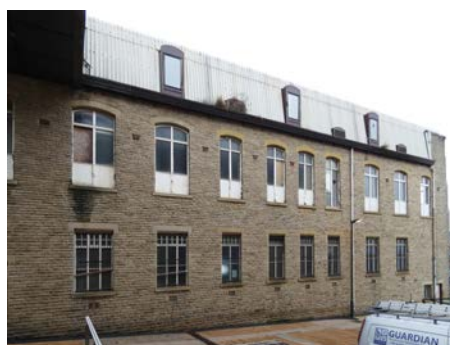
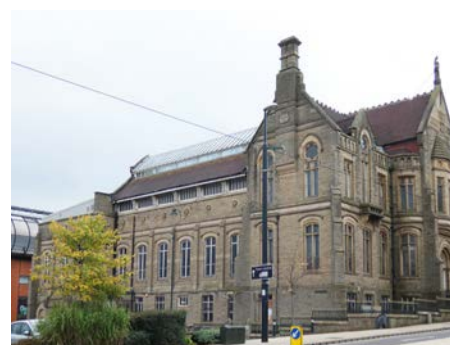
88 Union Street, Oldham Library west elevation

88 Union Street, Oldham Library rear elevation

88 Union Street, Oldham Library east elevation

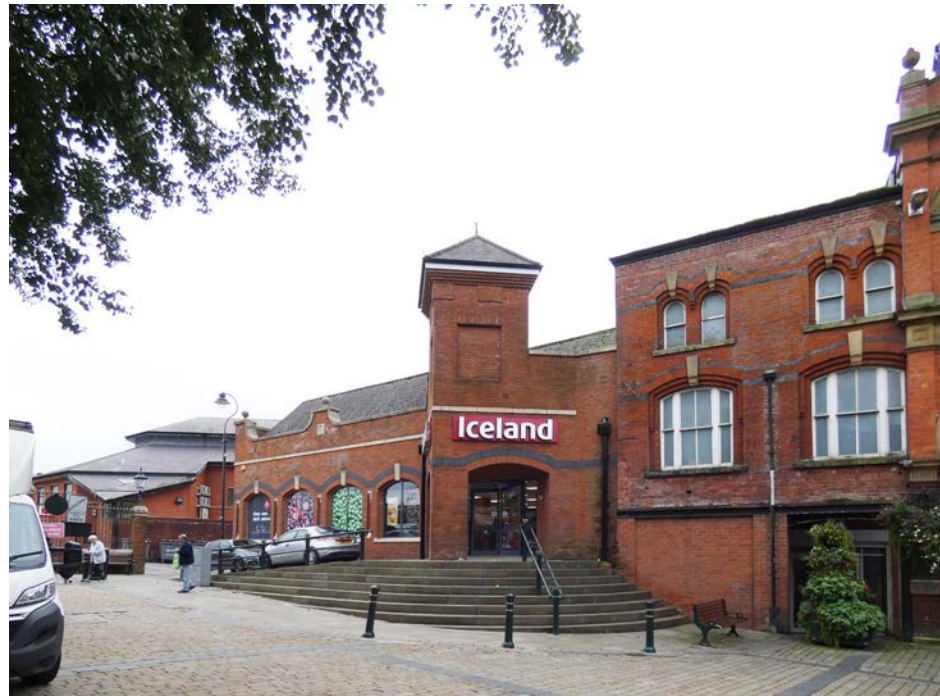
Notes: Late-20th century shop, a building of its time that attempts to follow historic monochromatic brickwork and keystone features of Hilton Arcade to west, and its position remains subservient. Signage and shopfronts are appropriate to building. Meets public realm to the north via curved flight of concrete steps. A service alley and public realm gate separate it from the modern post office building to the east. Blind east return elevation.

11 Albion Street, frontage respectful of Hilton Arcade

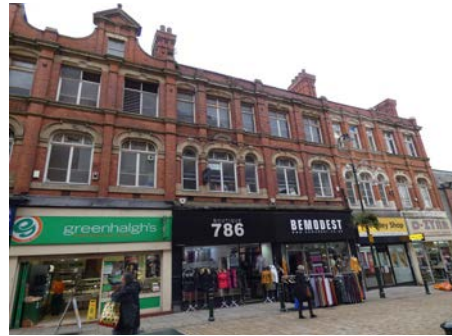
8-16 Curzon Street

Notes: Victorian retail and office building in red brick with stone dressings. Gabled roofline to north, stone dressings to arched first-floor fenestration are especially ornate, some with carved terracotta friezes above. Most windows retain decorative overlights. Detracting elements include second floor windows at no. 16 which have been replaced with louvered vents, projecting signage to no. 14, vegetation growth visible at roofline, roller shutters, projecting CCTV, poor concrete stallrisers in places enlarged fascias and poor shopfronts across the range, except for no. 8 which is of appropriate proportion. Frontage of no. 8 wraps around to Albion Street, and meets the Hilton Arcade. Nos.18-20 are somewhat narrower; no. 18 appears to have been recently cleaned.
