Adopted Oldham Town Centre Conservation
Area Appraisal and Management Plan
Supplementary Planning Document

August 2019

Donald Insall Associates
Chartered Architects and Historic Building Consultants

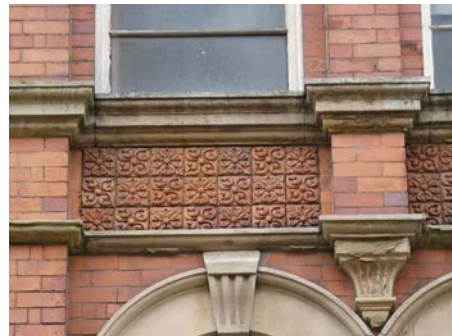
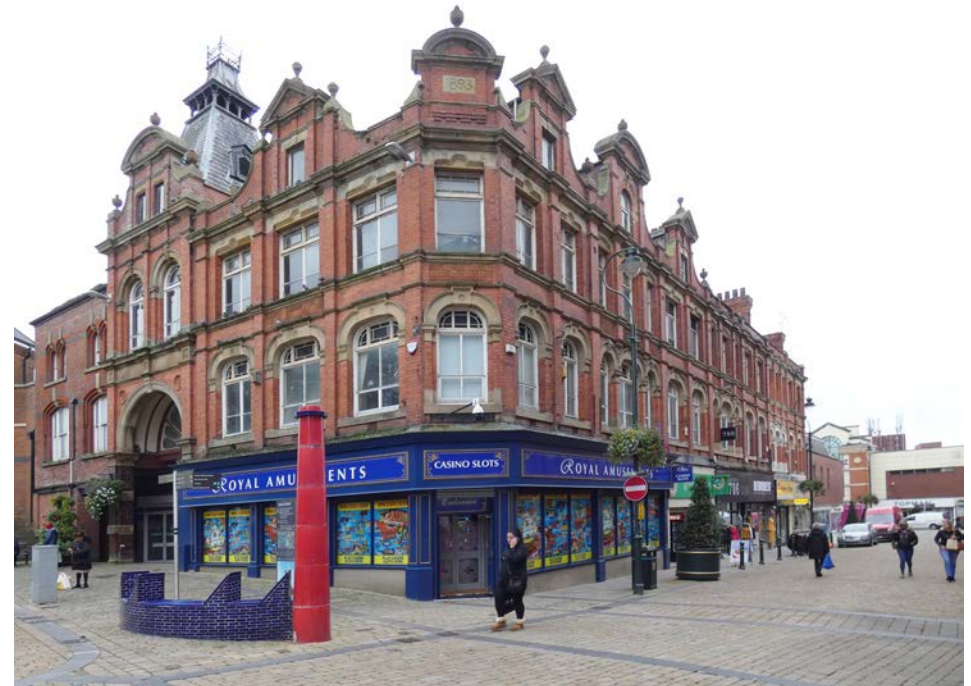
Notes: Victorian retail and office building in red brick with stone dressings. Gabled roofline to north, stone dressings to arched first-floor fenestration are especially ornate, some with carved terracotta friezes above. Most windows retain decorative overlights. Detracting elements include second floor windows at no. 16 which have been replaced with louvered vents, projecting signage to no. 14, vegetation growth visible at roofline, roller shutters, projecting CCTV, poor concrete stallrisers in places enlarged fascias and poor shopfronts across the range, except for no. 8 which is of appropriate proportion. Frontage of no. 8 wraps around to Albion Street, and meets the Hilton Arcade. Nos.18-20 are somewhat narrower; no. 18 appears to have been recently cleaned.

8-16 Curzon Street, decorative panel

8 Curzon Street

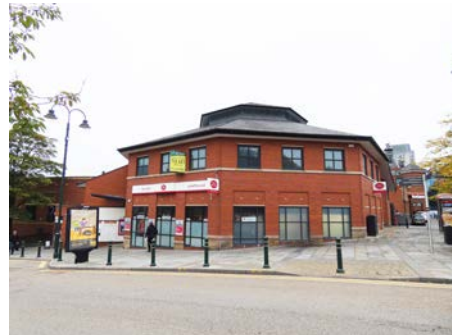
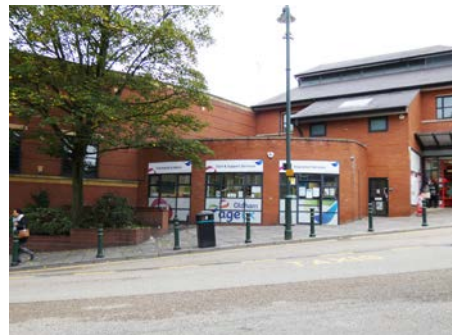
Notes: Late-20th century retail building in red brick, forms part of wider range of uniquely-shaped frontages. Greets corner of Lord Street and Albion Street well and steps back. Odd space created with street, owing to footprint. Signage and shopfronts are not in-keeping with character of the conservation area, but are suitable for the character of the building.

3 Lord Street

5 Lord Street

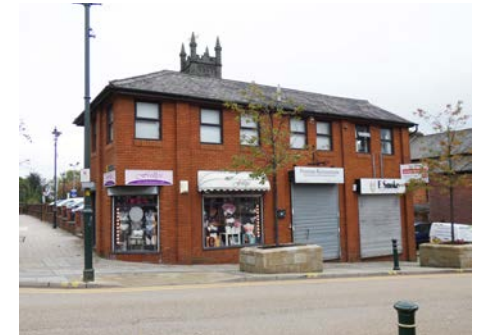
4-8 Lord Street

Overall Condition: Good

Notes: Two-storey late-20th century commercial building in red brick. Cantled principal entrance to shopfront at corner of Lord Street and Rock Street. Inconsistent signage, canopy and roller shutters detract. Cobbled alley to south, views of St. Mary's church and handsome rear elevations of Church Lane buildings beyond.

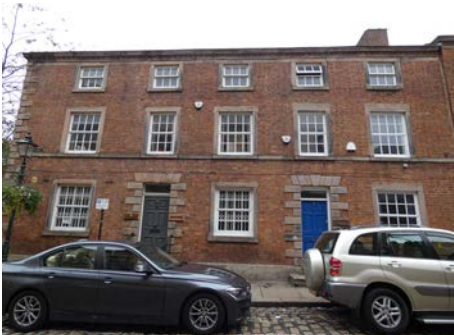
7-9 Church Lane

Notes: Pair of three-storey Victorian houses, in red brick with stone dressings and slate roofs. Rusticated stone entrance architraves, windows are later replacement. Detracting factors include visible alarm boxes and interior security grills to ground floor windows.

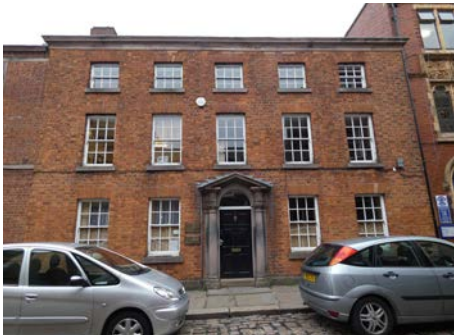
11 Church Lane

Notes: Three-storey Victorian house in red brick with stone dressings and slate roof. Symmetrical frontage of five bays. Detracting factors include horn detail to multiple replacement windows, visible cabling and alarm boxes.

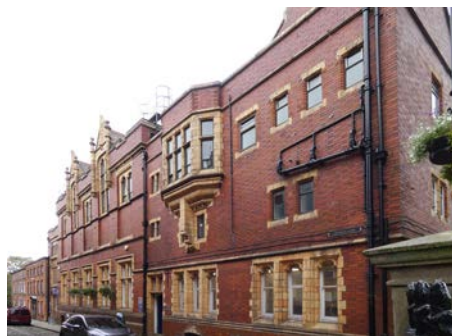
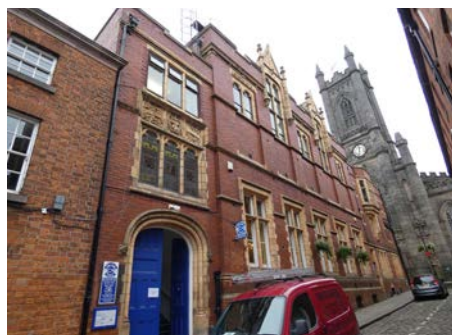
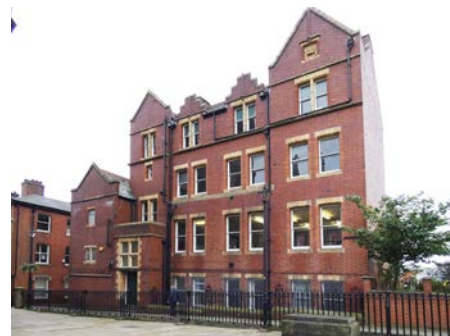
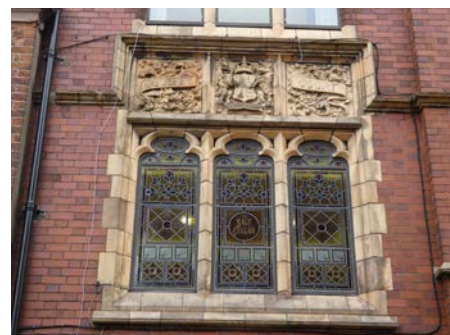
11a Church Lane, County Court, looking west

Overall Condition: Good

Notes: Former court house by architect Henry Tanner. Redbrick with elaborate white terracotta dressings and fenestration. Lively gabled roofline. Returns on to Church Passage to the east; brick infill on Rock Street detracts. Other detracting elements include visible alarm boxes, louvres to window openings, grilles on lower ground floor windows and parking signage.

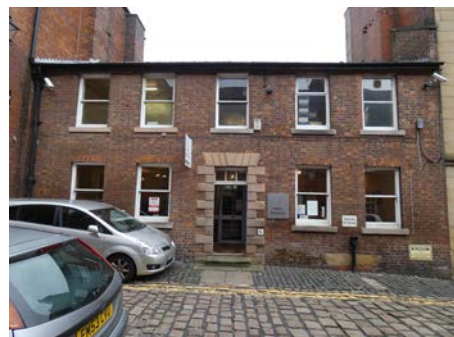
8 Church Lane

Notes: Two storey Victorian frontage in red brick with central principal entrance, domestic scale. Replacement windows in original openings. Extends into rear of bank building to west and south. Detracting elements include opaque window treatments, modern vents inserted in windows, CCTV cameras and inappropriate signage.

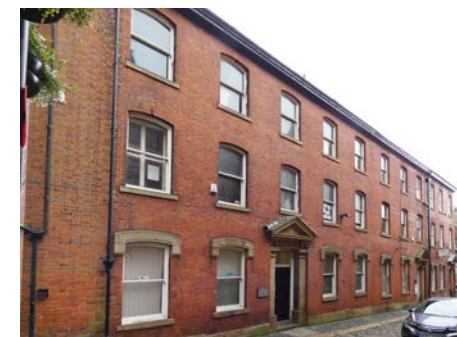
10-14 Church Lane

Overall Condition: Good

Notes: Terrace of three, three-storey Victorian houses in brick, rear elevations in white glazed brick. Chimneys have been truncated. Detracting elements include modern lighting, signage to nos. 10-12, secondary glazing visible from the street, and opaque glazing and window vents at no. 12. Air of partial vacancy also detracts.

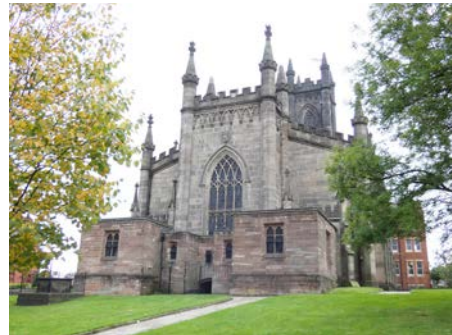
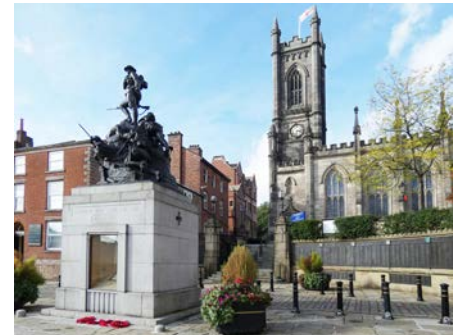
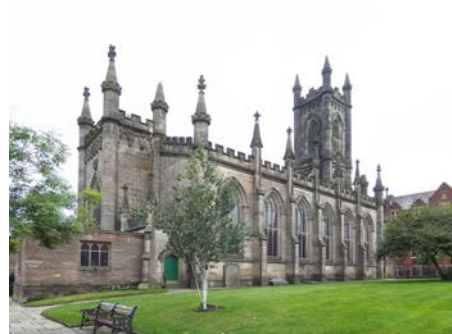
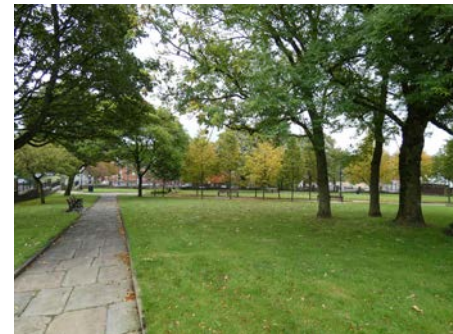
St. Mary's Church, south elevation

Overall Condition: Good

Notes: Parish church by architect Richard Lane, in coursed rubble with slate roof. See list description for further architectural details. Prominent position at summit of conservation area, providing a number of key views. One of Oldham's most important buildings, the church and churchyard form the heart and visual focus of the conservation area.

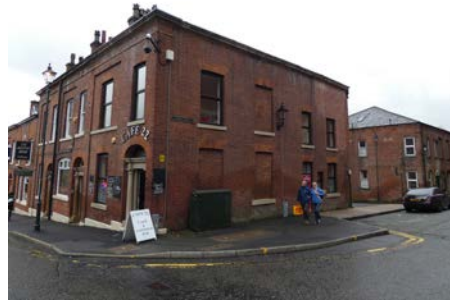
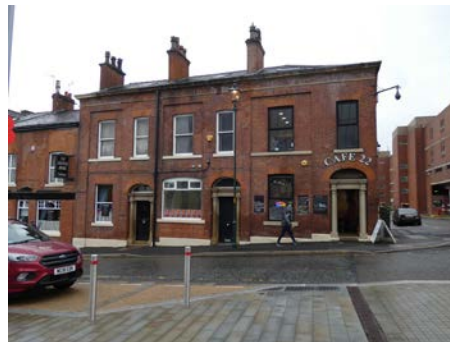
22-26 Clegg Street

Overall Condition: Good

Notes: Forms part of attractive group including buildings to either side of public house at nos. 28-30; group shares similar architectural detailing. Modern windows, but only wider windows at no. 24 detract. Modern conduit and cabling also detract. Rear elevations face Harrison Street, where a car park and substantial addition to nos. 24-26 extends to the street. The bottom half of this has been rendered and altered with modern brickwork, A/C units. Rear of no. 22 appears to have been rebuilt.

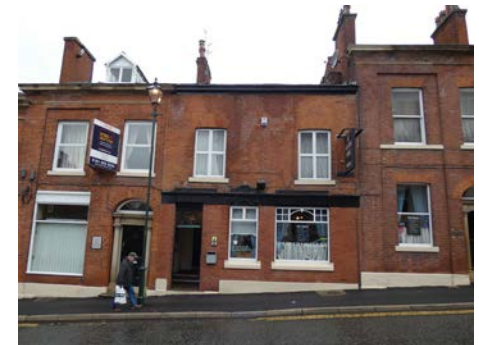
28-30 Clegg Street

Overall Condition: Good

Notes: Pub in red brick; forms a change in scale at the centre of the terrace; ground floor appears to have been rebuilt.

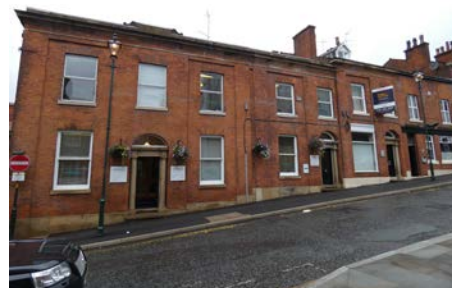
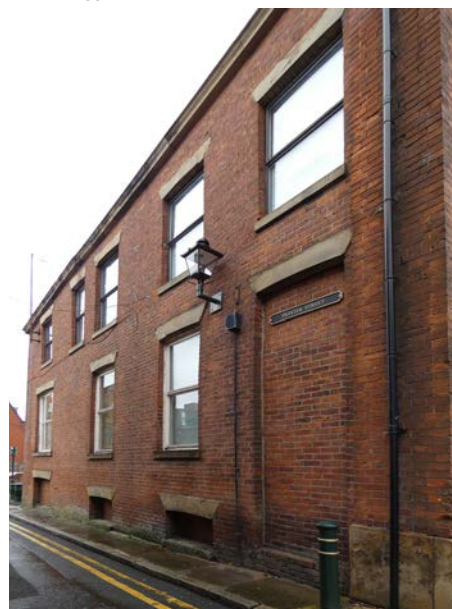
32-36 Clegg Street

Overall Condition: Good

Notes: Terrace (no. 36 is double-fronted) forms part of a group with the rest of Clegg Street in red brick, charming domestic scale. Modern windows, but only large ground floor window to no. 32 detracts, as well as modern cabling. Chimneys have been lost. Side return to Printer Street in red brick also positively contributes to the Victorian domestic scale of the conservation area.

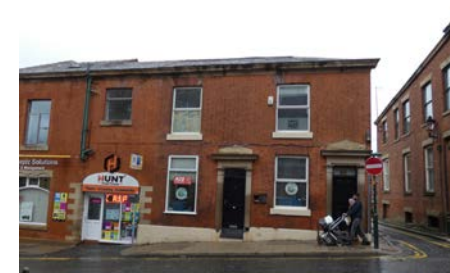
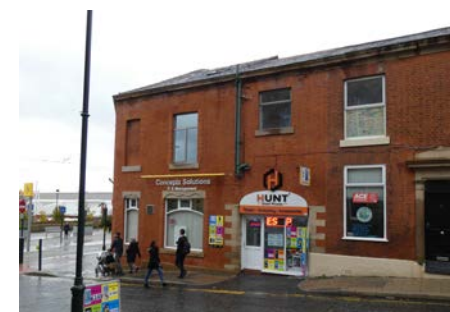
40-42 Clegg Street

Overall Condition: Good

Notes: Terraced buildings in red brick in-keeping with the domestic scale of Clegg Street. Attractive stone porticoes to nos. 40-42. Modern shopfront and signage inserted within an arched brick opening at no. 44 detracts.

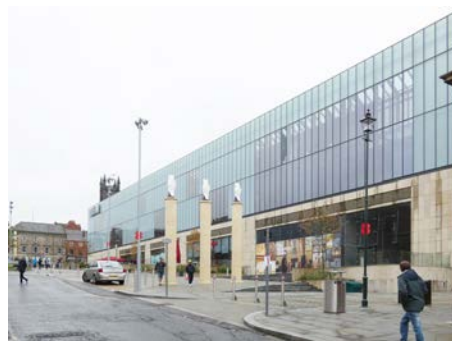
Clegg Street, Town Hall extension

Overall condition: Good

Notes: 2016 Town Hall extension by BDP. Modern mix of tile and glazing, enlivens town square to west. Shopfronts, gallery and event space at the ground floor face onto Clegg Street.

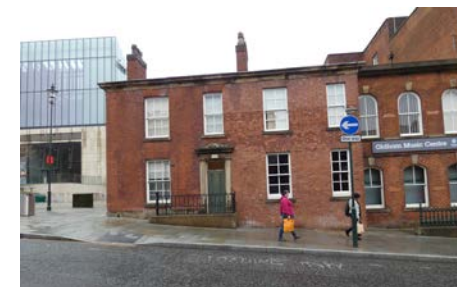
Clegg Street, Lyceum rear block

Notes: Attractive pair of buildings in red brick face Clegg Street, connected internally to Lyceum to south and included with the wider Lyceum list description. In good condition with attractive fenestration pattern. Frontage use could be improved; subsidiary use as rear wing of Lyceum renders the façades to Clegg Street somewhat dead. Some blocked windows, internal security shutters visible from street. Northern return forms a pleasing frontage to Firth Street in red brick, adjacent to a rear entrance to the Lyceum through modern glazed doors. Elevation continues along Firth Street, and includes another range of handsome two-storey cottages in red brick, also 19th century. Windows are largely original, with Gibbs' stone surround to ground floor entrance. The domestic scale here provides interest and contrast with the robust Town Hall and its modern extension opposite.

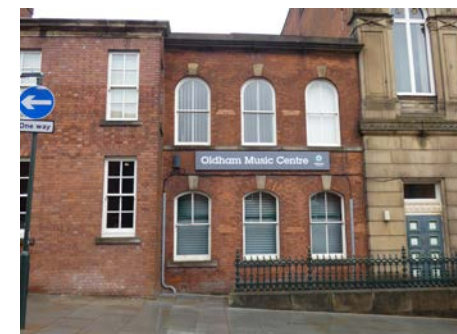
Clegg Street, Oldham Music Centre

Overall condition: Good

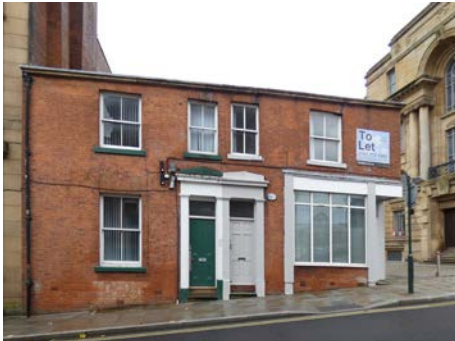
18-20 Greaves Street

Overall Condition: Good

Notes: Quaint terraced pair in red brick. Cabling, blocked lightwell, modern window vent detract from Victorian character. Modern shopfront at no. 18 also detracts, comprising modern infill in a prominent corner position; portico to no. 20, angled roofline and first floor fenestration provide contrast to height and stone of Lyceum return and contribute positively to the streetscape.

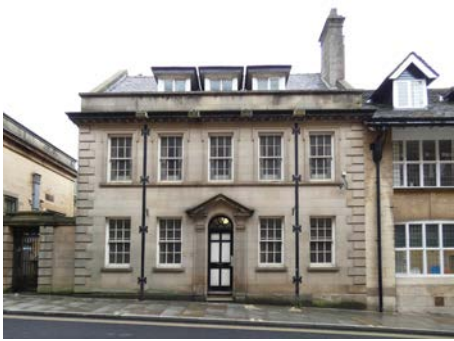
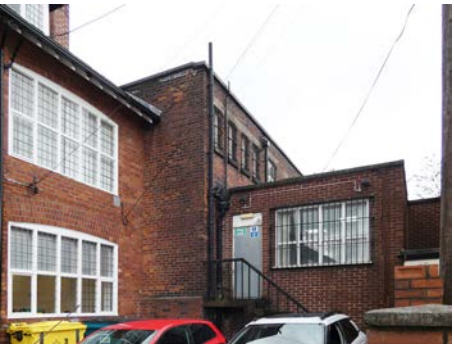
3 Greaves Street

Overall condition: Good

Notes: Classical two-storey façade in stone, return elevation to the north in yellow brickwork with stone dressings visible behind stone gate. Corner quoins and lugged architraves at first floor and prominent details, and downpipes add interest. Modern floodlights project from the cornice and ground floor level plant visible in the north courtyard through the adjacent gate detract. Original rear elevation is concealed by a later extension in red brick; security grilles to windows detract.

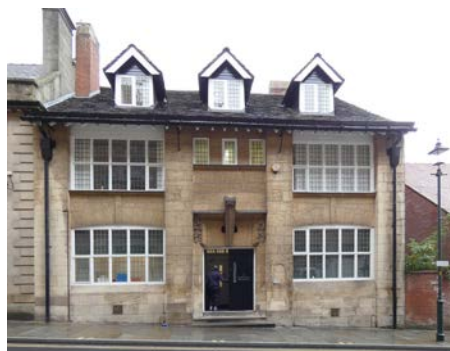
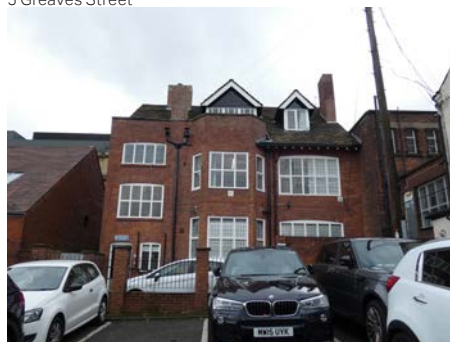
5 Greaves Street

Overall condition: Good

Notes: Handsome two-storey frontage in ashlar; full-height pediments separate three bays; Arts-and-Crafts details. Elaborate projecting keystone over central entrance. Rear elevation in red brick features projecting bays and leaded windows, and also makes a positive contribution to the conservation area.

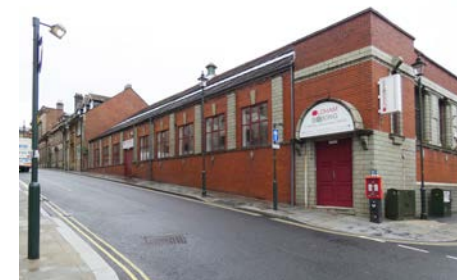
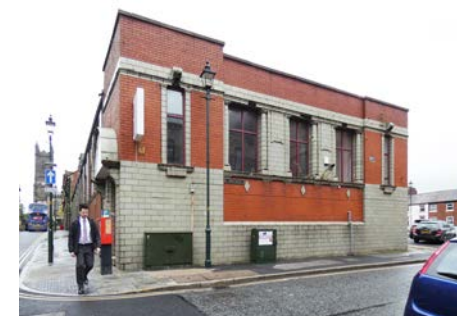
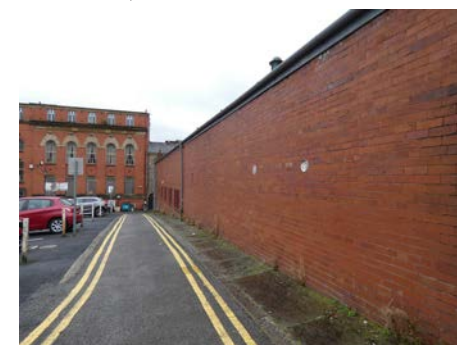
Victoria House, Greaves Street

Overall condition: Good

Notes: Broad, attractive frontage to Greaves Street in red brick with dressings and keystone motifs in glazed green tile, modern windows and doors. Rear elevation comprises a large blind section in red brick, and modern windows to south.

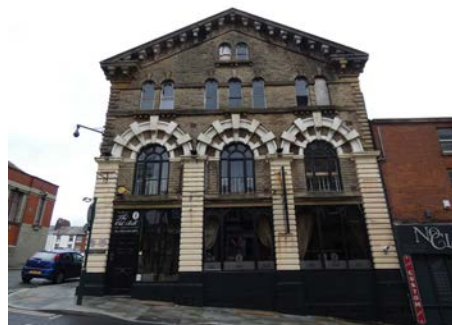
35 Greaves Street

Notes: Pitched roof with heavy bracketed cornice and distinctive stone dressings to arched first floor windows, double-height channelled pilasters further enliven the frontage. Upper storeys are in poor condition, particularly the windows, which are visible in views further down the street. Loose wires and conduit also detract. Return north elevation to Firth Street with lively fenestration also contributes positively to the conservation area.

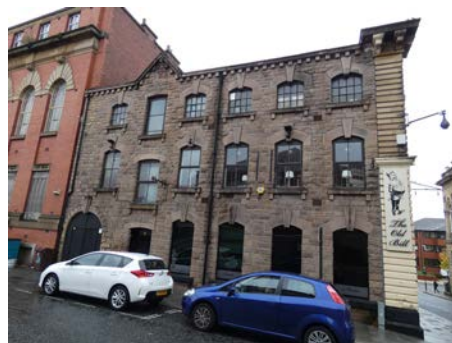
35 Greaves Street, north elevation to Firth Street

Overall condition: Fair, poor at upper floors

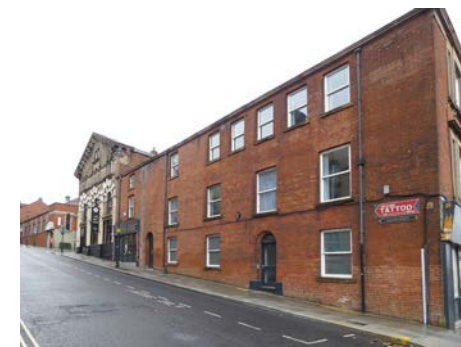
37-39 Greaves Street

Overall condition: Good

Notes: No. 39 forms the western return of 99 Union Street, prominent corner position. Modern windows and doors, but most of simple, late-Victorian elevation has been retained, including attractive arched entrance architraves. Modern shopfront at no. 37 has a neutral impact on the conservation area. Conduit detracts.

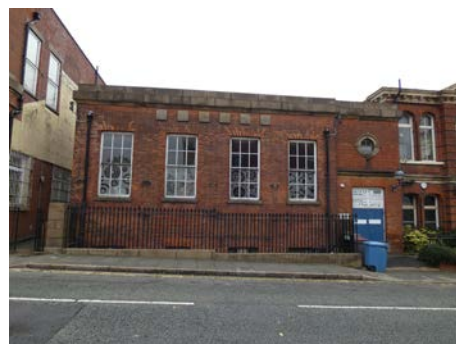
Former Museum, Greaves Street

Overall condition: Good

Notes: Single storey frontage in red brick over a basement, flat roof. Simple stone dressings and carved lettering emphasise the building's historic role within the community. Charming gap between former post office and former Friends' Meeting House, presenting a unified frontage to the street.

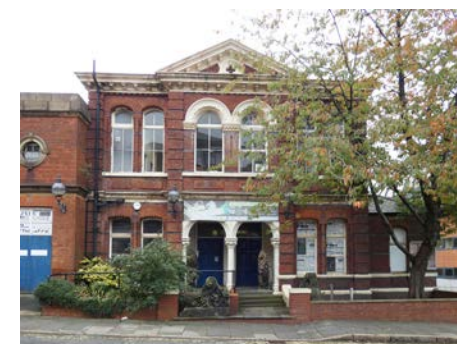
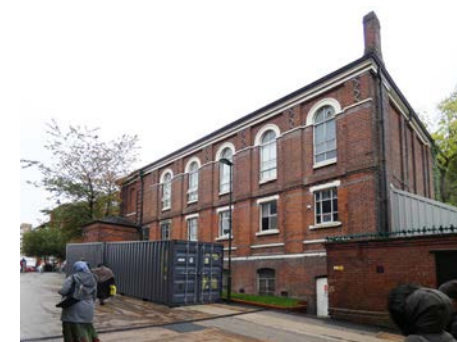
Former Friends Meeting House, Greaves Street

Overall condition: Fair, with some visible deterioration

Notes: Lively late-Victorian frontage features modillion cornice, portico, and projecting central bay. Decorative red brick window surrounds, though some windows are presently blocked by signage and infill. Modern wheelchair access has been implemented insensitively; this and the brickwork to the front boundary wall could be improved. Stonework brought in from elsewhere features in the front garden and entrance porch, adding interest. Arched fenestration and contrasting brickwork of the rear elevation presents a lively frontage to the pedestrian area to the south.

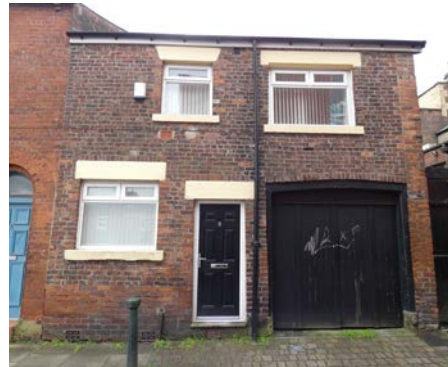
8 Hunter's Lane

Overall condition: Good

Notes: Quaint 19th-century house in red brick, stone cills and lintels. Modern windows, timber panelled garage door in arched opening. Blind north return elevation visible from street.

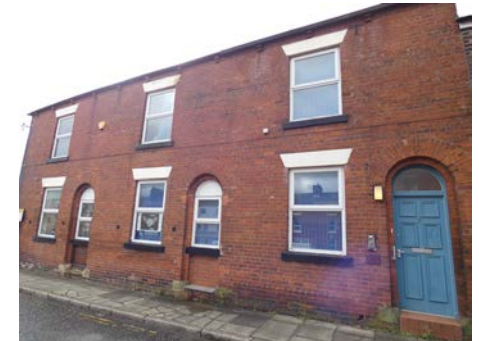
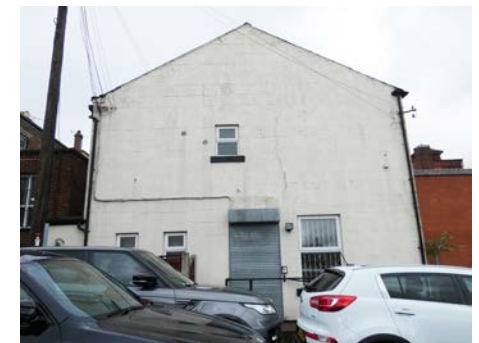
6 Hunter's Lane

Overall condition: Good

Notes: Three small, red-brick Victorian houses amalgamated into one; two southernmost doors have been infilled with modern windows and brick, detracting from the character of the frontage. Modern windows throughout. Return elevation is painted with roller shutter and concrete access ramp to a side entrance door; this and a modern bin store affixed to building also detract.

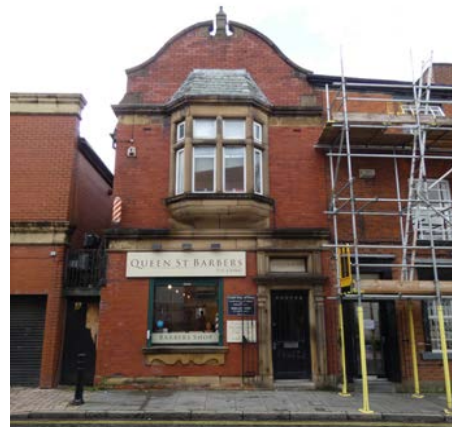
5 Queen Street

Overall condition: Good

Notes: Particularly attractive frontage in the Queen Anne revival style, in red brick with gabled roofline and oriel bay to first floor. Stone entrance surround with pilasters, and prominent stone string courses. Modern shopfront and roller shutter detract somewhat.

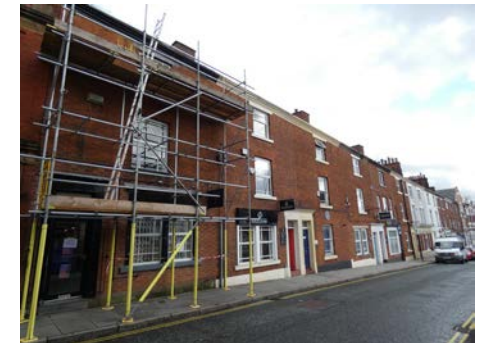
7-17 Queen Street

Notes: Victorian terrace comprising three storey houses of two bays in red brick with continuous cornice. Original windows survive at no. 11, and in partial form at nos. 7 and 9; unique pattern at borders. Modern replacements and sensitive and in a similar style to originals. Fenestration at no. 15 has been altered; modern single-pane window at second floor detracts from the wider character of the terrace, and widened shopfront window detracts from residential character. Signage at nos. 9 and 15 could also be improved. Local blue plaque at no. 11 marks the site as the former offices of Joseph Platt and Northern Union (later Rugby League).

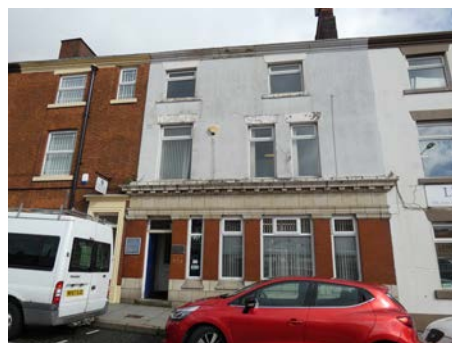
19 Queen Street

Overall condition: Fair

Notes: Part of Victorian domestic terrace at nos. 7-17, but render at first and second floors substantially detracts from the continuity of the range. Modern casement windows throughout. Ashlar courses and modillion cornice to ground floor shopfront; these are positive features.

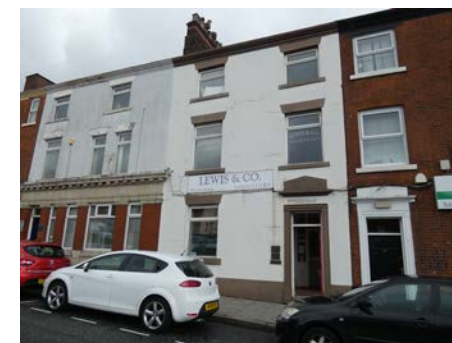
21 Queen Street

Notes: Fully rendered and modern windows throughout detract from the red brick of the wider range. Cracking to render visible in places.

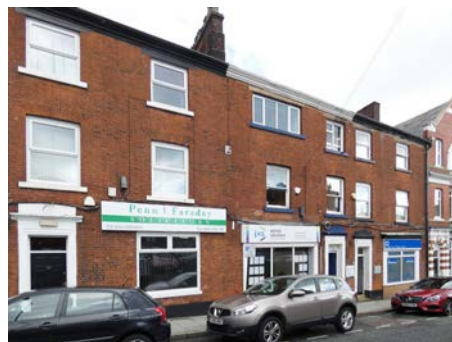
23-27 Queen Street

Overall condition: Fair

Notes: Three-storey, two-bay Victorian houses in red brick offer continuity to the wider terrace, but poor signage, enlarged window openings to the ground floor, substantial cabling and conduit and the modern window arrangement at the second floor of no. 25 all detract from the character of the buildings.

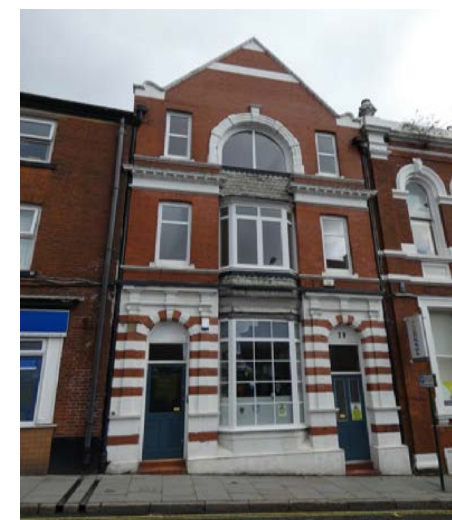
29 Queen Street

Overall condition: Good

Notes: Striking three-storey Victorian building in red brick, with stone detailing, and projecting central bay at the ground and first floors and a gabled roofline. Stone has been painted white, including banding to two entrances which flank a central window. Attractive use of slates above ground and first floor windows. Modern windows of mixed styles detract from the character of the frontage.

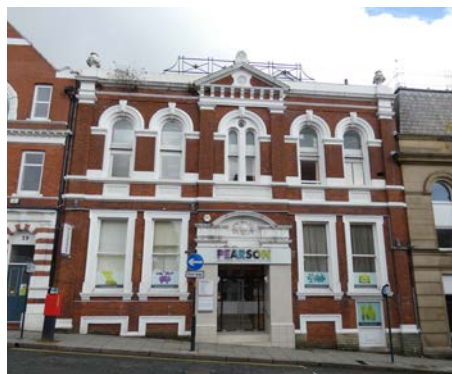
31 Queen Street

Overall condition: Good

Notes: Red brick Victorian office building with prominent stone detailing, painted white. Arched fenestration openings at second floor; pilastered central bay projects slightly beneath pediment. Basement windows have been infilled with brick, but maintain stone architraves. Modern entrance porch detracts, as does an internal mezzanine floor which cuts across windows at the second floor and is visible from the street. Plant growth at roofline. Rear comprises a modern, two-storey extension and bulky metal fire escape to Retiro Street, which detract. Arched fenestration pattern to second floor continues at the rear and is visible from Retiro Street behind the extension.

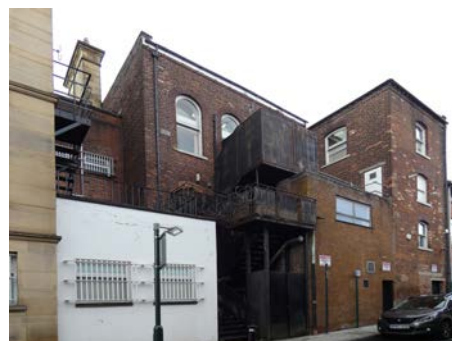
31 Queen Street, rear elevation

Overall condition: Good

Notes: Two-storey red-brick buildings (possibly originally offices) with stone surrounds to windows; pattern corresponds with that of 32 Yorkshire Street. Modern casement windows throughout. Detracting elements include infilled ground floor window to south, roller shutter and modern entrance door, and roller shutters to broad modern shopfront.

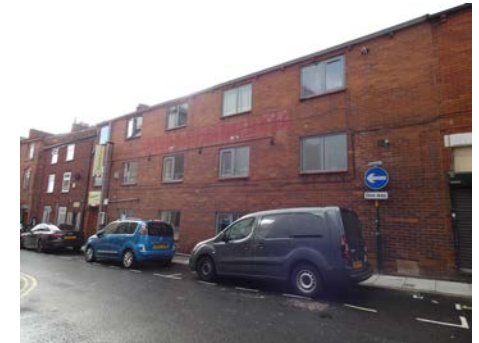
8 Retiro Street

Overall condition: Good

Notes: Modern three-storey apartment building in red brick, with interesting brown-brick surrounds to the windows, which maintain Victorian proportion found elsewhere throughout the conservation area. Modern security grilles at the ground floor detract.

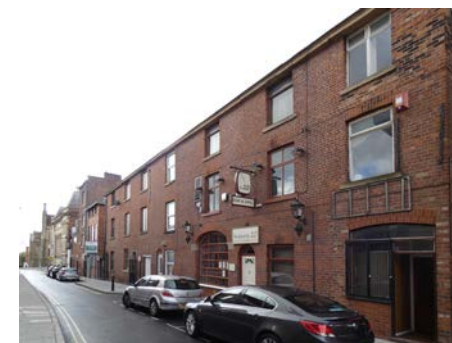
18-26 Retiro Street

Overall condition: Good

Notes: Three-storey block in red brick appears historic, but rebuilt in places. Modern fenestration to all windows except for no. 26, which also retains original arched entrance architrave. Wider ground floor shopfront openings at nos. 18-20. Modern doors detract from character, particularly at nos. 18-22, as do security grilles at no. 24.

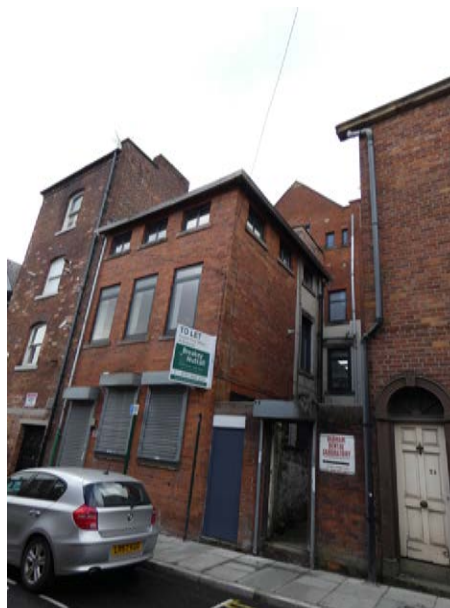
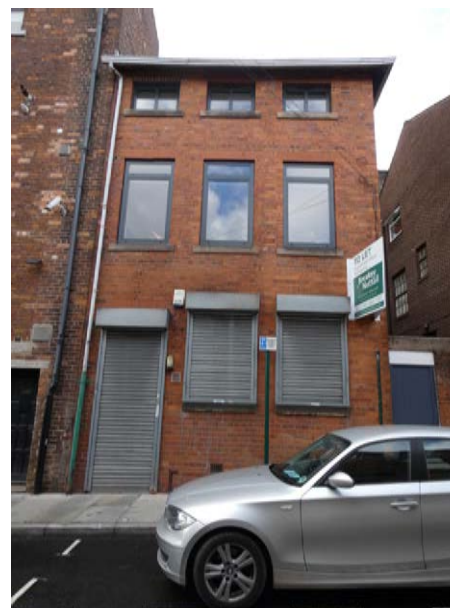
28 Retiro Street

Overall condition: Good

Notes: Glazed brickwork and fenestration matches rear of 29 Queen Street, linked at rear. Three-storey red brick office building extension with stone cills; north return elevation faces into courtyard/alley screened from Retiro Street by a brick wall. Modern windows throughout. Heavy roller shutters to ground floor door and windows detract from the character of the street.

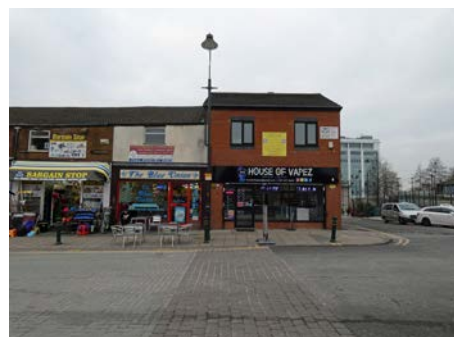
49 Henshaw Street

Overall Condition: Good

Notes: Two-storey building in red brick with ground floor shopfront, terminating the range of buildings along the west side of Henshaw Street. Modern glazed ground floor shopfront, two modern windows at first floor with contrasting surrounds in darker brick. North return elevation turns west, where first floor fenestration continues and another shopfront is situated on the ground floor. Roller shutters and signage detract.

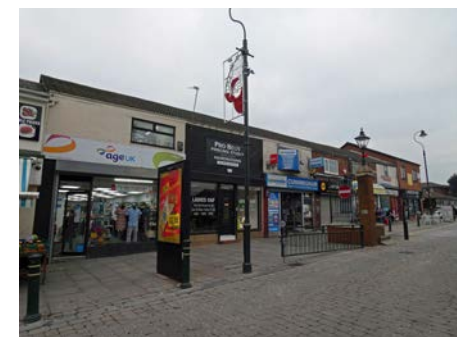
37-47 Henshaw Street

Overall Condition: Fair to poor

Notes: Range of quaint, two-storey brick commercial buildings, some rendered, no. 39 with weatherboarding at the first floor. Full-width modern shopfronts at the ground floor; nos. 43 and 47 retain original shopfront joinery to pilasters and fascia, though this appears to have been lost elsewhere in the range. Single modern casement windows at the first floor in various positions detract. Awnings, roller shutters and signage also detract.

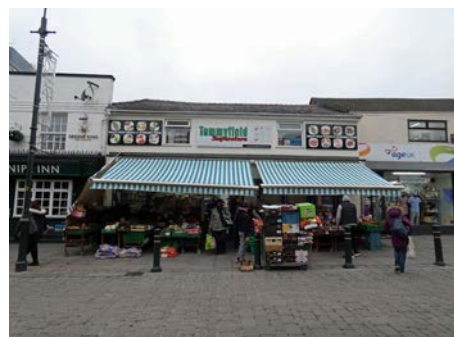
33-35 Henshaw Street

Overall Condition: Good

Notes: Pair of two-storey shops with frontages similar to nos.37-47, but buildings are deeper and project into Henshaw Street slightly. Faced in rendered brick with ground floor shopfronts and single modern casement windows at the first floor. Large, projecting awnings conceal much of the ground floor from street views and detract, modern signage affixed at first floor also detracts.

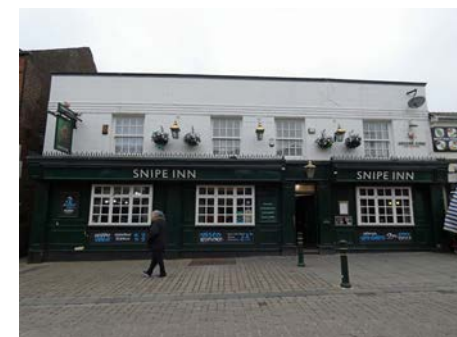
The Snipe Inn Public House

Overall Condition: Good

Notes: Two-storey public house extending over four bays, full-width timber pub frontage at the ground floor and rendered at the first floor. Multi-pane sashes at the first floor appear historic; modern multi-pane casements at the ground floor detract. Signage is appropriate to the building, modern conduit and satellite dish to frontage detract. Narrow pedestrian alley to south between the Snipe and 27 Henshaw Street with lantern overhead provides interest.

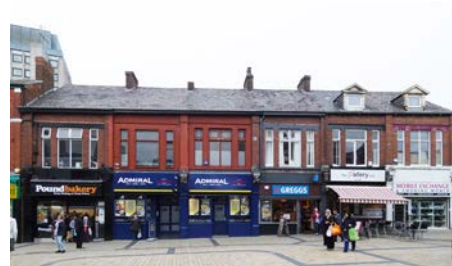
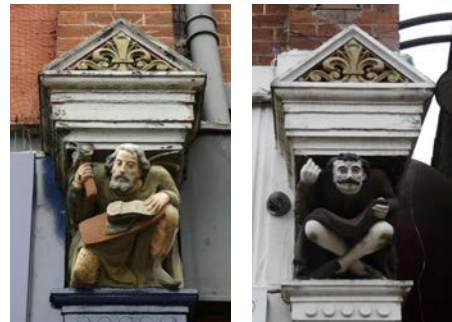
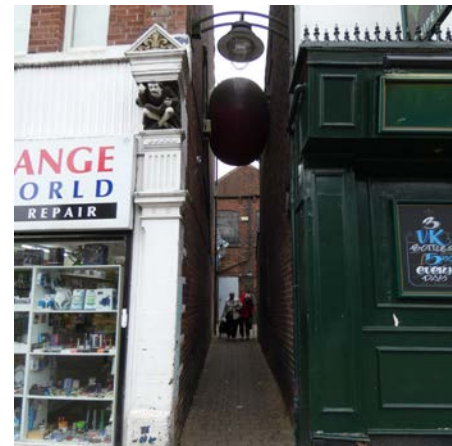
17-27 Henshaw Street

Overall Condition: Good

Notes: Range of quaint, two-storey commercial buildings in red brick that form the terminus of west-facing views from Albion Street. Tripartite window arrangements at the first floors; windows at nos.17, 19, 25 and 27 are replacements; originals with intricate glazing bar pattern to overlights at nos. 21-23. Dormers visible from street at nos. 25 and 27; these break up the roofline and detract. Poor shopfronts with oversized fascias which lack cohesion with the character of the range. Pilasters survive; carved corbels depicting 19th century trades add substantial interest; corbels painted over at no. 17.

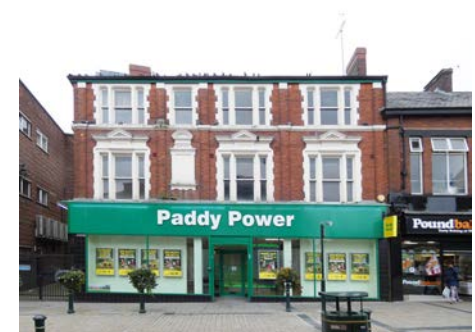
13-15 Henshaw Street

Overall Condition: Good

Notes: Victorian commercial buildings, three-storeys in red brick with contrasting painted dressings. Windows at first floor are pedimented. Large shopfront with black tiles and full-height glazing and oversized fascia detract and do not relate to upper floors. South return elevation are visible behind low service gate; decorative fenestration dressings wrap around, pedimented side entrance.

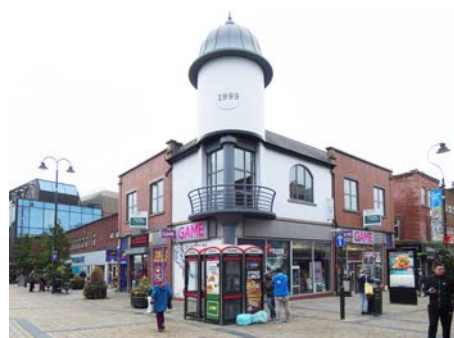
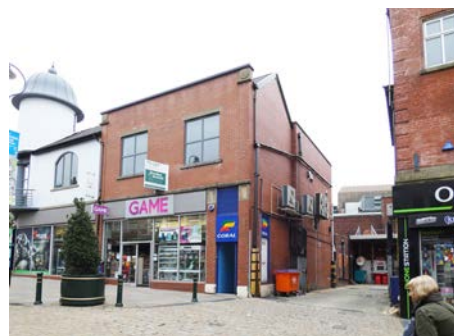
22-24 Henshaw Street

Overall Condition: Good

Notes: Corner retail and office building in three sections facing Henshaw Street and Albion Street in render and red brick. Whimsical design with domed tower at corner with projecting first floor balcony. Detracting elements include poor signage (including one at high level), louvres over doorways, visible plant affixed return elevation, a roller shutter to no. 34, and adverts obscuring ground floor shopfront windows. Entrance to Ratley Passage is directly south of the building, exposing service yard and rears of late-20th century commercial buildings behind.

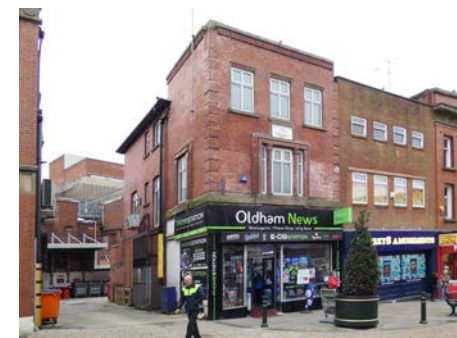
6 Henshaw Street, with north return elevation

Overall Condition: Fair

Notes: Three-storey retail building in red brick, brick quoins at corners and dentils at roofline. Attractive tripartite window arrangement at first floor, modern casements detract. Poor ground floor shopfront with oversized box sign detracts.

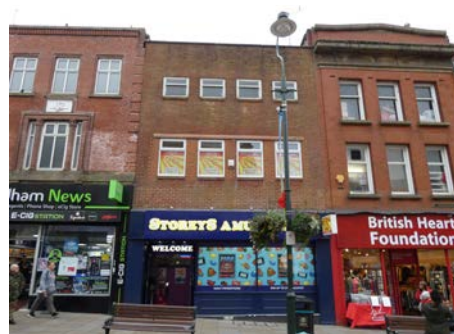
4 Henshaw Street

Overall Condition: Fair

Notes: Plain three-storey retail frontage in red brick, four bays of modern casements. Poor detailing to windows. At ground floor, oversized fascia, projecting signage and advertisements blocking windows detract.

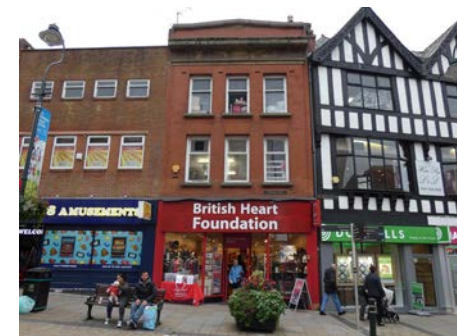
2 Henshaw Street

Overall Condition: Good

Notes: Three storey brick frontage with robust stone cornice and pediment at roofline. Modern casements at upper floors, modern shopfront with recessed central entrance. Oversized fascia and visible internal balustrade at the first floor detract.

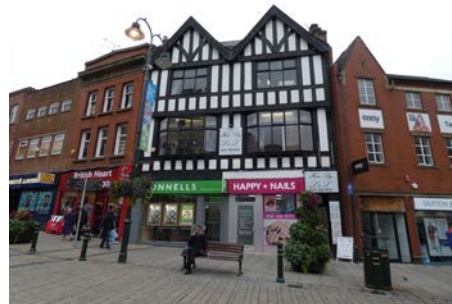
21 Market Place

Overall condition: Good

Notes: Three storey building in Tudor-esque style with gabled roofline adds interest to Market Place. Upper floor windows are modern but appropriate. Ground floor modern shopfronts have a poor relationship to upper floors, excessive signage and signage to upper floors detract.

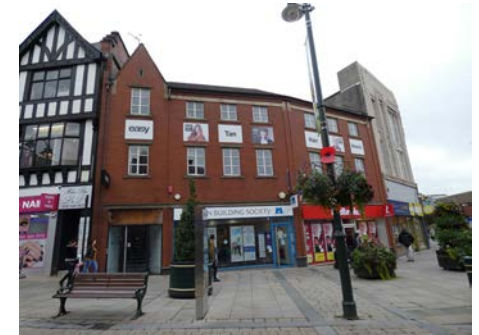
23-25 Market Place

Overall condition: Good

Notes: Three storeys in red brick with stone course near roofline, relatively plain frontage wraps around the curve of Market Place – a sensitive location in the visual transition between Henshaw Street with the High Street. Detracting elements include large shopfront to no. 23, over-boarded windows, high-level signage (both flat and projecting). Side entrance on northern end provides access to offices above.

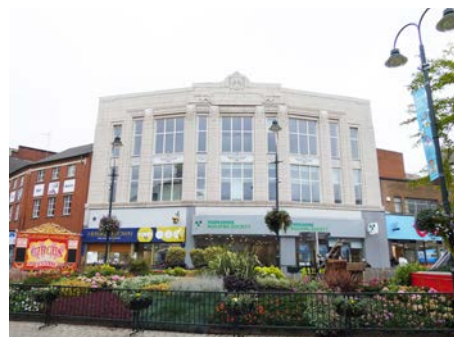
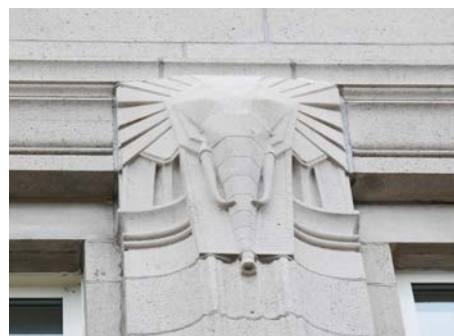
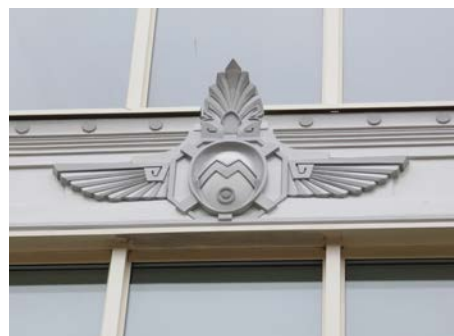
27-31 Market Place

Overall condition: Fair-to-good

Notes: Striking ashlar frontage at the centre of the curve of Market Place, of three storeys. Pilasters and elephant motifs generate interest; frontage helps to frame the greenery and pedestrian area in front. Modern windows to upper floors are consistent, detracting elements include oversized shopfronts, rendered ground floor pilasters, poor signage and a bulky, projecting canopy to nos. 29-31.

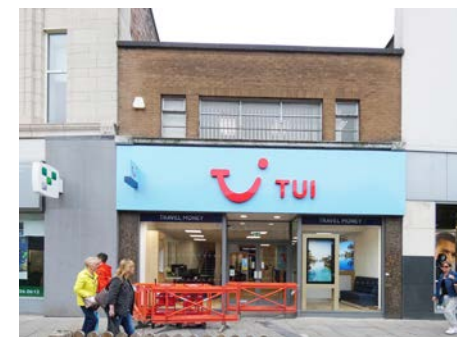
35 Market Place

Overall condition: Fair-to-poor

Notes: Squat two-storey building reads as infill. Brick and original windows at first floor. Oversized fascia detracts.

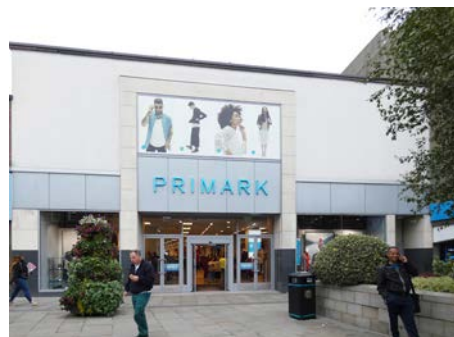
37-41 Market Place

Overall condition: Good

Notes: Bland retail façade with large, metal panels above shopfront. High-level advertising and large signage detract.

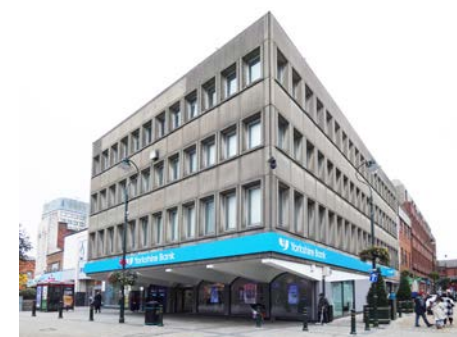
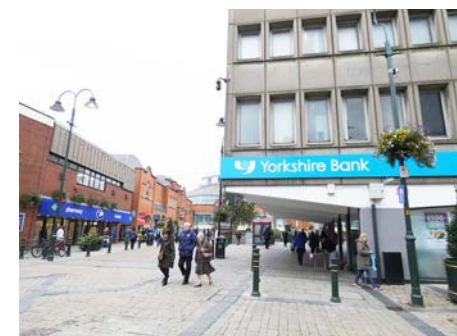
43-47 Market Place

Overall condition: Fair

Notes: As a set piece of architecture this is a building of quality with a clear expression of structure, cantilevered at upper floors. However, the bold projection over the streetscene compromises the character of the townscape. Fascia also detracts, obscuring textured concrete.

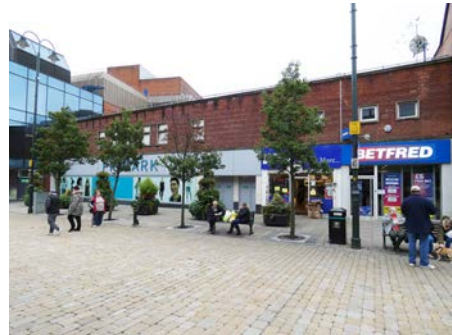
33-35 Albion Street

Overall Condition: Good

Notes: Two-storey retail frontage, nondescript in brick at the first floor. Small windows lack proportion. Elevation steps back from 37 Albion Street. Shopfronts, oversized signage and visible handrail at roofline detract. Neighbouring buildings to east comprise a retail service entrance; windows are obscured by signage and add to an overall back-of-house character.

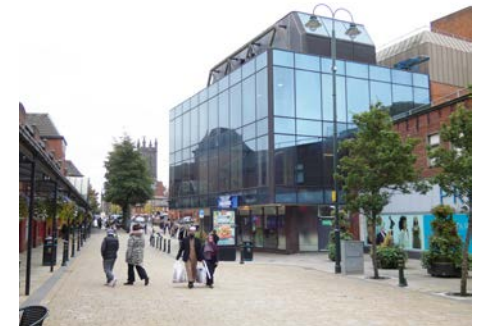
17 Albion Street

Overall Condition: Good

Notes: Bold, glazed massing projects into Albion Street. Interesting building in its own right, but projecting frontage detracts from the public realm, and interrupts eastward views. Signage has a temporary character and also detracts.

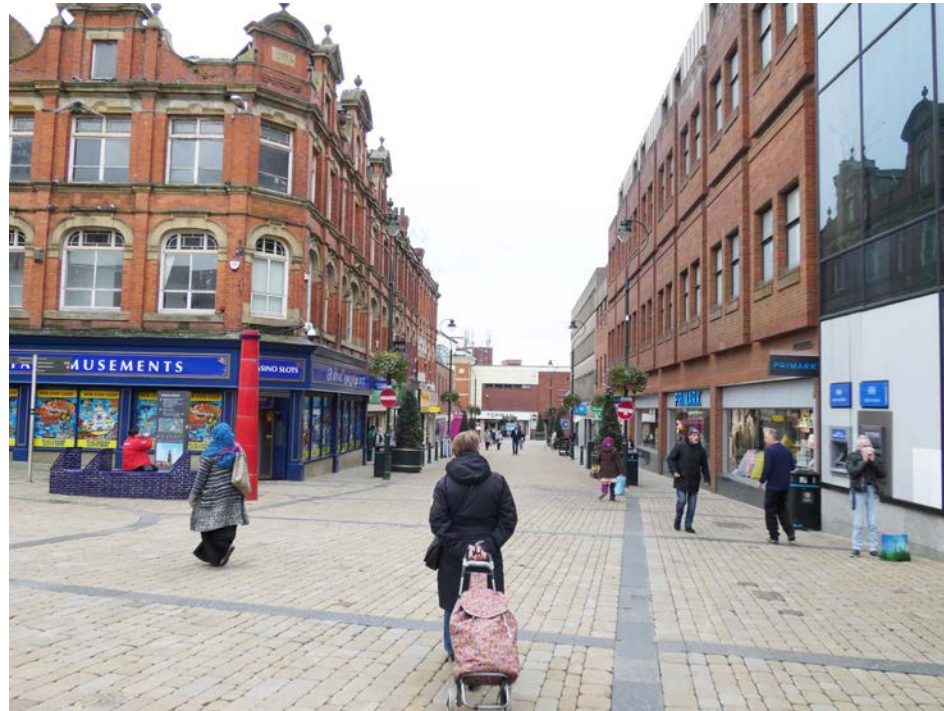
9 Curzon Street, modern facade on right

Overall condition: Good

Notes: Late-20th century retail and office building in red brick. Modern shopfront suits the building, but enlarged fascia detracts. Modern widows and metal roofing above are unassuming. Neighbouring building appears to be of the same scheme, also in red brick but in much heavier massing, with projecting brick bays and metal cladding to the upper floor; this is recessed. Shopfront display continues the full width of the building to the north, but fascia size here is appropriate.

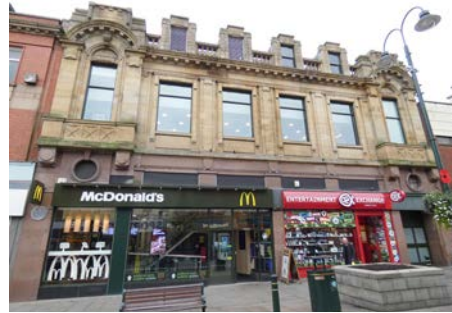
6-8 High Street

Overall condition: Good

Notes: Elaborate Neoclassical retail building, two storeys with attic dormers. Ground floor in granite, first floor in sandstone, elaborately decorated. Original shopfront has been substantially altered to accommodate two units; fascia is of appropriate size but box sign to no. 6 and infill above both is inappropriate and detracts from the character of the building. Original pilasters still visible. Replacement windows at first floor are well done. Local blue plaque states the building is on the site of the former Yates's Wine Lodge, opened in 1884.

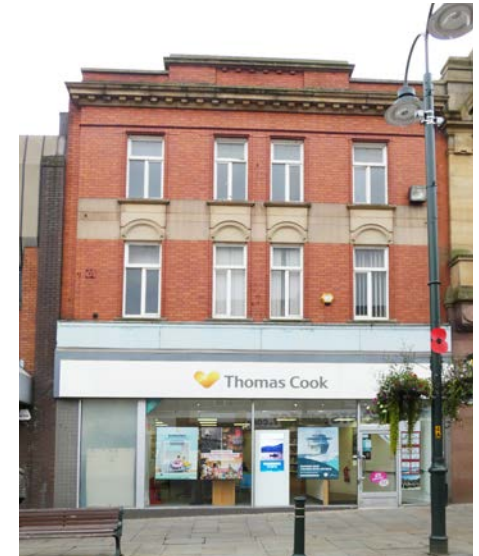
10 High Street

Overall condition: Good

Notes: Three storeys in brick with prominent stone band above first floor and dentilled cornice. Oversized shopfront and box signage detract; panel above fascia appears unnecessary and also detracts.

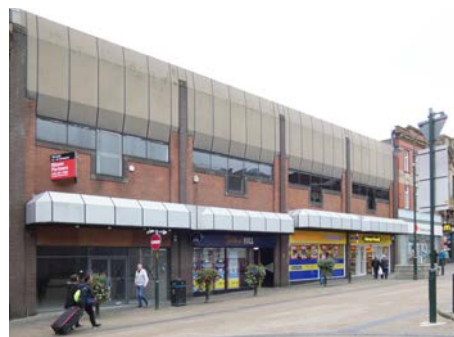
12-20 High Street

Overall condition: Fair

Notes: Late-20th century retail and office building in mixed materials. Design has interest and follows scale of street, including vertical brick definition between shopfronts. Projecting canopy particularly detracts from the streetscape. Shopfronts at nos. 12-16 and signage detract; shopfronts at nos. 18-20 are better, but no. 20 is vacant.

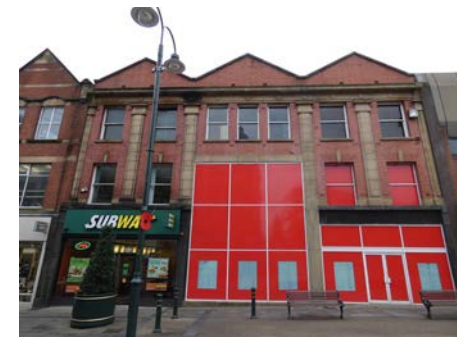
22-24 High Street

Overall condition: Fair

Notes: Vacancy is what detracts from the character of this building the most, but overall a positive contributor to streetscape. Three storeys in red brick with full-height stone pilasters and gabled roofline. Granite surrounds at ground floor. Large modern shopfront windows at centre of frontage detract; shopfront to no. 24 is of better scale, but of poor quality.

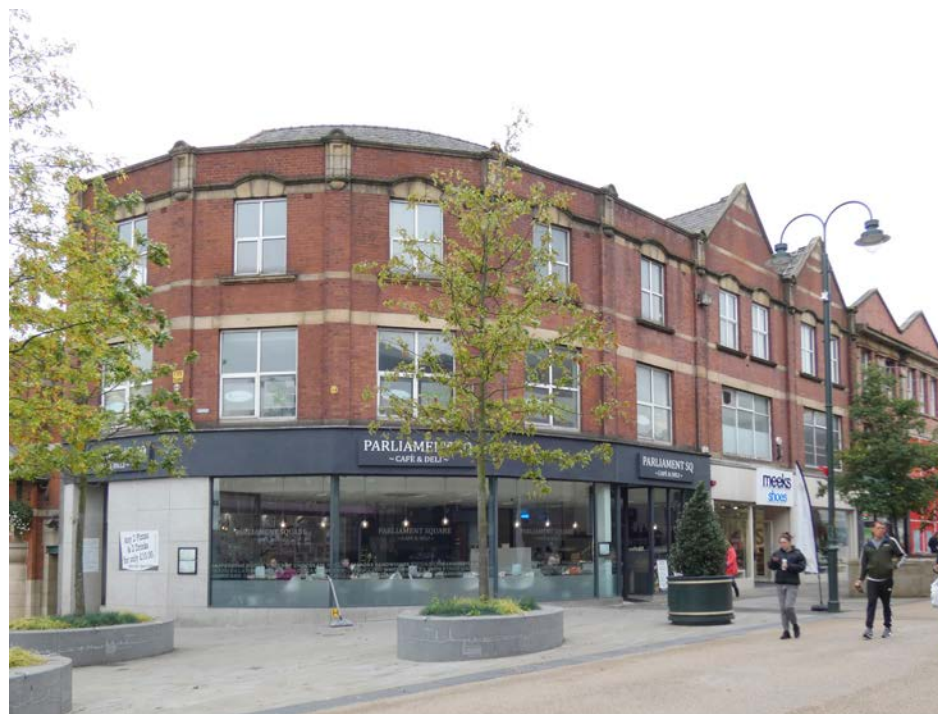
26-34 High Street

Overall condition: Good

Notes: Three storey retail and office building in red brick with stone banding, wraps around to Parliament Square. Gables to High Street elevation. Windows are modern replacements in a style which detracts from the character of the building. Loss of original pilasters detracts from the frontage at the ground floor; shopfront are large and bulky for the most part. Signage to Parliament Square is fine, but background is poor. Poor signage to shoe shop.
