Adopted Oldham Town Centre Conservation
Area Appraisal and Management Plan
Supplementary Planning Document

August 2019

Donald Insall Associates
Chartered Architects and Historic Building Consultants

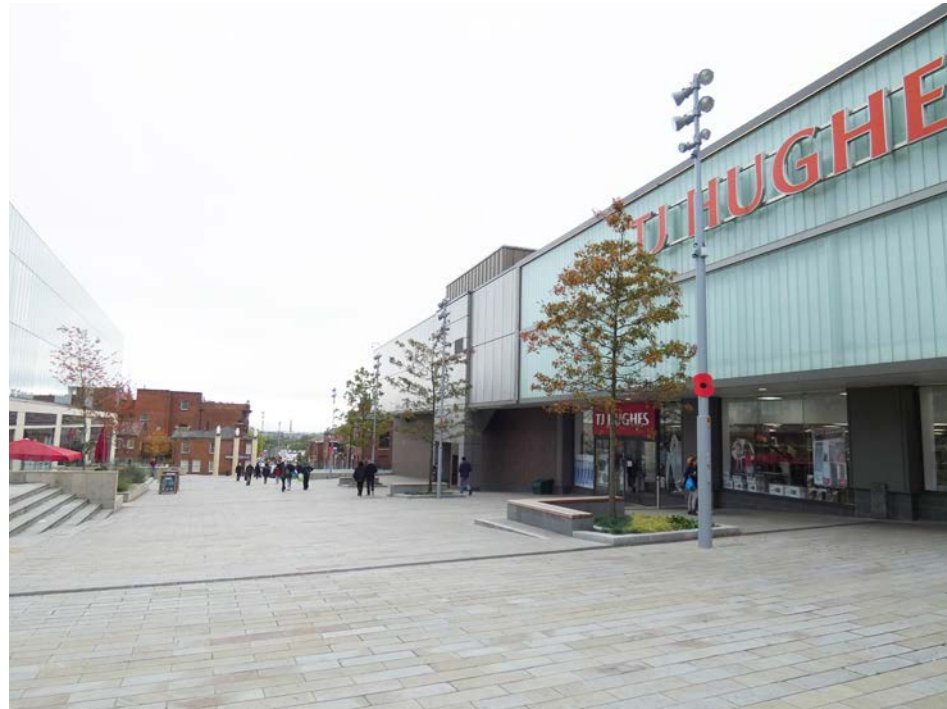
Town Square Shopping Centre facade, Parliament Square

Overall condition: Good

Notes: Façade has been upgraded in response to adjacent Town Hall development; thus, the two read together. Overall the improvement is effective and contributes to the 'square' character, but areas of blank space detract.

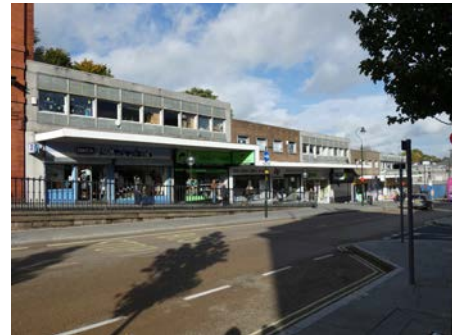
21-41 Yorkshire Street

Overall condition: Fair-to-poor

Notes: While this frontage offers interest as a mid-century commercial block in tile which appropriately steps down from the top of Yorkshire Street, its projecting canopies, mixed signage and overall condition clutter and jar with the adjacent late-Victorian streetscape. East return elevation to St. Mary's Way is blind, in red brick, turning its back onto a vehicular route into the conservation area. Cluttered rear elevations, roller shutters and car parking facing historic route of Old Church Street also detract.

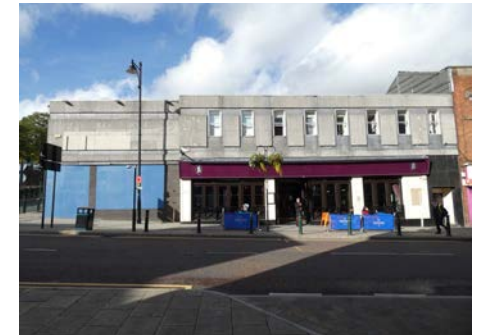
51-57 Yorkshire Street

Overall condition: Fair-to-poor

Notes: Mid-20th century block of lesser interest than nos. 21-41. Upper floor in concrete with modern casements, ground floor in a mix of brick and granite tile. Corner unit at no. 51 is vacant, with shopfront windows infilled. The 'historicised' public house frontage to the east of the building jars with architecture above.

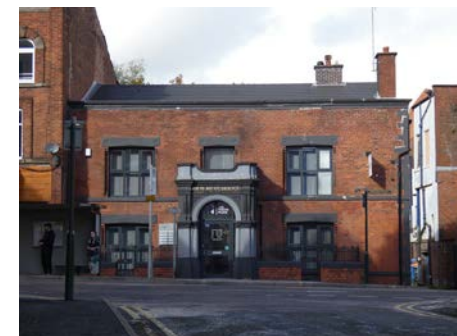
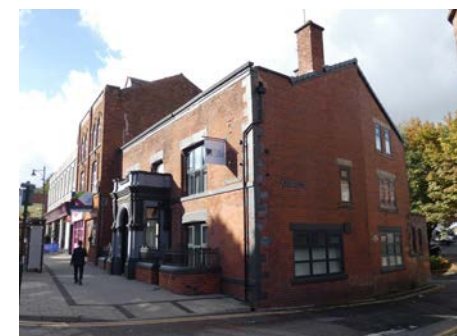
63-65 Yorkshire Street

Notes: Low two-storey frontage drops dramatically and is set back from no. 61. Former public house. Stone lintels and quoin detail to corner. Modern windows are grey in colour and blend well. Highly-decorative front portico retains original signage. Front garden wall appears to be a later addition, with modern metal railings. South return elevation appropriately angles back around curve into Old Church Street, creating gateway effect.

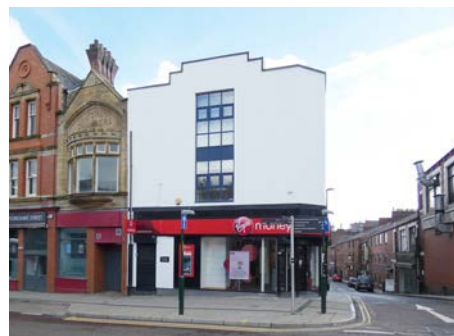
34-36 Yorkshire Street

Notes: Early-20th century Art Deco-style frontage creates interest and forms the terminus to a uniquely diverse block of frontages. Ground floor shopfront is poorly done. Modern windows and vents to return elevation also.

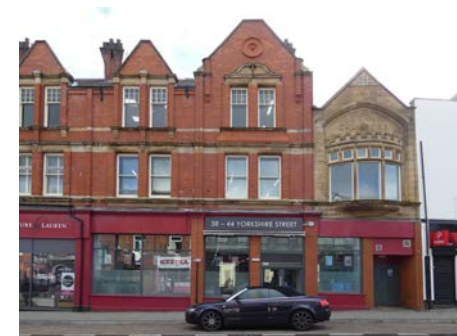
38-44 Yorkshire Street

Notes: Victorian office frontage formed of two buildings, including the single-bay York Chambers building in stone with a crenellated oriel window at the first floor and dramatic range of chimneys. The rest is Queen Anne revival in red brick with stone banding and dressings below brick gables. Oversized shopfront windows detract, as well as poor entrance into York Chambers. Pilasters have been retained but are difficult to read. Building extends into large block facing a rear alley.

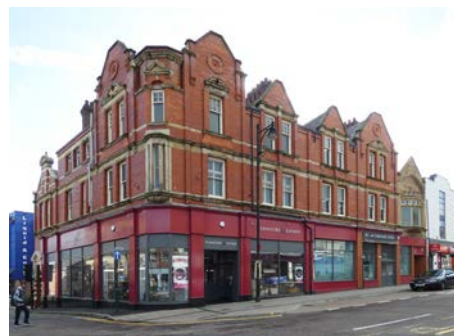
46-48 Yorkshire Street

Notes: Continuation of red brick range at nos. 40-44, wraps elegantly around to Waterloo Street below gables which step down. Delicate oriel window at first floor projects from a canted corner. Original windows largely retained, but inappropriate secondary glazing is visible from street level. Oversized shopfront windows and fascia boards detract.

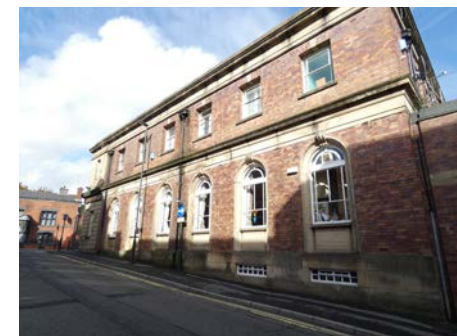
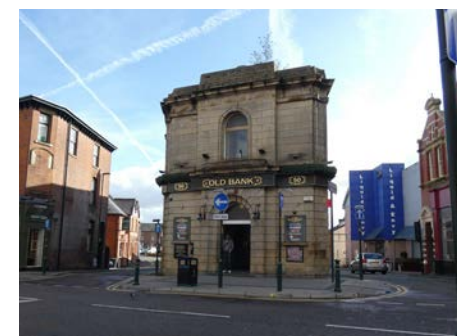
50 Yorkshire Street, east return elevation to Waterloo Street

Overall Condition: Fair

Notes: Neoclassical bank building, in channelled ashlar to Yorkshire Street with return elevation in red brick with stone dressings to Waterloo Street and Bow Street. Prominent isolated position at the junction of a historic local route, emphasised by single central projecting entrance bay with arched doorway and first floor window. String courses continue stone along returns to either side, handsome window surrounds and keystone detailing. Present condition detracts somewhat, with vegetation growth visible at the facades, as well as poor condition of some windows. Single-storey service extension to rear, also in red brick.

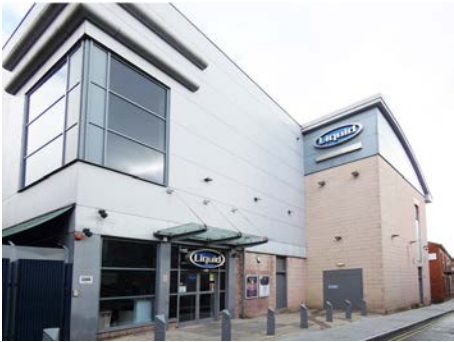
Liquid, Retiro Street

Notes: Large modern building comprising entire block between Retiro and Waterloo Streets. Substantial massing, lack of fenestration and use of modern materials detract from the character of the conservation area. Principal façades step back from the street in views from Yorkshire Street.

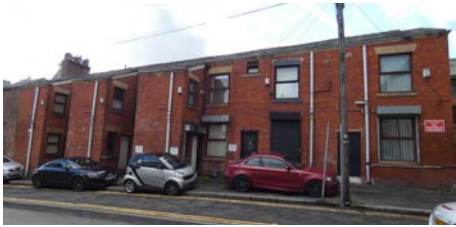
3-21 Retiro Street, rear closet wings

Notes: Terrace of quaint, two storey Victorian houses in red brick; charming domestic scale. Stone entrance pilasters and surrounds, cornices, cills and lintels, and brick dentil detail below the cornice. All windows are modern replacements but generally sympathetic in design. Return elevations to north and south are largely blind. Excessive signage at no. 7, detracting door and windows to no. 13 and detracting windows and roller shutters at nos. 15-21. Most chimneys appear to have been demolished. Pattern of projecting closet wings to rears, except for at nos. 3-5; render and roller shutters in places detract from the close-knit space of Woolacott Street.

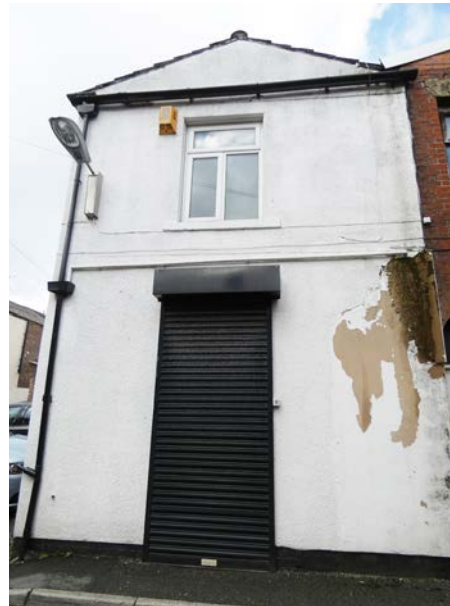
4 Walter Street

Overall condition: Poor

Notes: Single bay rendered elevation to Walter Street; render is deteriorating in places. Modern roller shutter obscures entrance. Modern casement window to first floor. Modern conduit. Reads as a later extension.

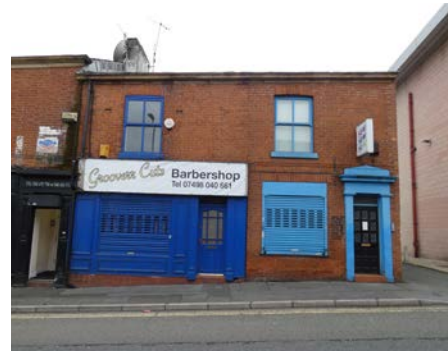
4-6 Waterloo Street

Notes: Victorian cottages in red brick, of two bays each. Domestic scale and some details are positive elements, but rendered north return elevation and rear elevations and ground floor façade alterations detract substantially, including enlarged window openings and inappropriate signage.

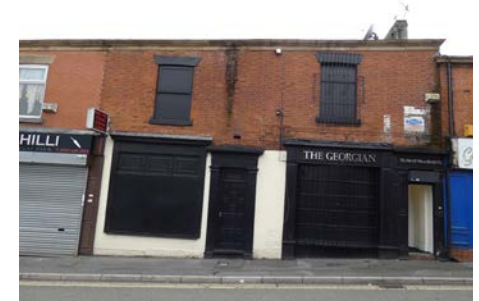
8-10 Waterloo Street

Notes: Victorian houses of attractive scale, but later alterations have detracted from their character. No. 8 has a curved, multi-pane shopfront window but it is completed back painted in black, and obscured by a large security grille. First floor window and all windows to no. 10 also backpainted. Pilastered entrances remain; signage to no. 8 is appropriate. Signage, roller shutter and first floor casement window to no. 12 detract. Rear elevations have been rendered, and windows removed from nos. 8-10. Closet wing extension to no. 8, modern single-storey extensions to nos. 10-12.

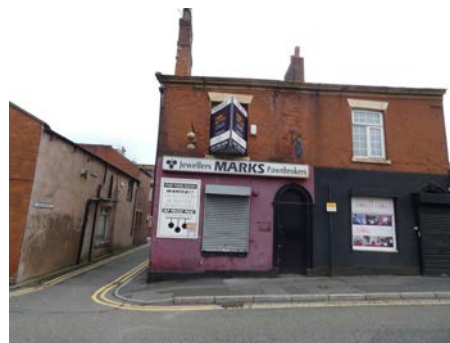
14-16 Waterloo Street

Overall condition: Fair; poor at south return elevation

Notes: Pair of Victorian two-storey houses in red brick with visible original chimneys, rendered at the ground floor. Replacement timber doors set within arched stone architraves; roller shutters cover door at no. 14 and ground floor window at no. 16. Window to no. 14 is blocked by signage, all of which detract. Modern windows to the first floor. No. 12A is a modern extension to no. 14 which detracts from the wider range; this is 'temporary' in appearance, with roller shutters spanning the full width and inappropriate signage. Return south elevation to Walter Street in red brick, with arched window and door openings; windows and doors at the ground floor level have been infilled but retain lintels and cills. Windows at upper storeys are largely modern replacements, save for a surviving example of an original window with arched, coloured margin light. Brickwork has been replaced in places also.

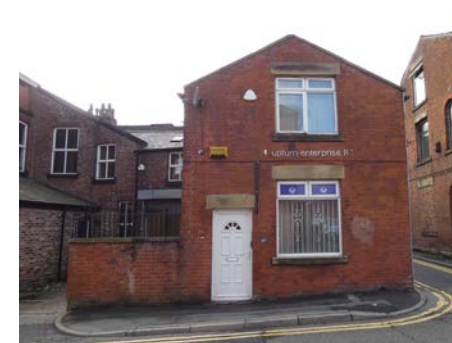
18 Waterloo Street

Overall condition: Fair; poorer along north return elevation

Notes: Two-storey Victorian building in red brick, with heavy stone lintels and pitched roof. Modern entrance door, casement windows and window signage detract. North return elevation to Walter Street is rendered; one rear door opening had been bricked up. Modern security bars to replacement sash window at first floor, conspicuous downpipes and ventilation pipes.

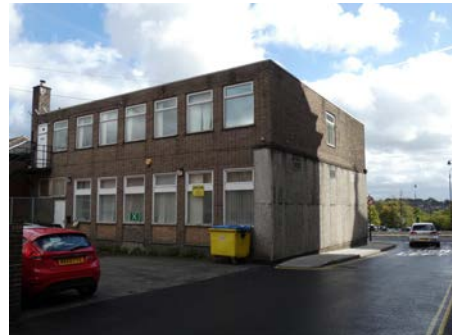
111 Union Street, rear elevation to Walter Street

Notes: Plain mid-20th century office block, two storeys in brown brick. Overall composition, proportion and relationship to bank to north and late-19th century houses to east all detract, as well as modern windows and canopy. Return elevation partially in concrete, symmetrical range of modern windows face Walter Street to rear; fire escape stairs project into car park and detract.

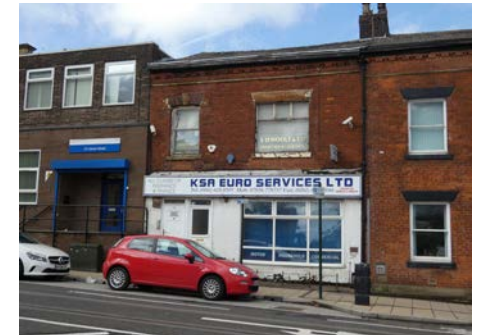
113 Union Street

Overall condition: Poor

Notes: Positive character in virtue of its shared scale and details with neighbouring buildings to east. Poor condition and ground floor shopfront detract. Deep rear closet wing in red brick; poor condition and windows.

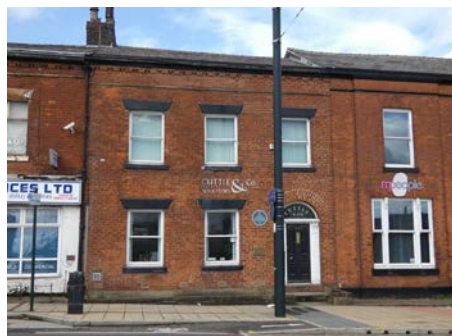
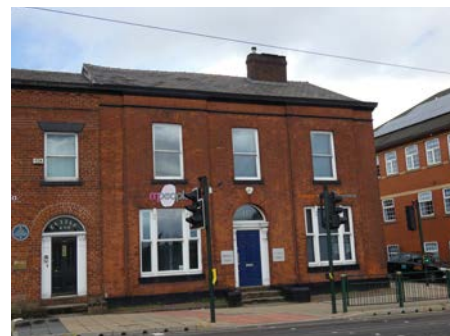
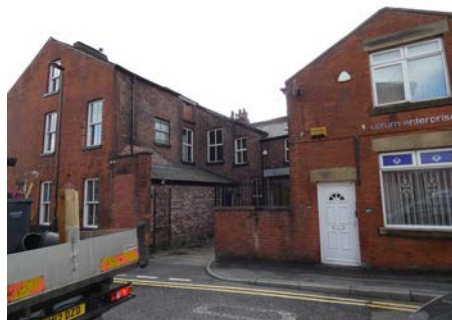
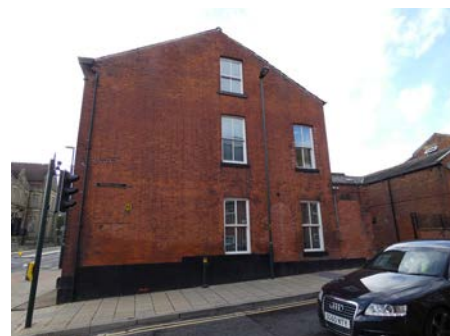
Notes: Late-19th century cottages form an attractive grouping, together with no. 113. Both buildings are in good repair and signage is appropriate. No. 117 has return red brick elevation to Waterloo Street, forming a pleasing corner; original windows to this façade, some openings have been infilled. Access to car parking with roller shutter, off-street yard to rear.

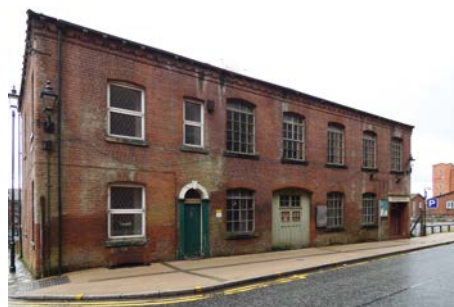
1-3 Ascroft Street, no. 1 to left

Overall condition: Poor

Notes: Forms end block of handsome group in red brick with no. 3. Modern windows. Requires repair and refurbishment. Rear faces into intimate space of Harrison Street.

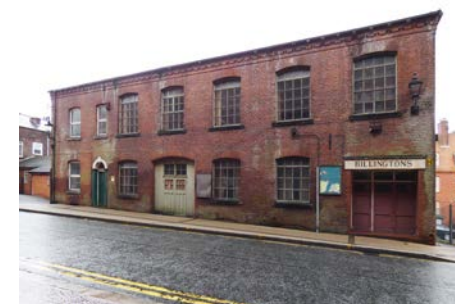
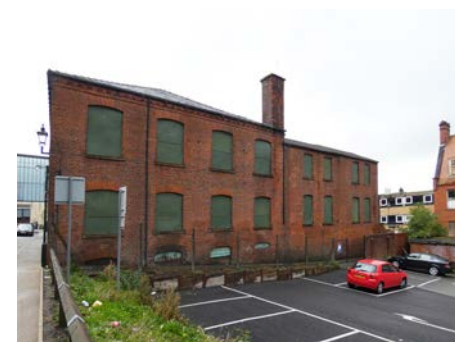
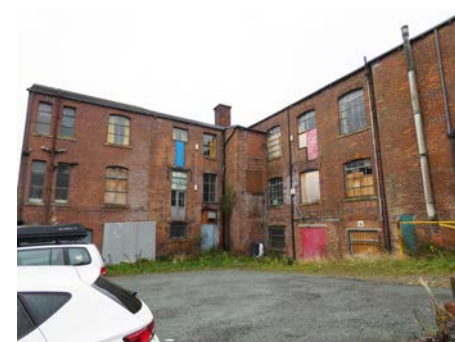
Overall Condition: Poor

Notes: Handsome 19th-century industrial building presents a charming frontage to the streetscape, but needs re-use; condition detracts. Windows blocked to side and rear elevations but are largely original; yard presently used as car park; boundary wall damaged with substantial overgrowth.

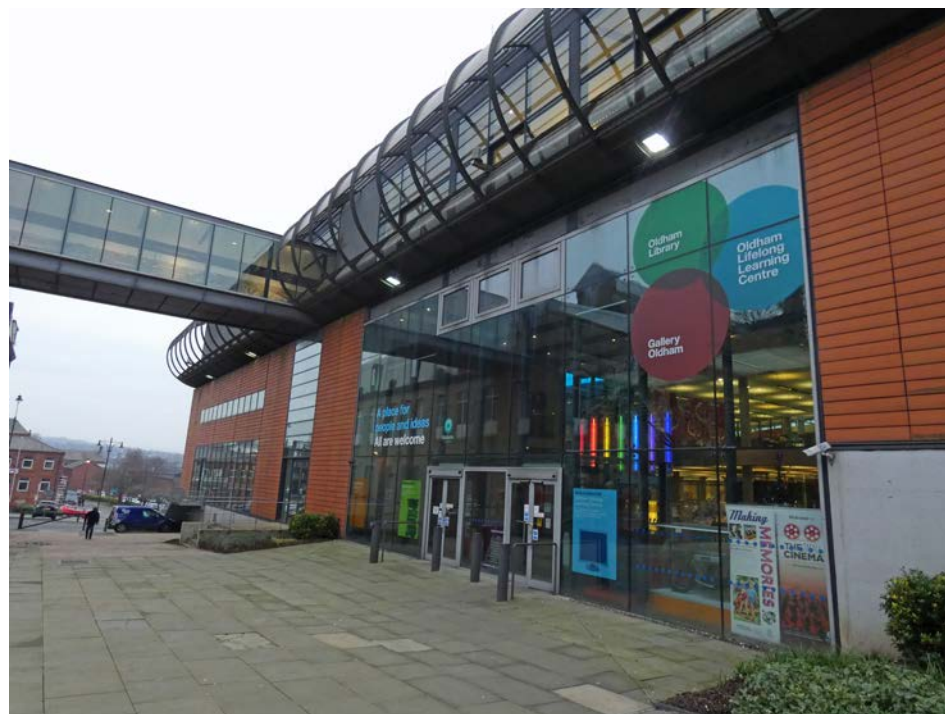
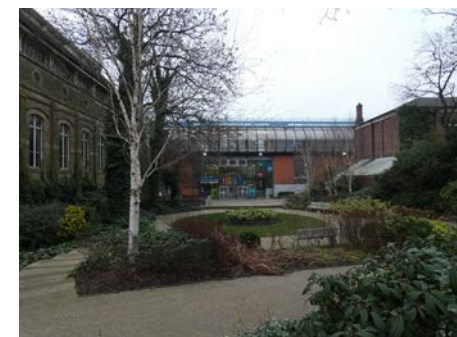
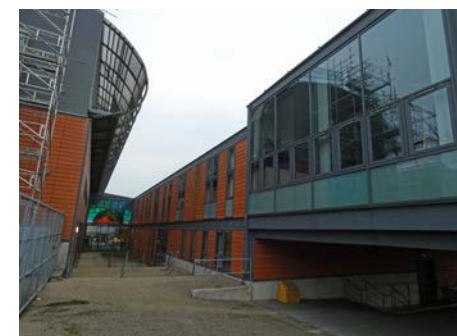
Notes: Art gallery and museum completed in 2002 to the designs of Pringle Richards Sharratt; the library was completed as an extension in 2006. Lower floors of the gallery are in rectangular terracotta tiles, upper floor features a projecting steel hoop design and is glazed. Large glazed entrance faces north, and is visible through the park from Union Street. A glazed bridge links to the rear of the Central Library building. The library to the rear sits a storey lower, but also in terracotta tiles. A two-storey glazed link runs between the gallery and its extension. The façade of the building forms a unique and pleasing contrast within the setting of the surrounding Victorian streetscape, and frames views of the park.
