Donald Insall Associates
Chartered Architects and Historic Building Consultants

**Oldham Town Centre Conservation Area Appraisal and Management Plan
Supplementary Planning Document**

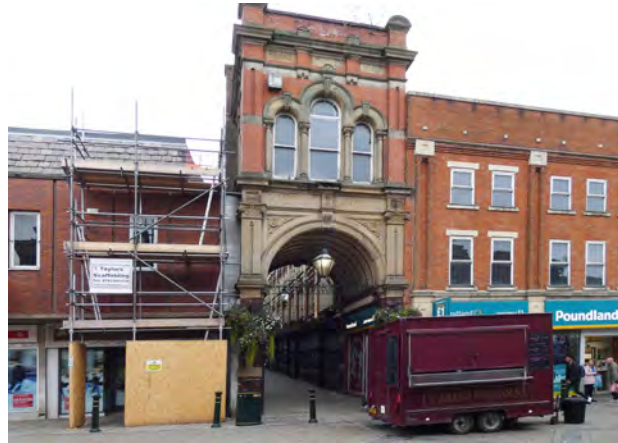
Only one townscape block on the northern side of the High Street is currently located within the conservation area. In townscape terms it has a weak corner, with the modern buildings at nos.1 and 3 cutting into the corner of the Hilton Arcade block (an important local landmark containing a Victorian arcade recommended for inclusion on the local list of buildings of merit). Typical of many high-quality buildings in the conservation area, they in the main part form a dead frontage, despite the replacement of the poor arcade shopfronts in recent years, giving an overall atmosphere of vacancy and neglect. Externally the retail frontages to almost the entire townscape block are poor **[Plates 5.11 and 5.12]**.

Plate 5.11 Hilton Arcade, recommended for inclusion on local list but marred by poor retail frontage and detracting building at nos.1-3 which cuts away corner

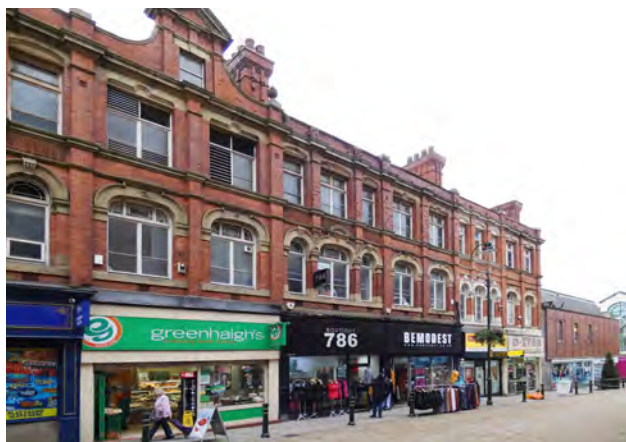
Plate 5.12 Poor retail frontage along Curzon Street at ground floor to Hilton Arcade group

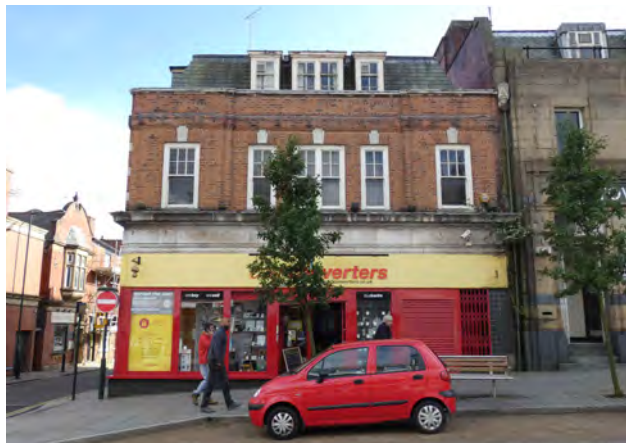
Plate 5.32 Impact of poor quality retail frontage, roller shutters and signage on quality of buiding above at 22-24 Yorkshire Street

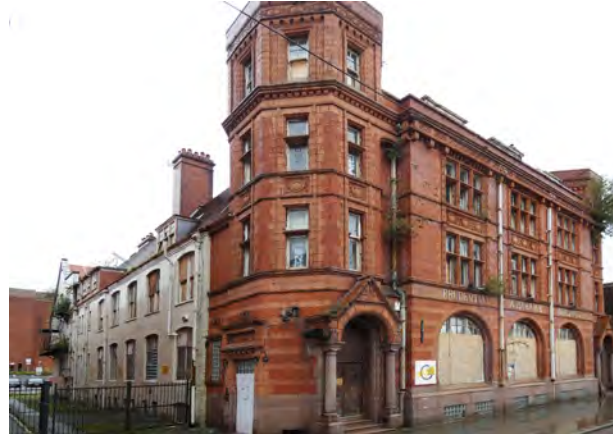
Plate 5.40 Prudential Assurance Building

The Prudential Building was constructed in 1889 to designs by Alfred Waterhouse. It is constructed in red brick with elaborate terracotta dressings set on a polished granite plinth with polygonal towers over the entrance to each side and rich ornamentation. The western return façade is clad in glazed brick. The building is vacant and in a very poor state of repair and is recommended for inclusion on a local heritage at risk register. It occupies a prominent location adjacent to Oldham Central tram stop and is in urgent need of reuse and restoration both for the conservation of the building itself and owing to the significant potential it presents for improving the identity of, and wayfinding into, the conservation area.

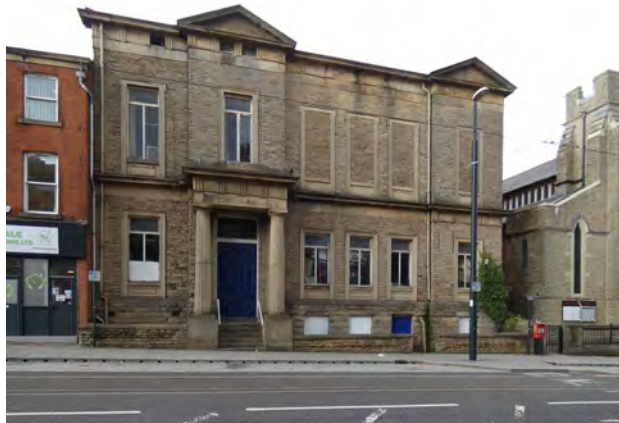
Plate 5.42 The Masonic Hall

The Masonic Hall was constructed in 1880 again in rusticated rubble in the Greek revival style including a portico with fluted Doric columns. A further red brick rear wing was added in 1924. It counterbalances the former post office and library on the facing side of the street and collectively they have a strong visual presence. The building is vacant and in a poor condition; it is in need of reuse, repair and refurbishment to secure its long-term conservation.

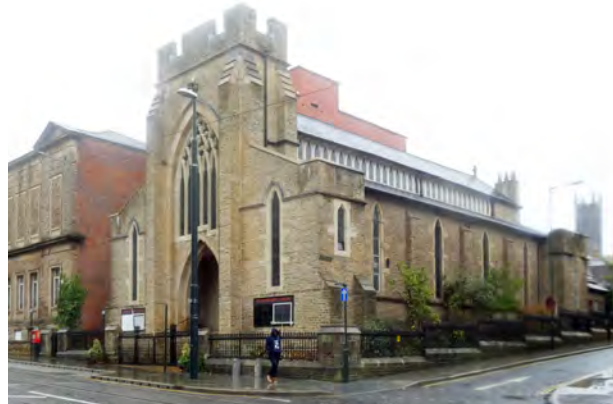
Plate 5.43 United Reform Church

The United Reformed Church was built in 1877 and was formerly a Congregational chapel. It follows the pattern for rusticated rubble with a squat central tower in the south wall with a six- light decorated window and wide plain stepped Early English arch to porch. The church sits next to the Masonic Hall and forms part of the grand architectural group with the former post office and library. The church is currently on Historic England's At Risk Register although it is noted that it has recently been the subject of a scheme of repair and refurbishment.

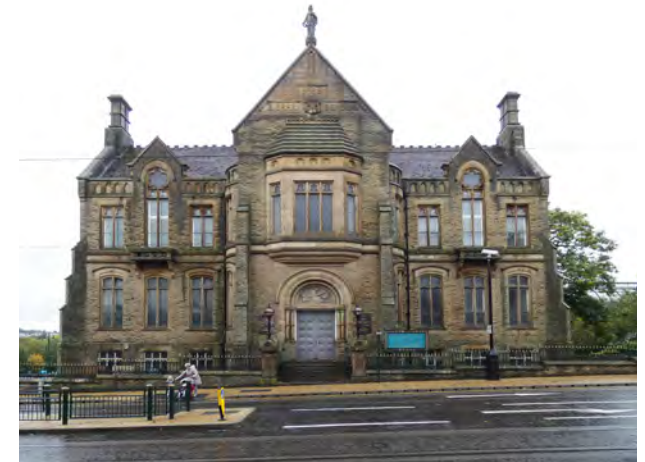
Plate 5.44 Former Central Library

The Library and Art Gallery were constructed in 1883 (with additions in 1894) in rusticated rubble, with a Romanesque style entrance and cresting to the pitched roof ridge. To the street frontage the cast-iron railings and terminating piers flanking the entrance steps with cast-iron globe lamps are good examples within the conservation area. Vacated by the new library and gallery constructed to the rear, the building is soon to be brought back into use as a Heritage Centre.

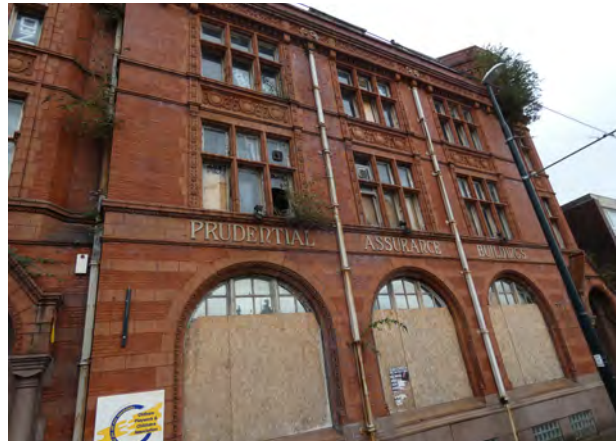
Plate 8.3 The Prudential Building, vacant and in a deteriorating condition

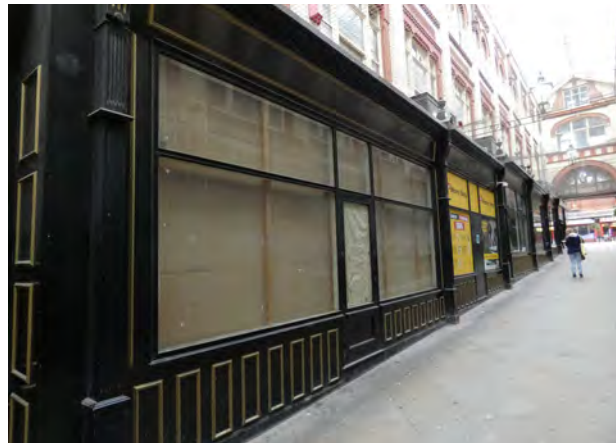
A number of key buildings within the conservation area are vacant and in poor condition; typically they are large-scale buildings occupying prominent locations and significantly detract from the character of the conservation area. Most critical is the Prudential Building, which is clearly in a deteriorating condition and is recommended for inclusion on a local heritage at risk register **[Plate 8.3]**. Others include the vacant half of the Lyceum, the soon-to-be-vacated former post office, the Masonic Hall and the Greaves Arms (see entries in the Gazetteer for further details). Whilst not strictly vacant, the Hilton Arcade has an air of vacancy owing to the dead frontage that the shops backing on to the central arcade have created **[Plate 8.4]**.

Plate 8.4 Blank shopfronts along the Hilton Arcade

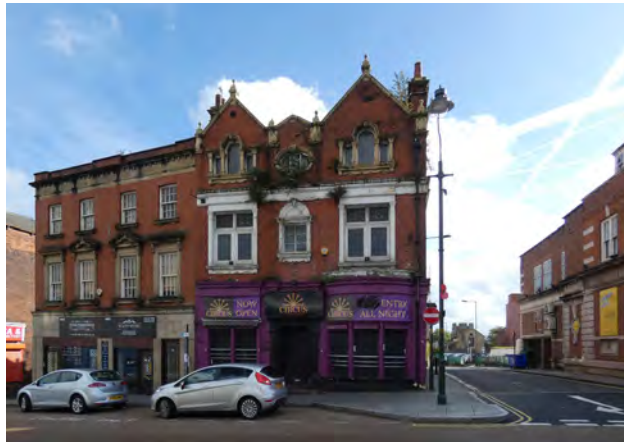
Plate 8.5 Poor condition typical of many buildings within the conservation area

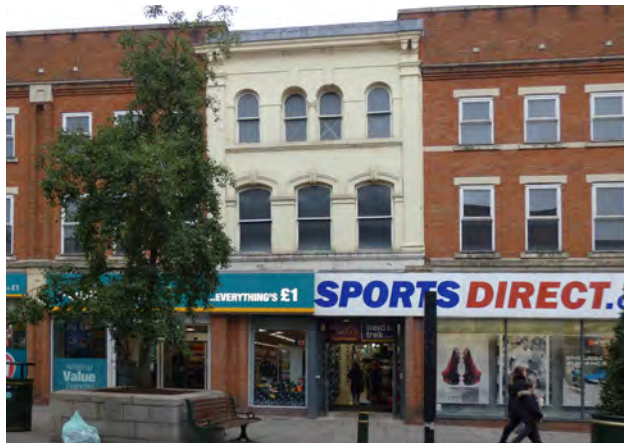
The most significant detracting feature within the conservation area is the retail frontage. Oldham Town Centre benefits from being largely pedestrianised, and as a consequence the human experience at ground level is dominated by a ground floor-level of buildings unhindered by traffic. Whilst the absence of traffic is a major benefit, the poor-quality contemporary shopfronts, often comprising large, single-glazed openings, projecting box signs and internally illuminated and often oversized fascias, dominate otherwise typically handsome buildings above and overly intrude into the streetscene. Roller shutters are also commonplace, creating a deadening frontage when closed and adding to the perception of crime and antisocial activity at night time **[Plates 8.7 – 8.9]**.

Plate 8.8 Poor shopfronts and signage across 15 -17 High Street which fails to relate to architecture of building above

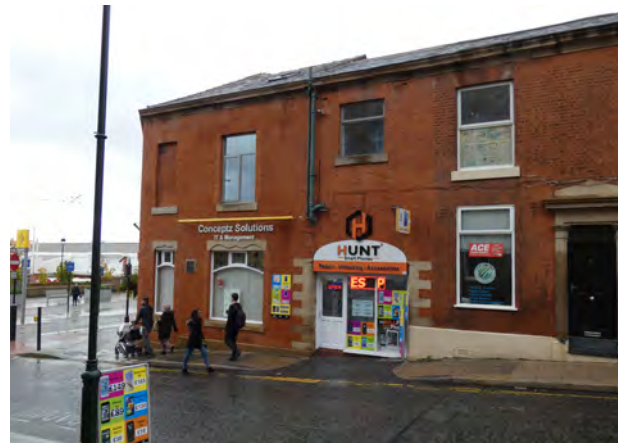
Plate 8.9 Poor shopfront infilling historic archway at southern end of Clegg Street

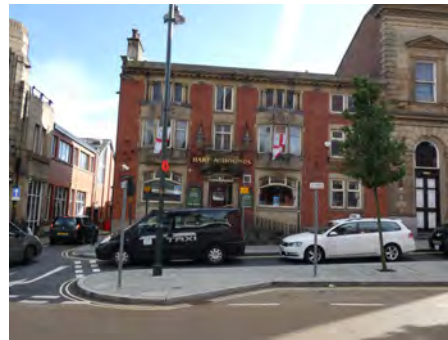
16 Yorkshire Street

Notes: Three storey public house in red brick; stone detailing provides attractive contrast but would benefit from cleaning. Conspicuous cabling and later windows at first and second floors detract; secondary glazing within visible from street level. East return elevation to Hunter's Lane built in three visible phases, stepping down to a single-storey elevation at rear. Conduit and condition of brickwork and windows detract.

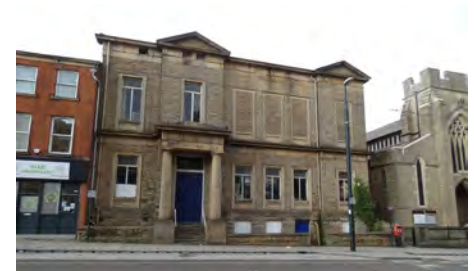
105 Union Street, Masonic Hall

Notes: Asymmetrical frontage in Greek revival style provides interest, but present condition detracts from the character of the conservation area, including laminating brickwork, poor repointing repairs, visible water ingress, broken pipes, etc. To the rear, a four-storey wing in red brick with stone detailing; blocked windows and a modern upper-storey extension are visible from Firth Street and detract. New use needed.

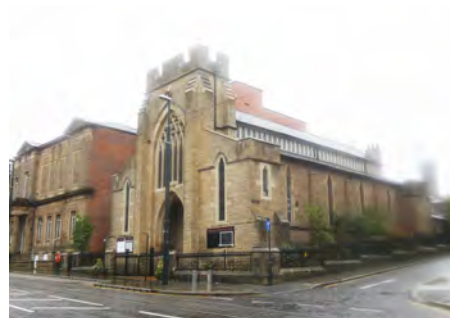
107 Union Street, United Reformed Church

Notes: Improved condition following a recently-awarded HLF repairs grant, but remains on the Buildings at Risk Register. One of few remaining churches by Moffat Smith; Gothic, non-conformist style in sandstone. Distinctive spire lost in 1930s. Rear is in good condition.

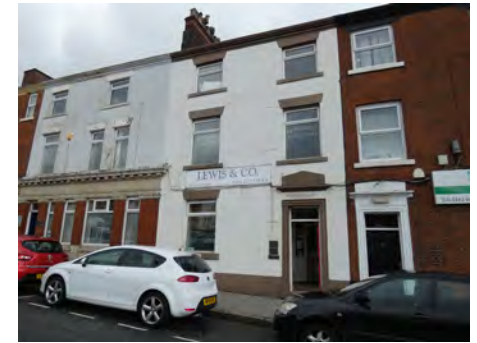
21 Queen Street

Notes: Fully rendered and modern windows throughout detract from the red brick of the wider range. Cracking to render visible in places.
