# 8<sup>th</sup> and 10<sup>th</sup> June 2016 Flood Investigation Report

**Oldham Council**

Monday, 24 April 2017

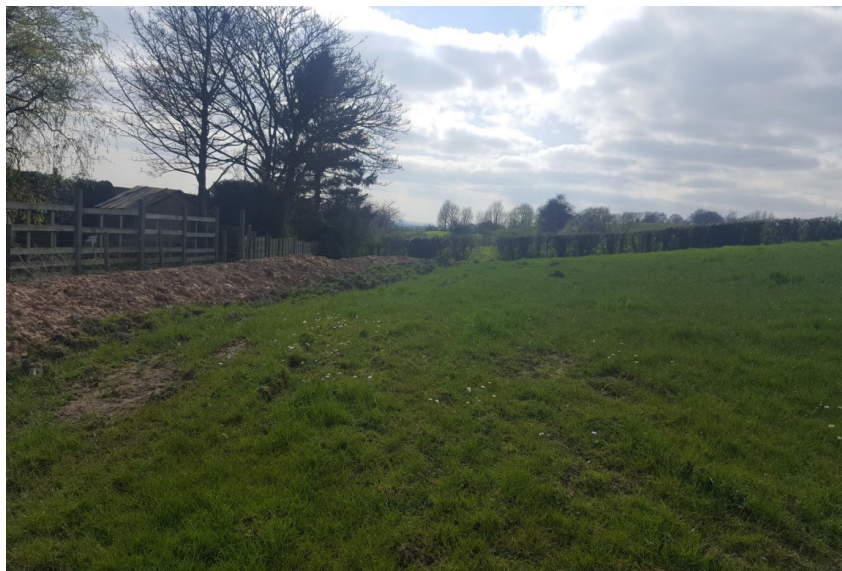
Figure 7: Grasmere Road, Royton North

The total number of incidents of flood water entering the habitable space of a property at this location is 3. The total number of incidents of flood water entering a property garden and/or outbuilding at this location is 18.

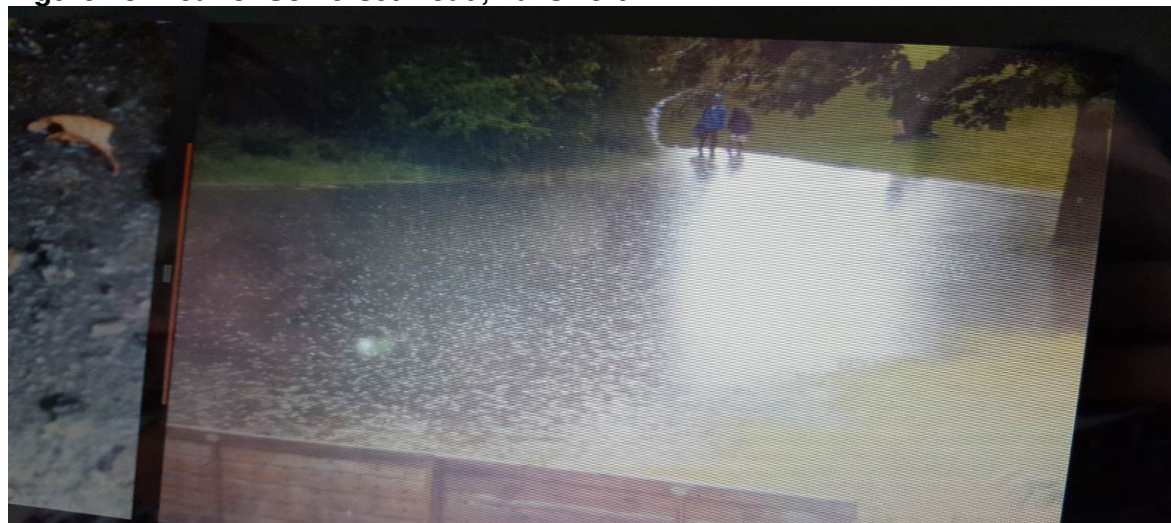
Figure 13: Rear of Somerset Road, Failsworth

The total number of incidents of flood water entering the habitable space of a property at this location is 2. The total number of incidents of flood water entering a property garden and/or outbuilding at this location is 3.

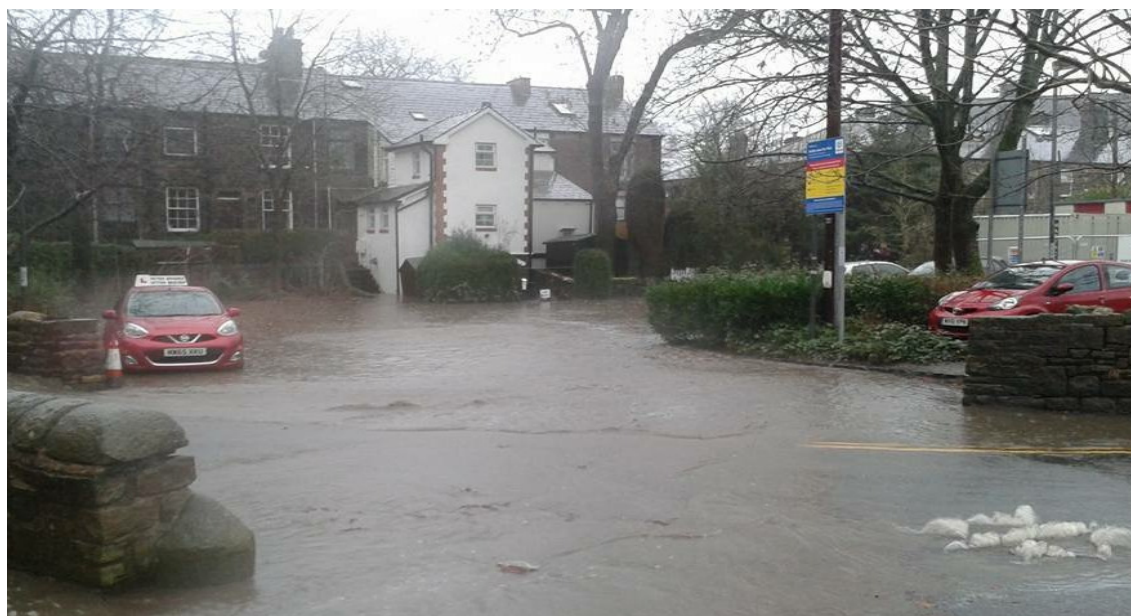
Figure 19: Flooding to Smithy Lane, Uppermill

The total number of incidents of flood water entering the habitable space of a property at this location is 7. The total number of incidents of flood water entering a property garden and/or outbuilding at this location is 10.

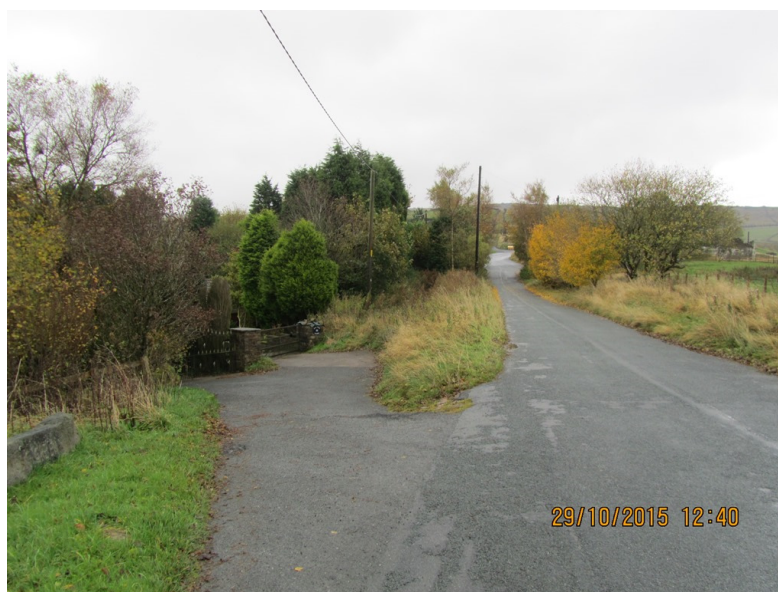
Figure 22: Bleak Hey Nook, Standedge Foot Road

The total number of incidents of flood water entering the habitable space of a property at this location is 1. The total number of incidents of flood water entering a property garden and/or outbuilding at this location is 3.
