13th September 2016 Flood Investigation Report

Oldham Council

Monday 24 April 2017

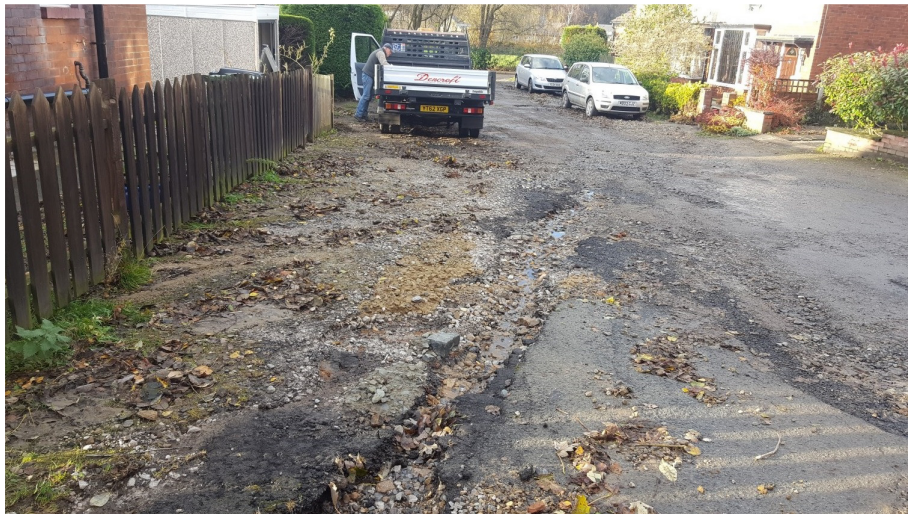
Figure 12: Arthurs Lane, Greenfield

Evidence gathered as part of an investigation indicates that Arthurs Lane, Greenfield flooded on the 13th September 2016 from surface water, a culvert and the hydraulic incapacity of the existing drainage system. During a short period of intense rainfall a trash screen on Golborne Clough (a culverted watercourse) became blocked with debris - due to its poor design. Flood water collected and overspilled onto a nearby bridle path and ran along its length following the existing drainage channels. Overspilling water cascaded down onto Arthurs Lane and flooded numerous properties. The capacity of Golborne Clough was overwhelmed and resulted in a manhole located on the Bridle path surcharging, which contributed to the flooding at Arthurs Lane.
